Stage 1 Road Safety Audit

South Circular Rd to Bishops Quay Cycle Lane, Limerick City

On behalf of Limerick City & County Council

September 2022

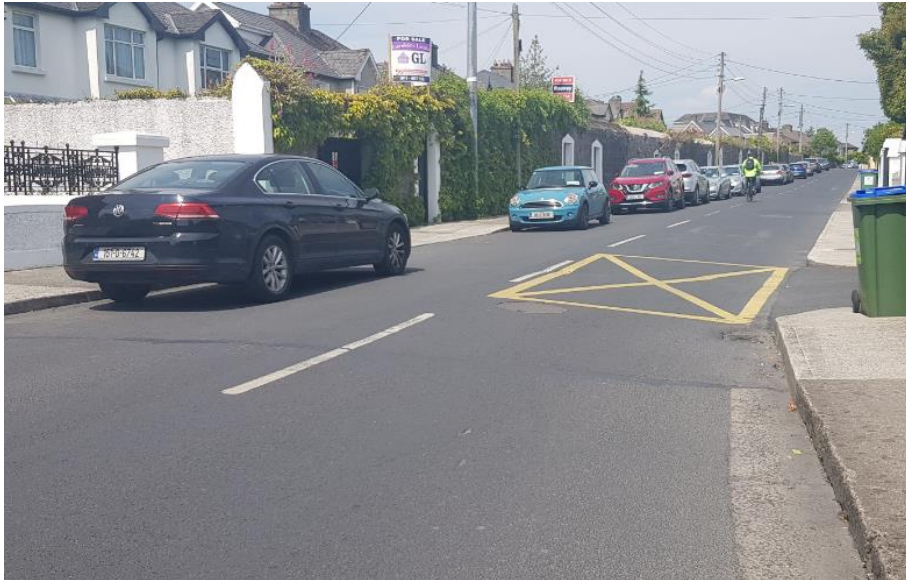
Problem: The proposals involve removal of the majority of existing car parking from South Circular Road. There is no alternative parking indicated on the drawings.

Hazard: Cars parked by house occupants may continue to park in the general area of their residence. This may be on the reduced width carriageway or footpath. The cyclists may be required to enter the opposing traffic lane to pass the parked vehicle. Impact with opposing traffic may result.

Recommendation: Adequate car parking should be provided in close proximity to the existing parking demand.

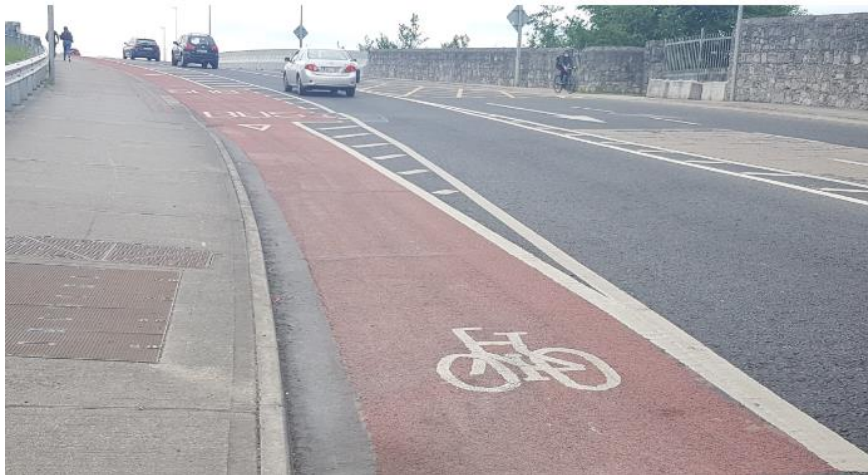
Problem: The existing southbound cycle lane to the east of Ballinacurragh Road is not shown on the drawings. It is likely the majority of southbound cyclists will make use of this lane and not the proposed lane to the west of the road. Northbound cyclists are likely to become complacent and make use of the full cycle facility to the west of the road.

Hazard: Occasional southbound cyclists who decide to make use of the facility on the western side of the road are at risk of impact from opposing cyclists.

Recommendation: Omit the southbound facility to the west of the road.

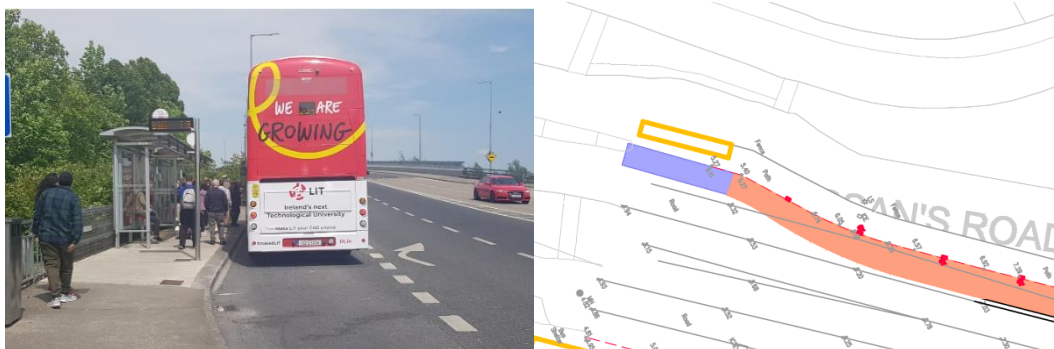
Problem: The cycle facility is shown starting at the existing bus stop (it is not clear how cyclists are intended to get to this point) with cyclists passing in-between the bus shelter and the bus bay.

Hazard: Passengers alighting the bus are at risk of impact from passing cyclists.

Recommendation: Commence the cycle facility to the north of the bus stop.

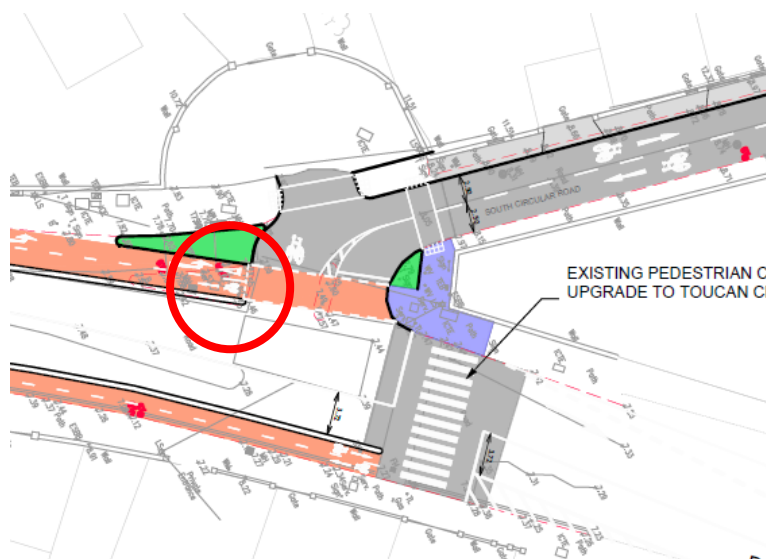
Problem: Northbound cyclists are advised to yield at the junction. It is unclear who these cyclists are meant to yield to.

Hazard: Some cyclists may slow/stop at the yield symbol and be subject to rear end collisions from other cyclists.

Recommendation: Omit the yield markings. See also 3.3.5 below.

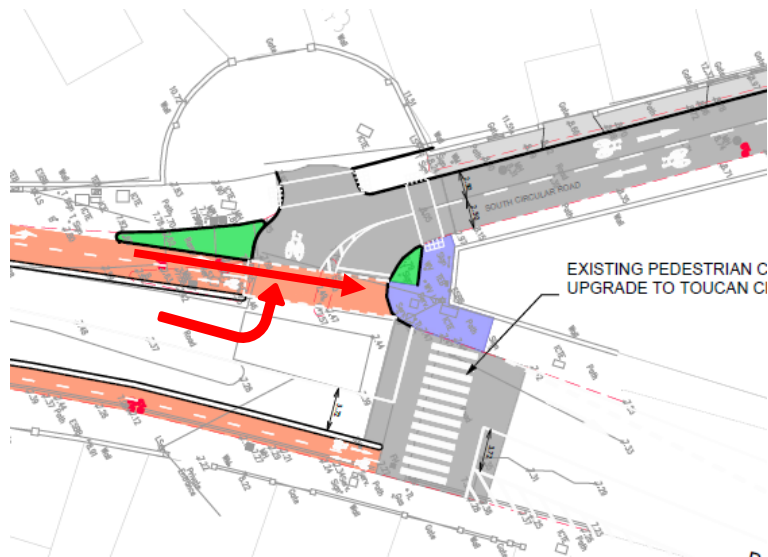
Problem: There is a 'yield' symbol shown to northbound cyclists arriving at the junction. However the cyclist may proceed straight through the junction at the same time as Ballinacurragh motorists turn left into South Circular Road.

Hazard: Cyclists / motorist impacts may result.

Recommendation: Adjust the road layout such that cyclists are introduced into the Ballinacurragh main carriageway in advance of the junction, whereby it is obvious to the motorist that the cyclists may proceed through the junction.

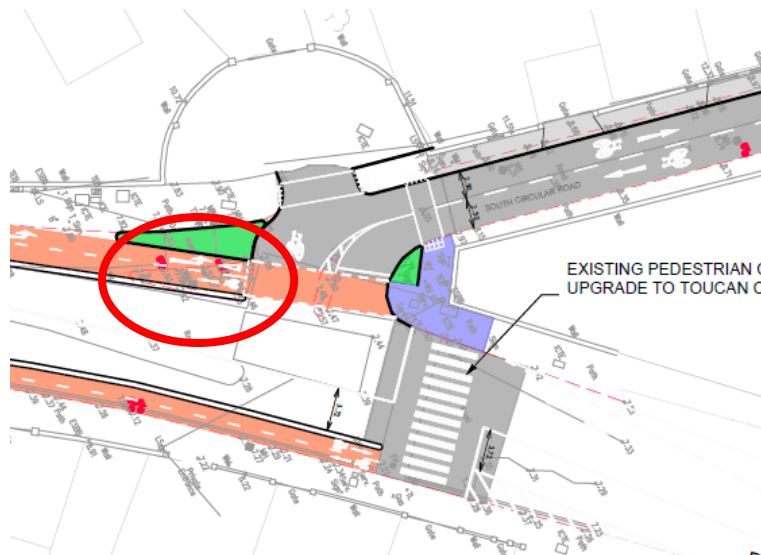
Problem: It is not clear how southbound cyclists are meant to access the cycle lane to the west of Ballinacurragh Road.

Hazard: There is risk that cyclists on Ballinacurragh Road or South Circular Road will cut across and in front of motorised traffic in order to access the cycle lane.

Recommendation: Omit the southbound cycle lane to the western side of the road.

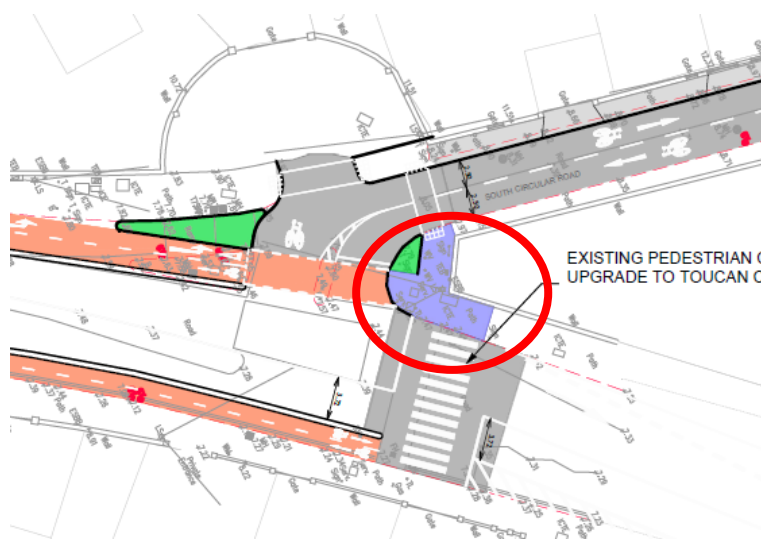
Problem: Cyclists are directed onto a shared surface / footpath at the junction. Cyclists wishing to continue north-west on Ballinacurragh Road are directed onto the existing footpath.

Hazard: Impact with pedestrians may result.

Recommendation: Terminate the cycle facility short of the existing footpath and cater for cyclists within junction. North-west bound cyclists should be directed onto the main carriageway, not the footpath.

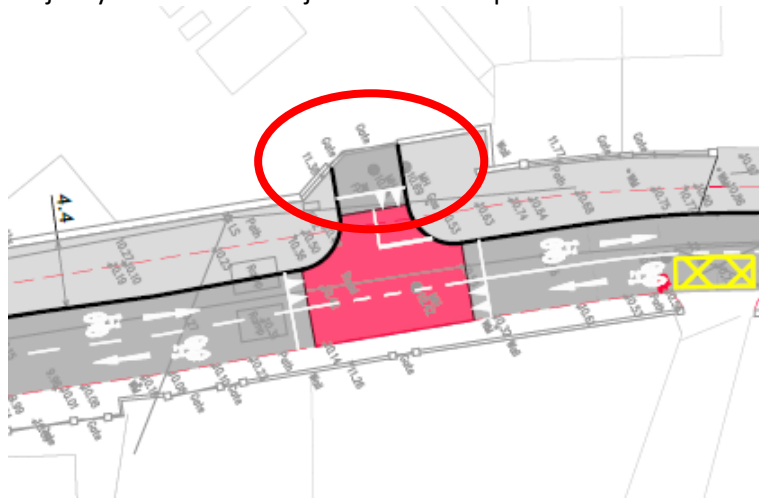
Problem: The gated access to the north of Greenpark Close is shown with a raised table type junction. Motorists exiting this access are offered priority over pedestrians passing the access. It is likely the majority of traffic at this junction will be pedestrian.

Hazard: Motorists exiting the development may not take adequate care as they have priority. Impact with crossing pedestrians may result.

Recommendation: Omit the vehicular priority and treat as a simple footpath crossover.

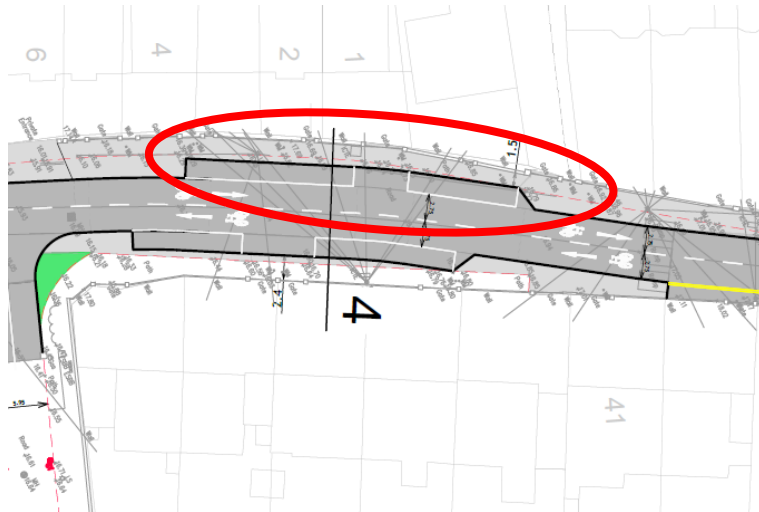
Problem: The proposed parking bays cross multiple private driveways.

Hazard: Occupiers may get their car blocked in by vehicles parked in the bay. The dwelling occupant may decide not to park in their driveway on future occasions due to this risk of blocking. This may result in additional demand for on street parking / congestion / risks to cyclists passing on street parked vehicles.

Recommendation: Provide yellow box markings for all active driveways.

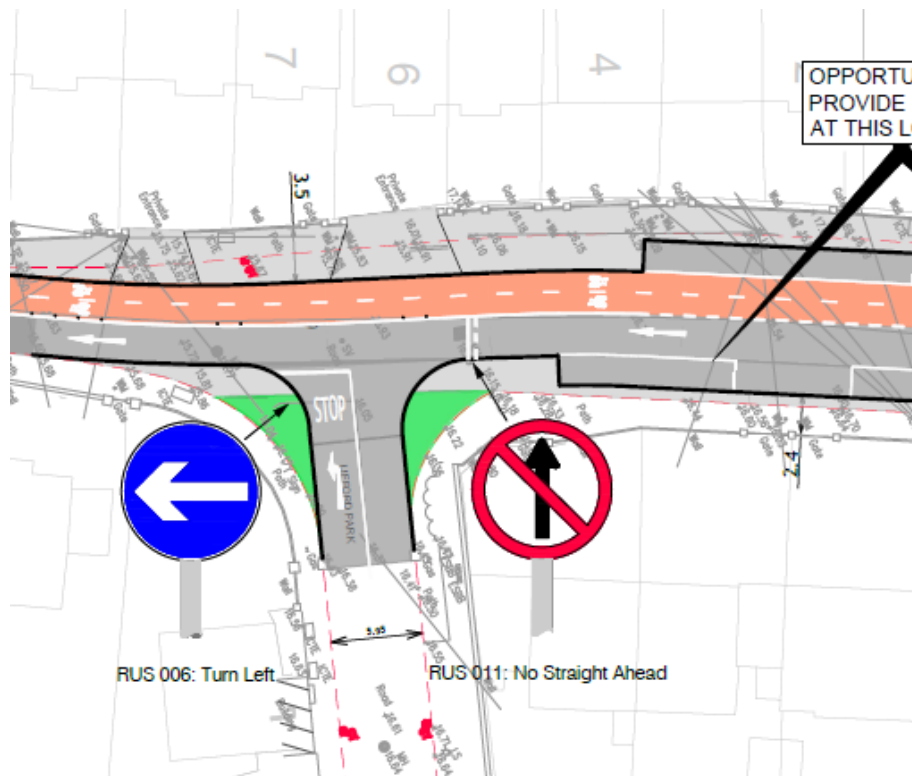
Problem: The carriageway width is indicated as 2.5m. There is no restriction to traffic type on this road. There is a road junction with Lifford Park and some of the houses have private driveways accessed perpendicular to the carriageway.

Hazard: Wide and/or long vehicles may have difficulty in navigating such a narrow road. Users may have difficulty in turning left out of Lifford Park. Cars may experience difficulty in exiting their driveways. In all scenarios the user may bump up the segregation strip and enter the cycle facility.

Recommendation: Ensure adequate carriageway width is maintained. The alternative option offered on drawing 402 does not have such problems.

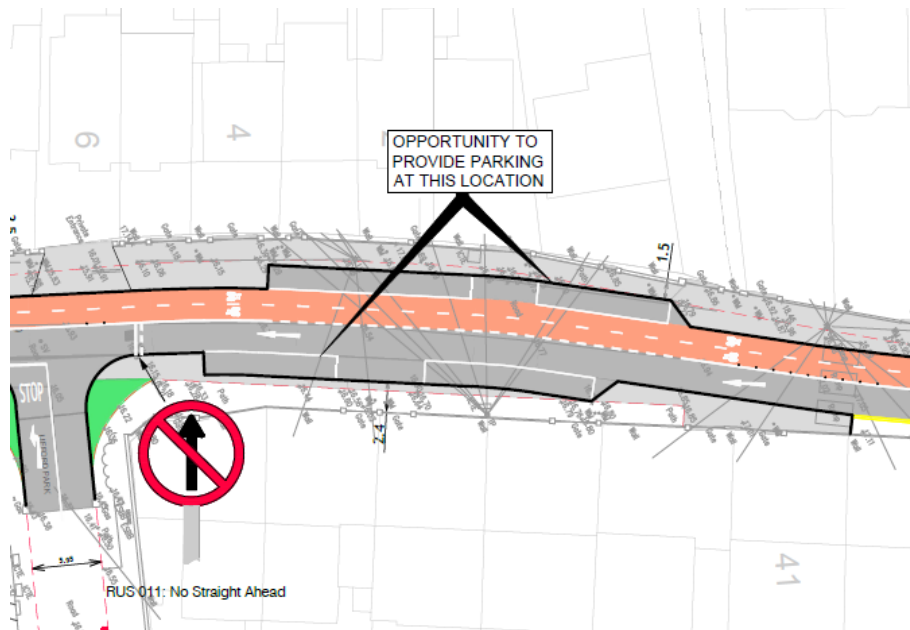
Problem: The cycle facility abuts the car parking bays to the north of Lifford Ave.

Hazard: Car passengers may open their door into the path of oncoming cyclists.

Recommendation: Provide a buffer strip so cyclists are guided away from the potential opening door. This may require using some of the footpath space for the car parking bay. This issue pertains to both options shown on drawing 402 and 406.

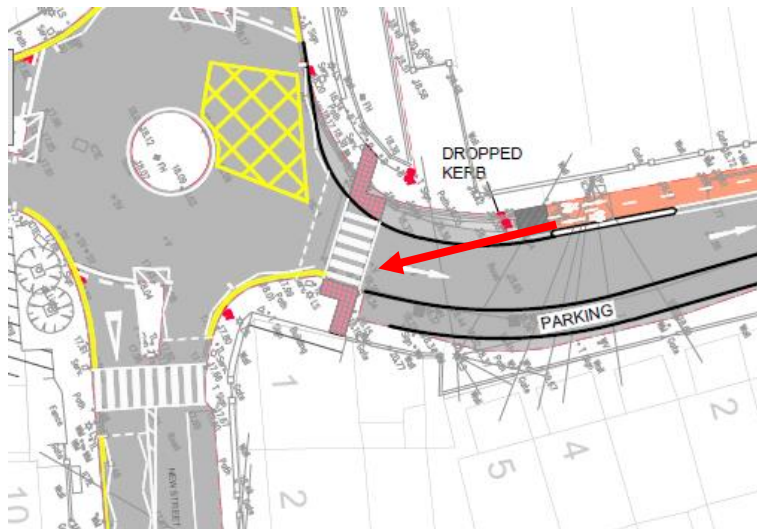
Problem: Southbound cyclists arriving at Ashbourne Avenue roundabout are not provided with any guidance or facilities to access the roundabout safely.

Hazard: The cyclist may depart the cycle lane into the path of opposing motorised traffic.

Recommendation: Terminate the southbound cycle lane at / near the pedestrian / toucan crossing at the school and provide a southbound cycle facility to the eastern side of South Circular Road as far as the roundabout.

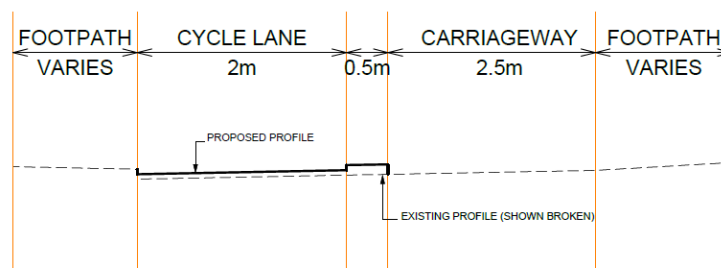
Problem: The carriageway width is indicated as 2.5m. There is no restriction to traffic type on this road. Some of the houses have private driveways accessed perpendicular to the carriageway.

Hazard: Wide and/or long vehicles may have difficulty in navigating such a narrow road. Cars may experience difficulty in exiting their driveways. In both scenarios the user may bump up the segregation strip and enter the cycle facility.

Recommendation: Ensure adequate carriageway width is maintained.

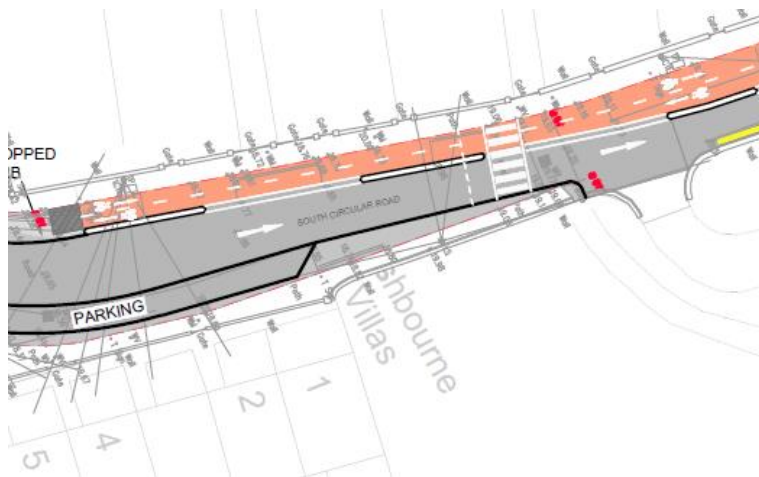
Problem: The proposals will reduce carriageway width near the entrance to Scoil Mháthair Dé. It is not known if this area is used for temporary set down for school collections / drop off.

Hazard: The reduced carriageway width may result in congestion in the area and traffic backing up on the roundabout junction. Rear end shunts may result.

Recommendation: Ensure adequate provision is made for school collections / drop offs.

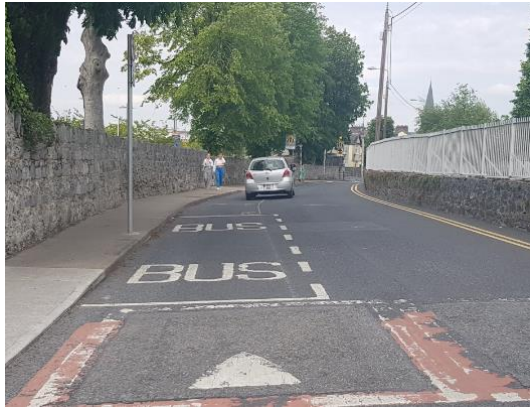
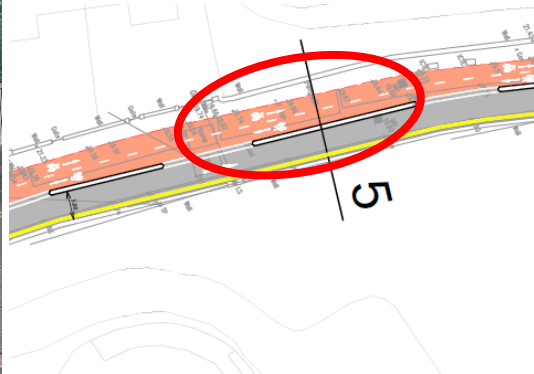
Problem: There is an existing bus stop opposite Scoil Mháthair Dé. This stop is not shown on the proposal's drawings. The carriageway in this area is to be reduced in width such that passing a stationary bus will not be possible.

Hazard: Traffic may back up onto the roundabout. Rear end shunts may result.

Recommendation: Ensure delays from any stationary bus are acceptable and do not result in excessive queuing.

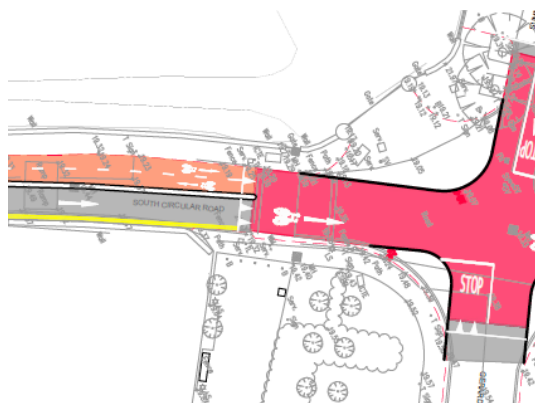
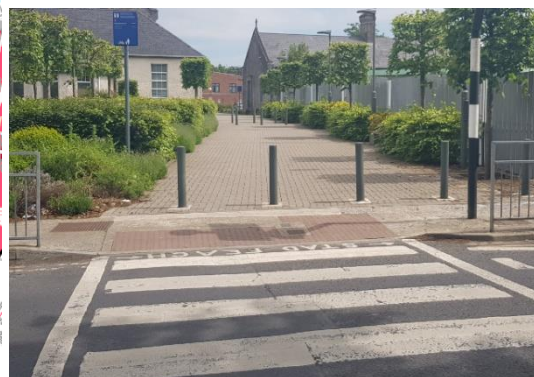
Problem: The existing zebra crossing of South Circular Road at Mary Immaculate College is being removed by the proposed works. It is likely this pedestrian crossing is well used during term times.

Hazard: Crossing pedestrians are at increased risk of impact from South Circular Road traffic.

Recommendation: Maintain the zebra crossing.

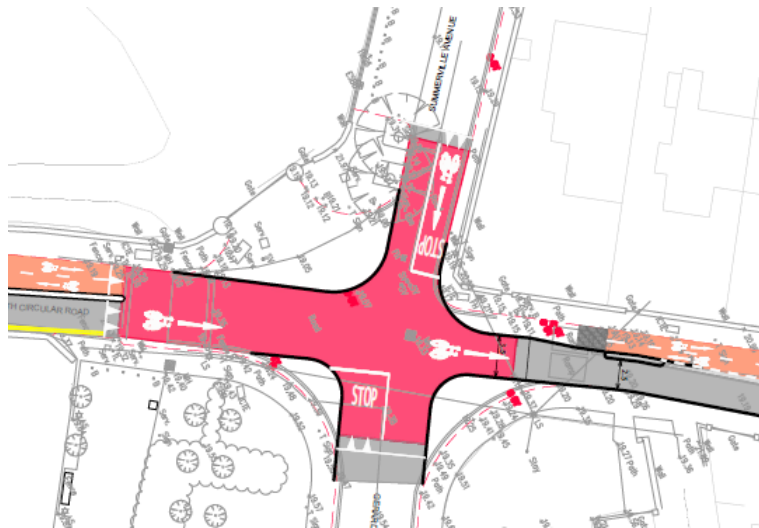
Problem: The kerb lines at the Summerville Ave junction are to be reduced in radius by the works. Users exiting the college turning left into Summerville Ave are unlikely to be able to undertake the turn without entry to the opposing traffic lane.

Hazard: Head-on impact with Summerville Ave traffic may result.

Recommendation: Undertake swept path Autotracks and amend the design as deemed appropriate.

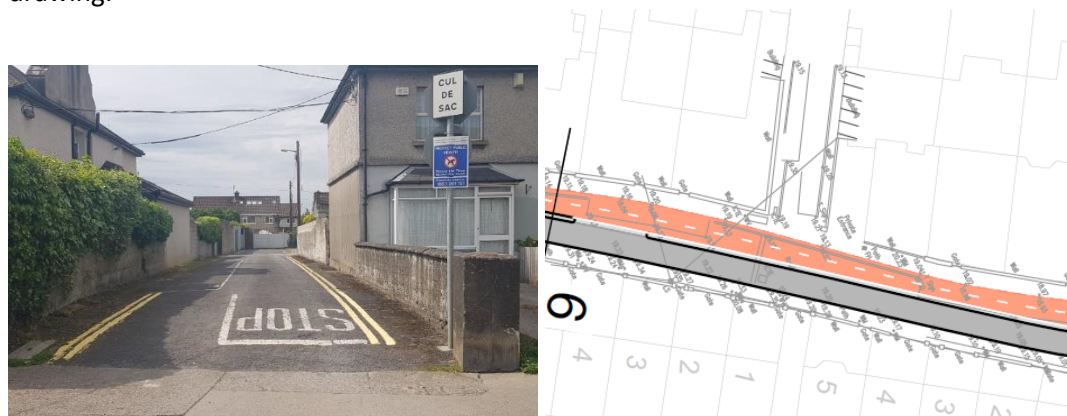
Problem: There is an existing vehicular access lane to the north-west of Summerville Ave that serves access to dwelling houses. This access is shown as being blocked off by a raised strip on the proposals drawing.

Hazard: Motorists may make use of the opening to the south and drive along the cycle facility in order to access the lane. Impact with cyclists may result.

Recommendation: Provide direct access to the lane.

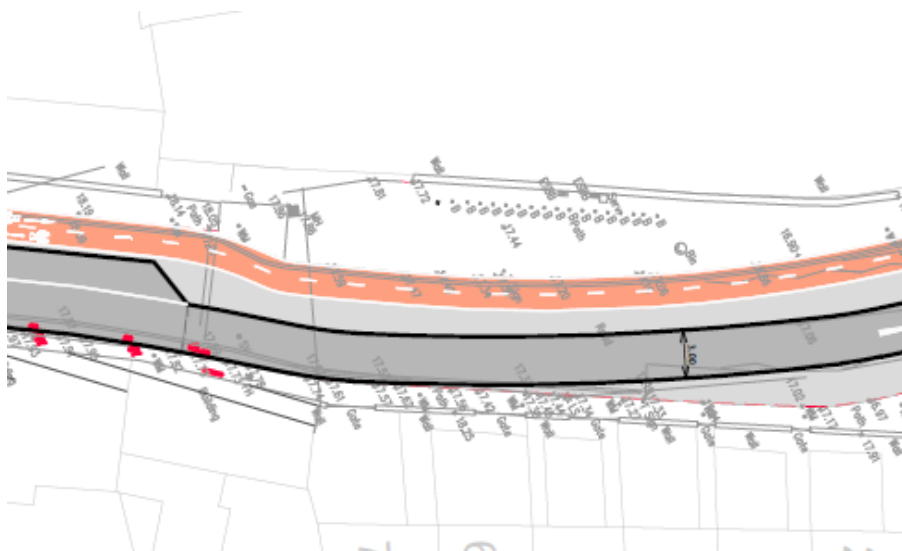
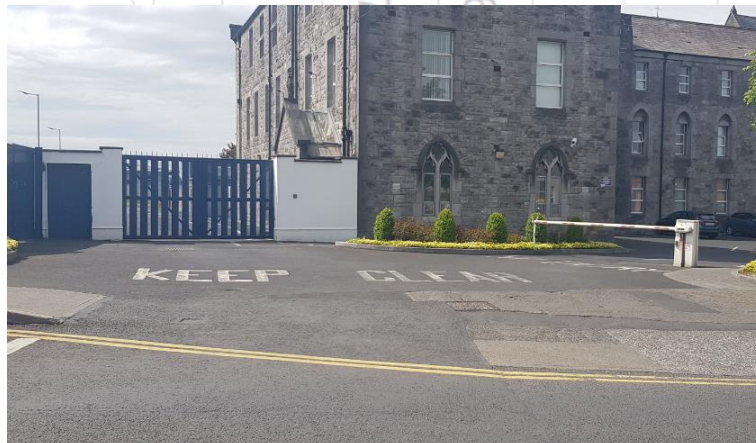
Hazard: Lack of guidance to / from the church car park may result in impact with other church traffic and/or cyclists/pedestrians.

Recommendation: Provide a clear access/egress arrangement for church traffic to access the carriageway.

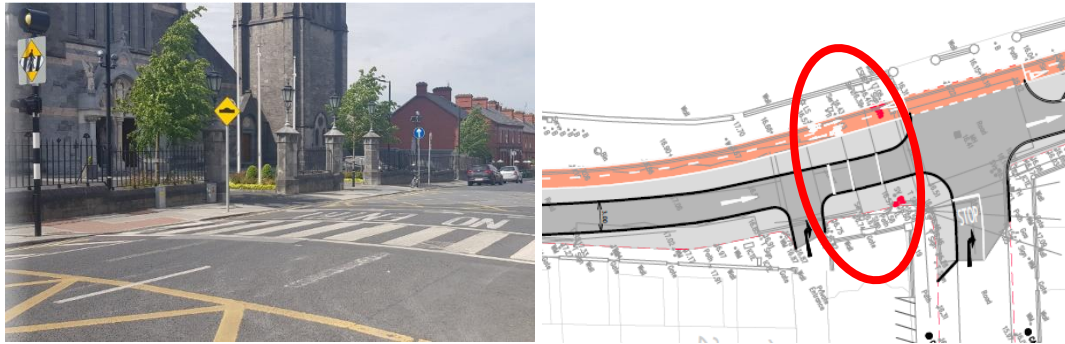
Hazard: Pedestrian confusion may encourage cyclists to continue over the crossing. The cyclist may impact with other crossing pedestrians.

Recommendation: Provide a new crossing with a central refuge and appropriate tactile paving, so the crossing can be undertaken in two halves. Ensure the cyclist is informed to yield to pedestrians.

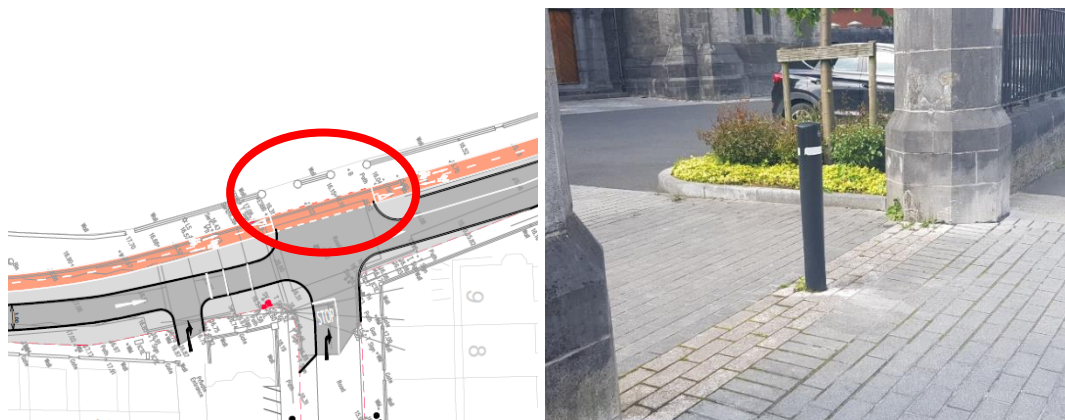
Hazard: Motorists may errantly arrive at the fixed bollard believing it is automated and will lower. This motorist will be required to reverse back into South Circular Road and may impact with approaching vehicles while doing so.

Recommendation: Amend the junction bell mouth to guide users to the open gate only.

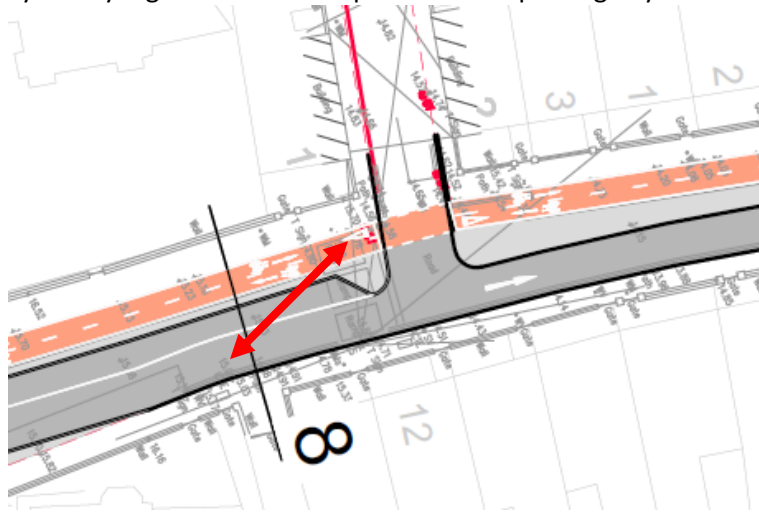
Hazard: The cyclists may commence the crossing of St Alphonsus St. at the same time as the motorist arrives at the junction. Impact with cyclists or rear end shunts may result.

Recommendation: Omit sufficient parking bay to achieve adequate inter-visibility.

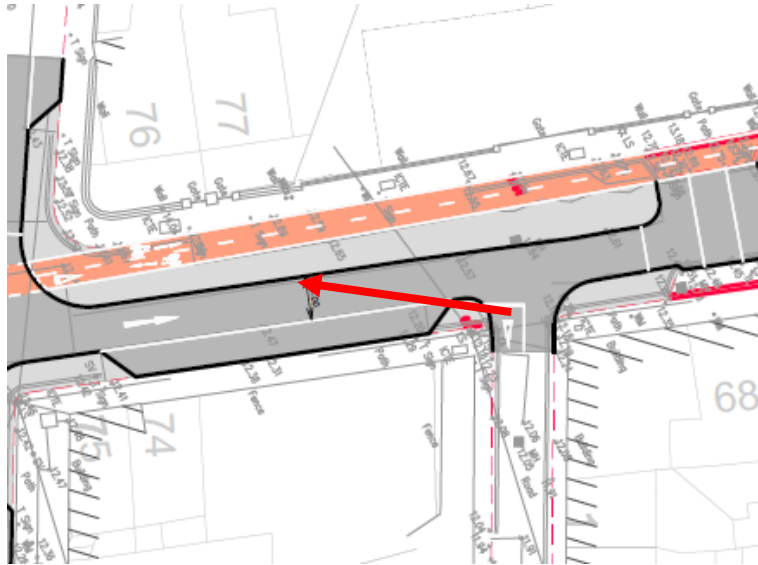
Hazard: Users may errantly exit the junction into the path of oncoming traffic.

Recommendation: Omit sufficient parking to the left of the junction to ensure adequate junction visibility is achieved.

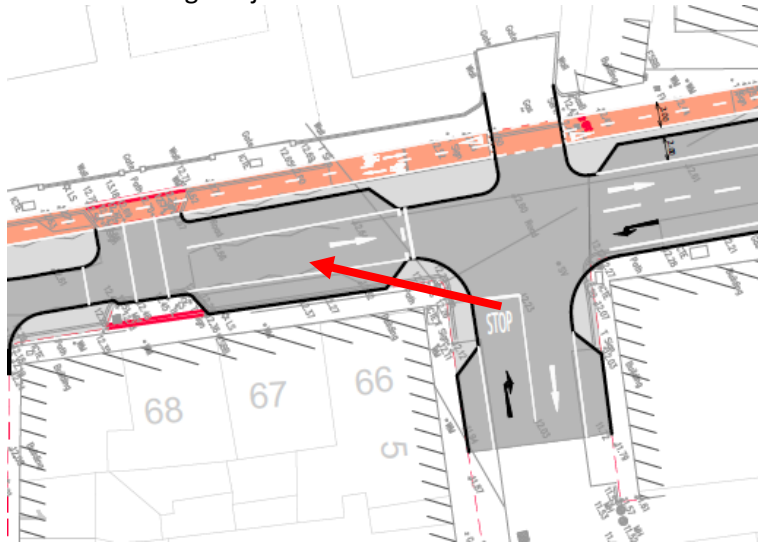
Hazard: Users may errantly exit the junction into the path of oncoming traffic.

Recommendation: Omit sufficient parking to the left of the junction to ensure adequate junction visibility is achieved.

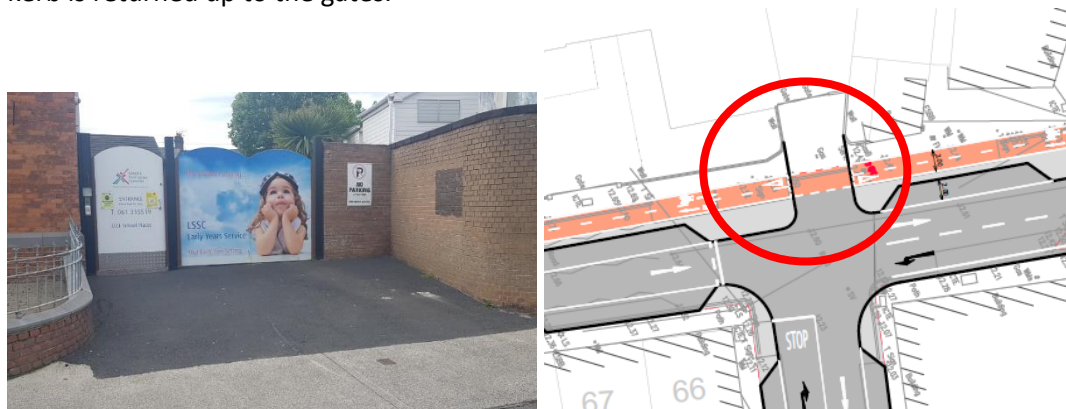
Hazard: Confusion may arise between pedestrians/cyclists and motorised users to who has priority here. Impact between these users may result.

Recommendation: Omit the kerb returns and treat as a standard footpath crossover.

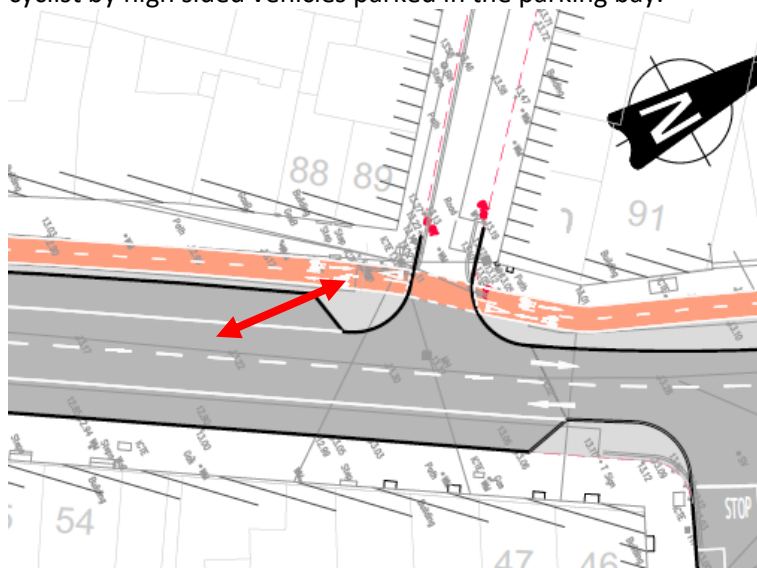
Hazard: The cyclists may commence the crossing of Windmill Street at the same time as the motorist arrives at the junction. Impact with cyclists or rear end shunts may result.

Recommendation: Omit sufficient parking bay to achieve adequate inter-visibility.

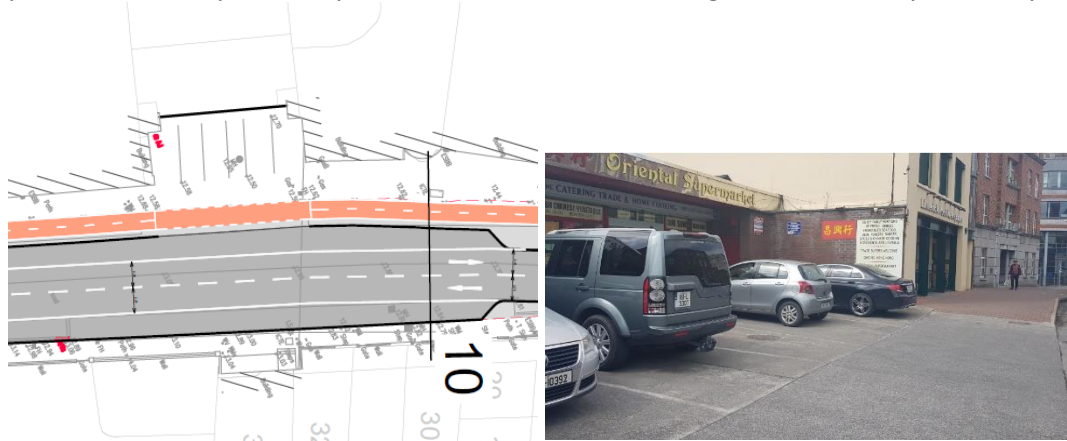
Problem: There are a number of car parking spaces to the front of the oriental supermarket. These users were observed driving forwards into the spaces and reversing back onto Henry Street. The provision of the cycle facility will result in the user reversing back over the cycle facility.

Hazard: Impact with cyclists may result.

Recommendation: Omit the perpendicular parking bays.

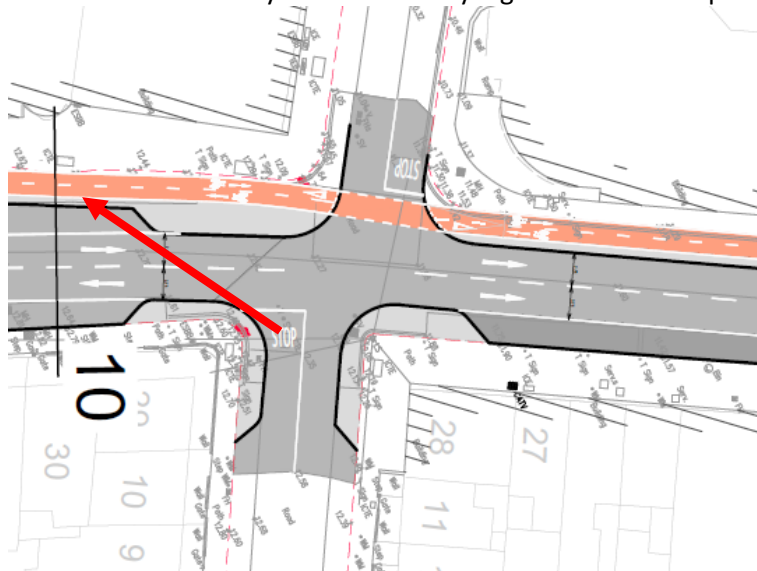
Hazard: Impact with cyclists crossing Mount Kenneth Place may result.

Recommendation: Omit some of the problematic parking bay on Henry Street.

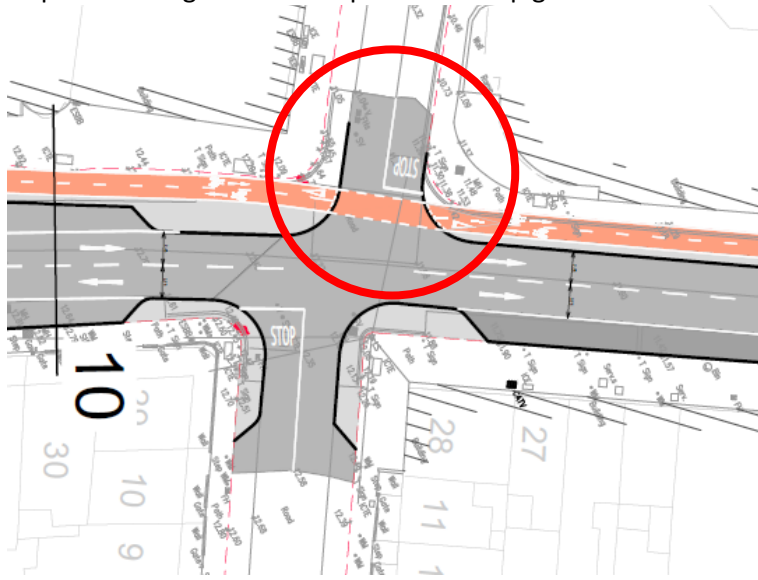
Hazard: The driver may roll backwards or stall upon attempting to exit the junction.

Recommendation: Amend the junction arrangement to provide a dwell area for traffic exiting Mount Kenneth Place.

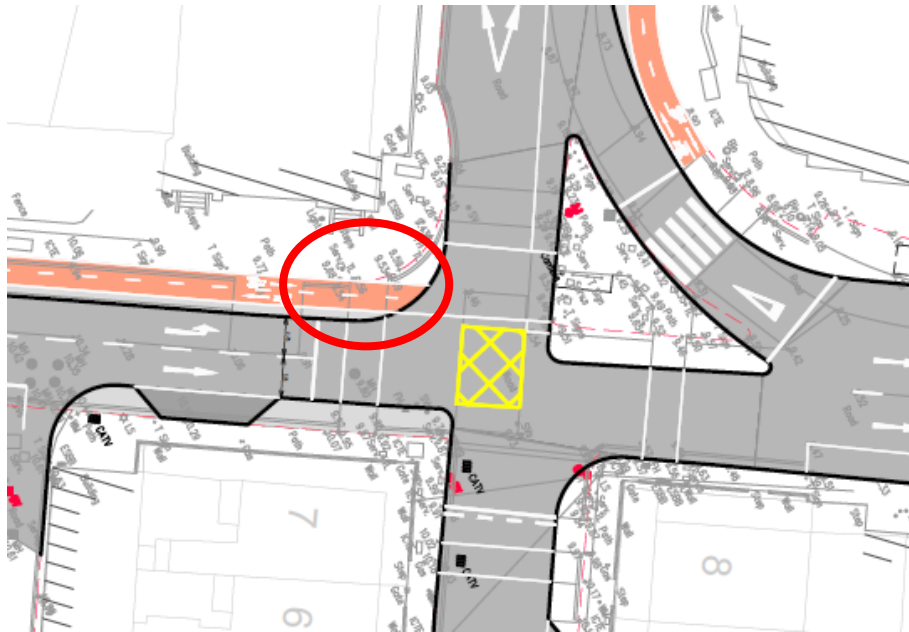
Hazard: Pedestrian / cyclist impacts may result.

Recommendation: Terminate the dedicated cycle facility short of the pedestrian crossing(s) at the junction.

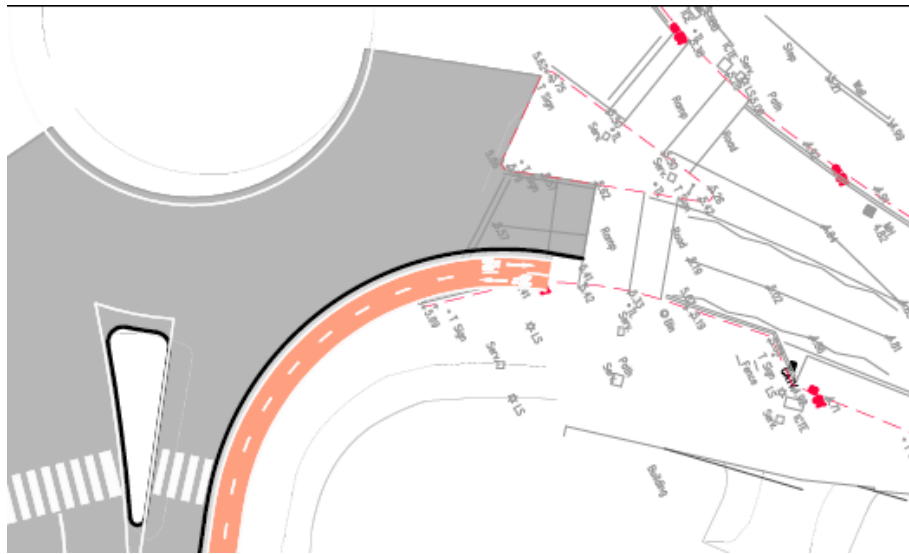
Hazard: The cyclist may make sudden and unexpected directional choices. Impact with pedestrians or motorised vehicles may result.

Recommendation: Provide suitable design(s) for permitting cyclists to continue their journey to all roads at this junction.

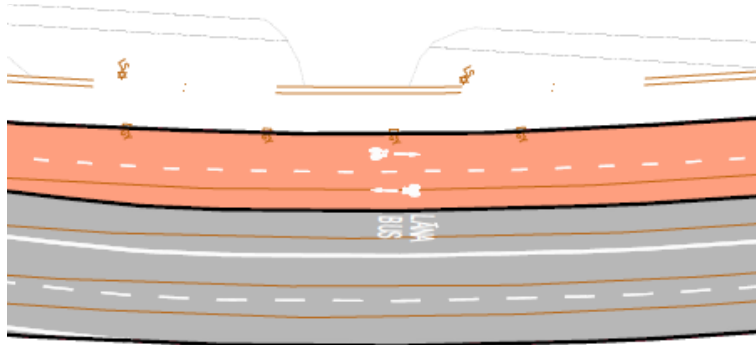
Hazard: Errant cyclists who may enter the carriageway are at risk of head-on collisions with motorised vehicles.

Recommendation: Amend the design such that the cyclist adjacent to the carriageway is travelling in the same direction as the adjacent motorist.

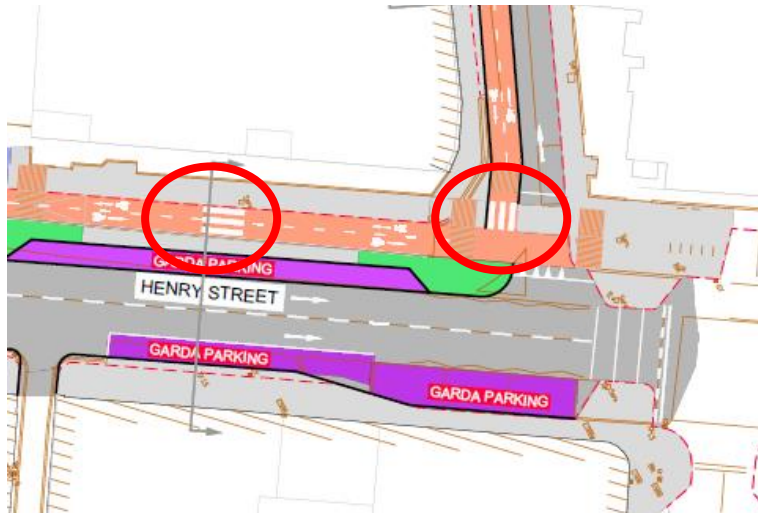
Hazard: Both users may believe they have priority and impact between users may result.

Recommendation: Ensure a full suite of markings and signals / beacons are provided to offer guidance to the user.

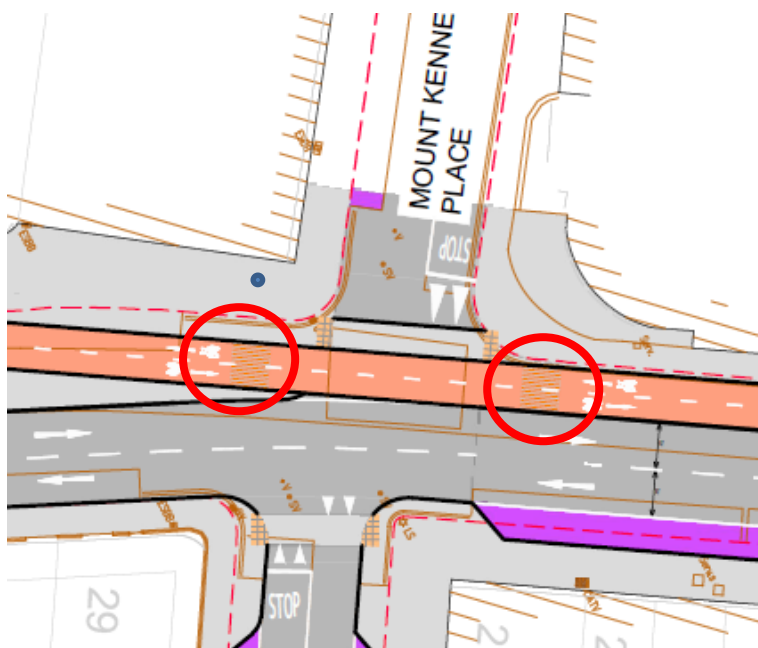
Hazard: Sight impaired users may errantly enter the cycle path in the area of the junction, in between the ladder paving units. The user may be stuck by cyclists.

Recommendation: Maintain a level change between the cycle path and footpath throughout and omit the ladder paving.

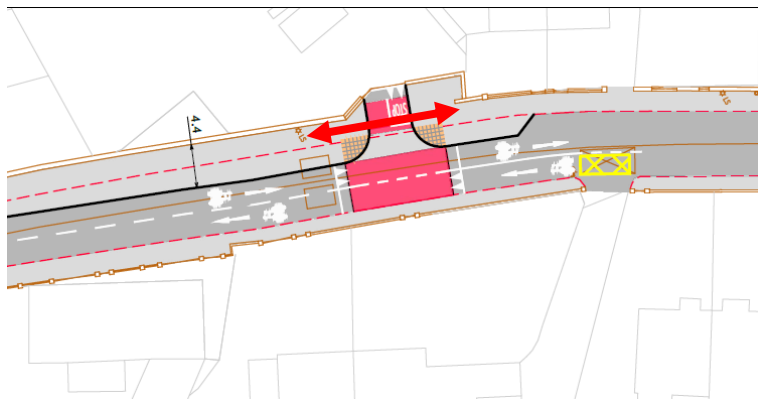
Hazard: Sight impaired users may errantly step into the carriageway into the path of oncoming traffic.

Recommendation: Amend the tactile layout to provide suitable tactile for the intended users and amend the associated road markings to suit.

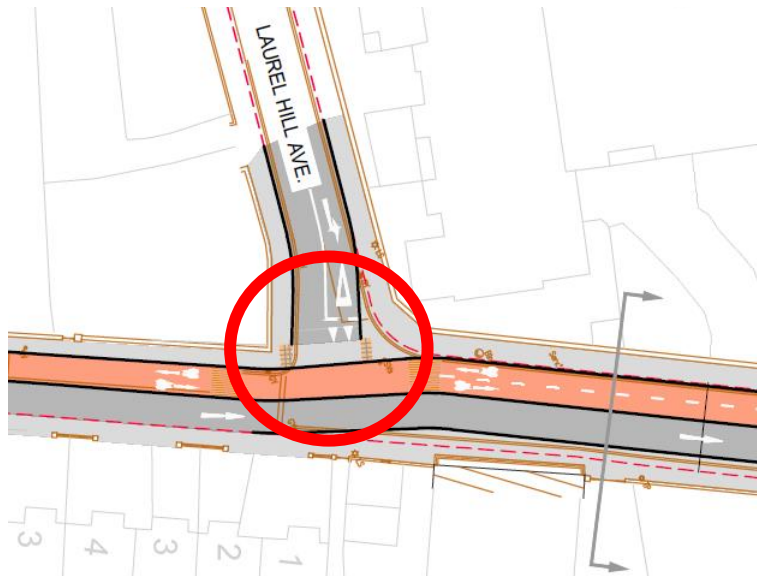
Hazard: Sight impaired users encountering the blister paving are likely to believe they are required to wait for motorists to clear the junction prior to proceeding to cross the road. Confusion between motorists and pedestrians may result in collisions between the users.

Recommendation: Omit the tactile paving, ensure no kerb face is provided on the route of the pedestrian and ensure signage / road markings adequately inform the motorist that pedestrians have priority.

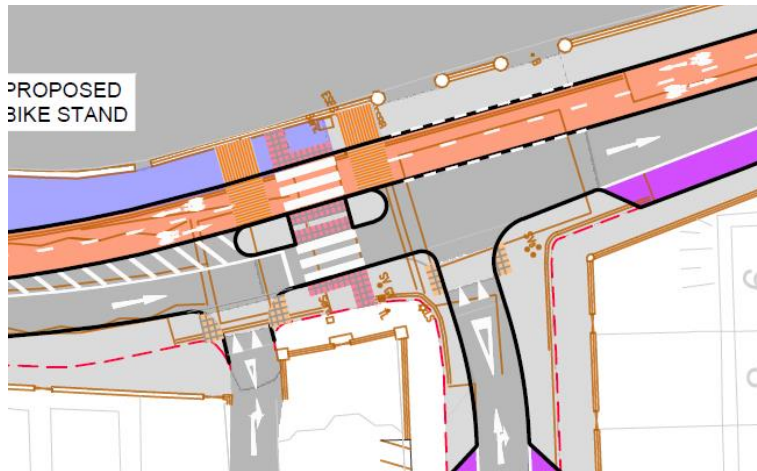
Hazard: Sight impaired users may experience difficulty in understanding the crossings. Additionally large volume of pedestrians may overspill the central refuge and be subject to vehicle strikes.

Recommendation: Provide a single stage crossings of both the carriageway and cycle path.

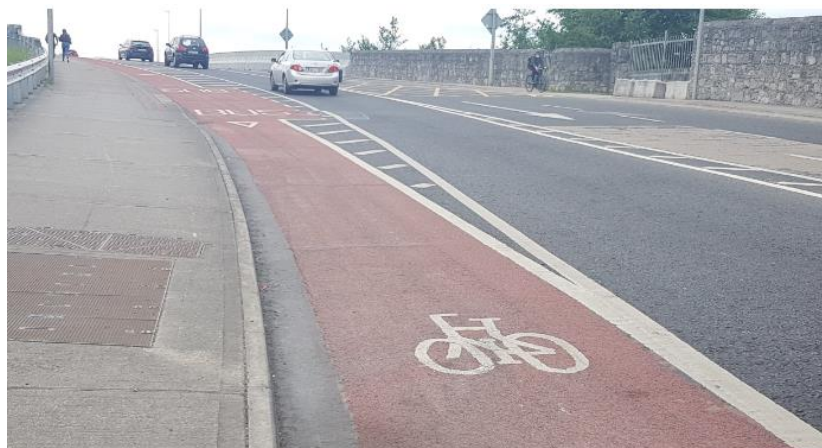
Hazard: Occasional southbound cyclists who decide to make use of the facility on the western side of the road are at risk of impact from opposing cyclists.

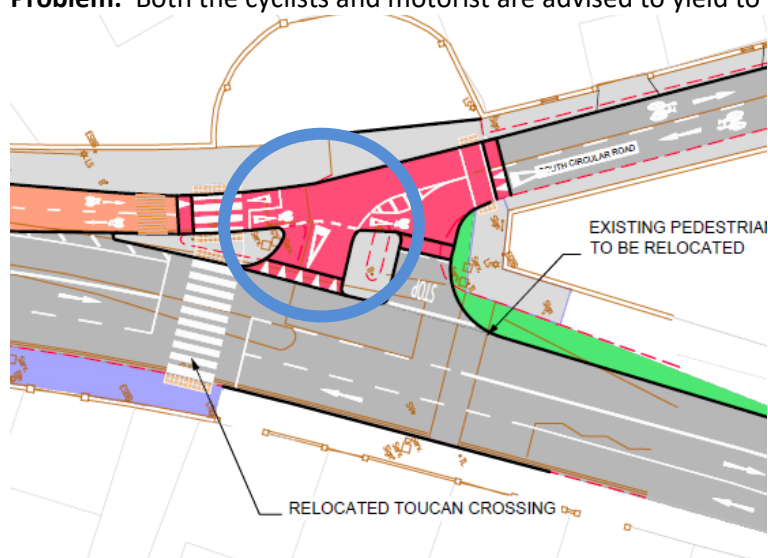
Problem: Both the cyclists and motorist are advised to yield to each other at this junction.

Hazard: Motorists who yield to the cyclists are at risk of creating a tail back onto the Ballinacurragh road with the resultant risk of rear end shunts.

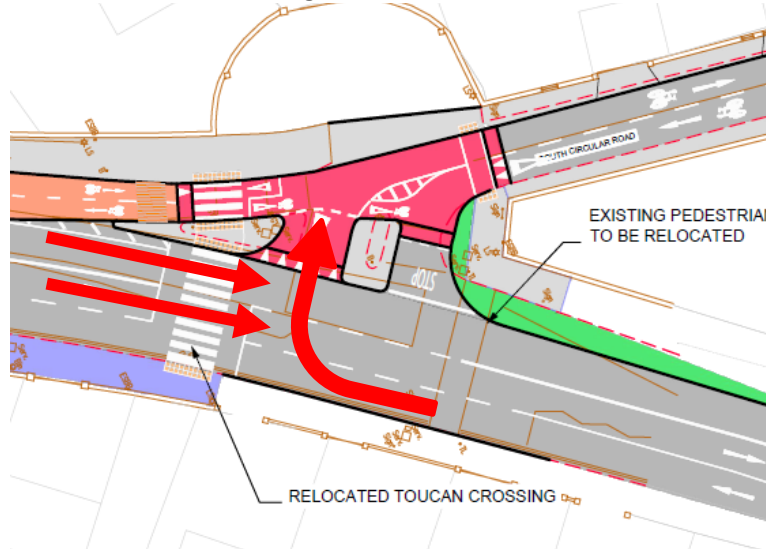
Hazard: Queuing high sided vehicles in the offside lane may shield smaller and faster moving smaller vehicles in the nearside lane. The right turner may commence their turn and impact with vehicles in the bus lane.

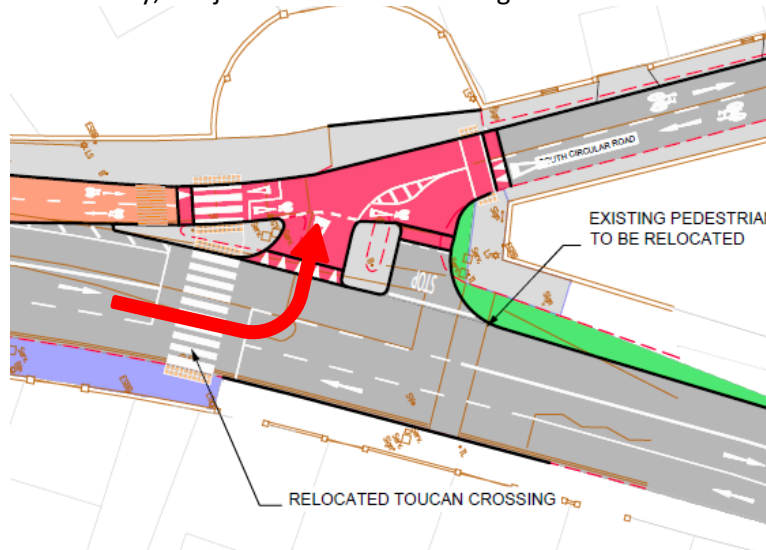
Hazard: The left turning motorists may be stuck by an approaching vehicle in the bus lane. Additionally, the user may strike the kerb.

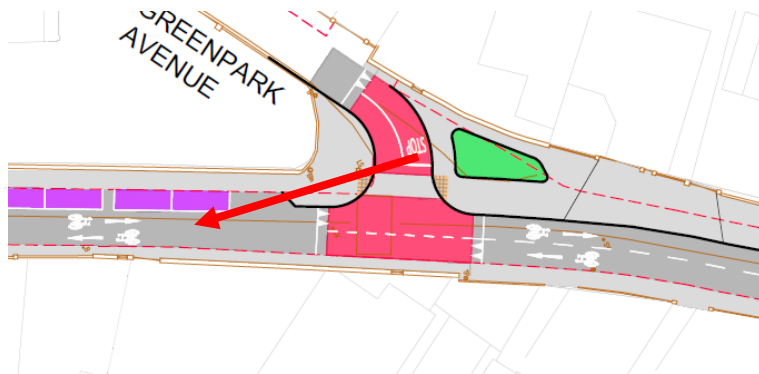
Hazard: High sided parked vehicles may restrict junction visibility for users exiting Greenpark Avenue

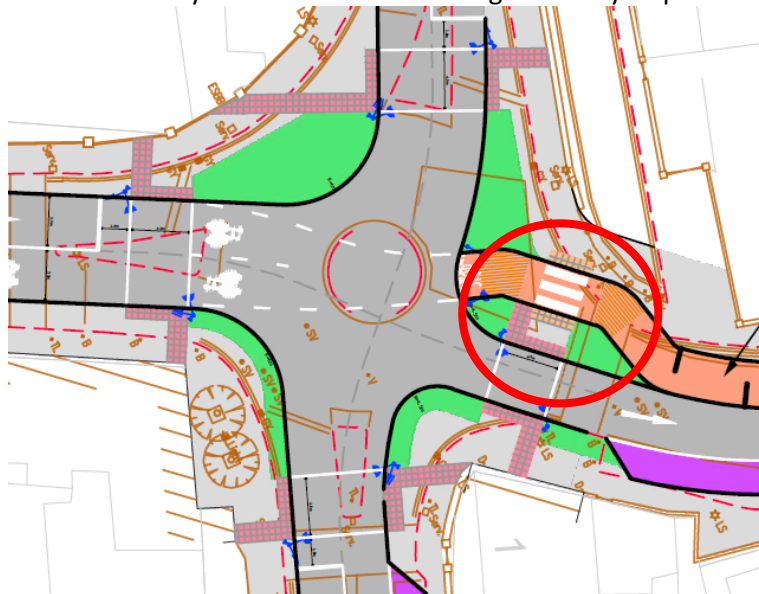
Hazard: Sight impaired users may experience difficulty in crossing the cycle path. Errant entry into the path may result in impact with cyclists.

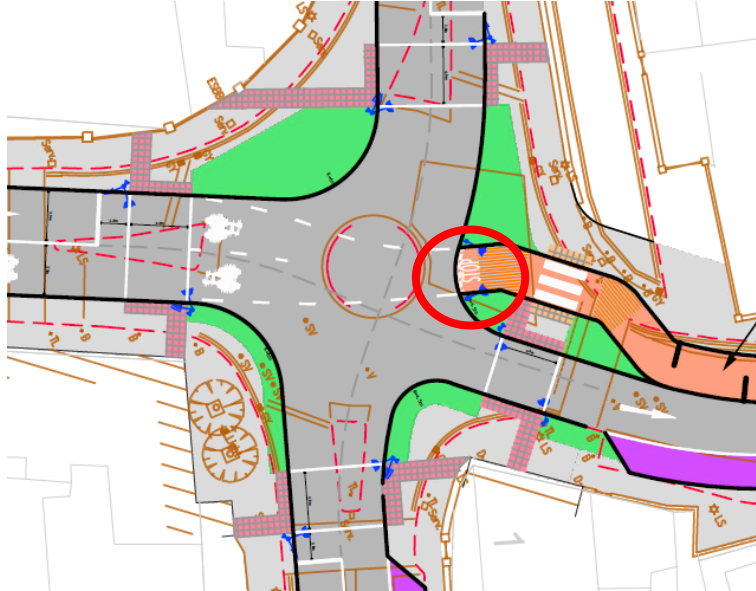
Hazard: Cyclists may errantly look at the wrong traffic stream and note no oncoming vehicles, just at the same time as one of the other streams of traffic are offered a green light. Impact with motorists may result.
