Stage 1 Road Safety Audit

South Circular Rd to Bishops Quay Cycle Lane, Limerick City

On behalf of Limerick City & County Council

September 2022

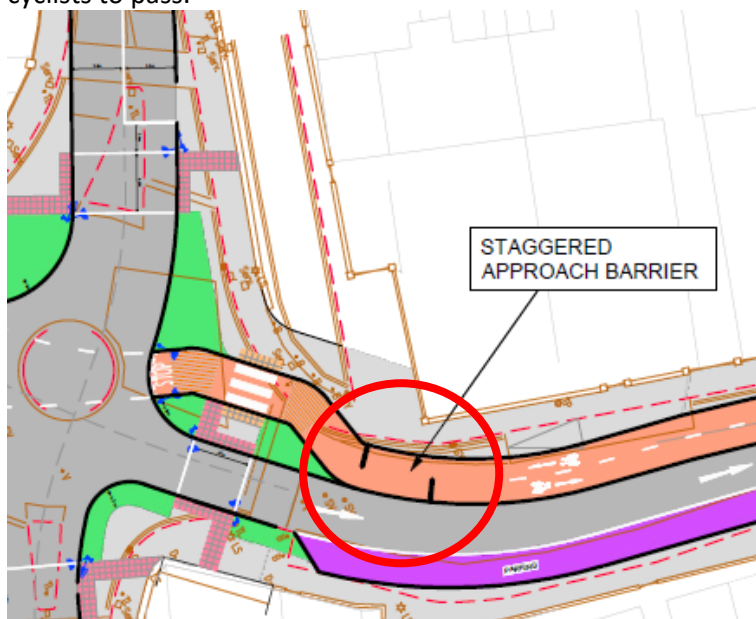
Hazard: Opposing cyclists may fail to discretionary yield, resulting in head-on impacts.

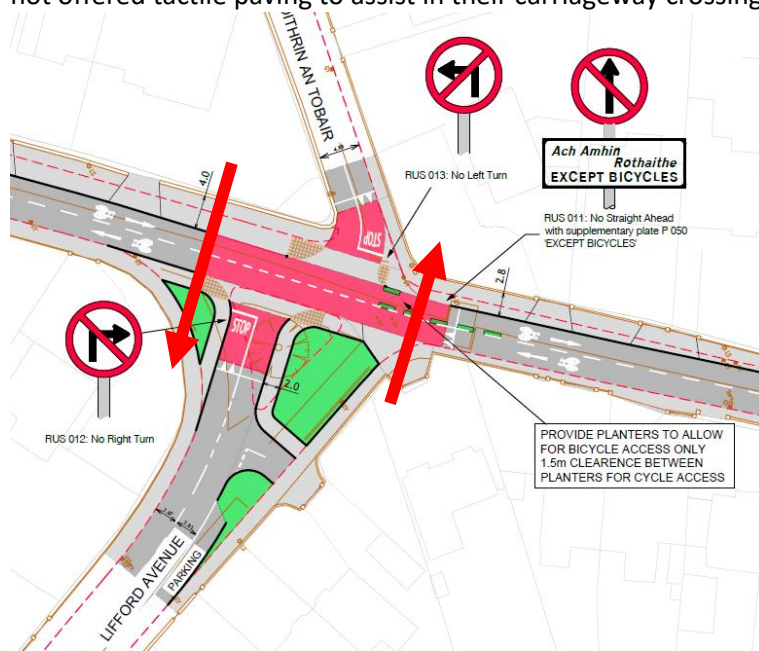
Hazard: Users may errantly enter the carriageway or may trip/stumble on high kerbs.

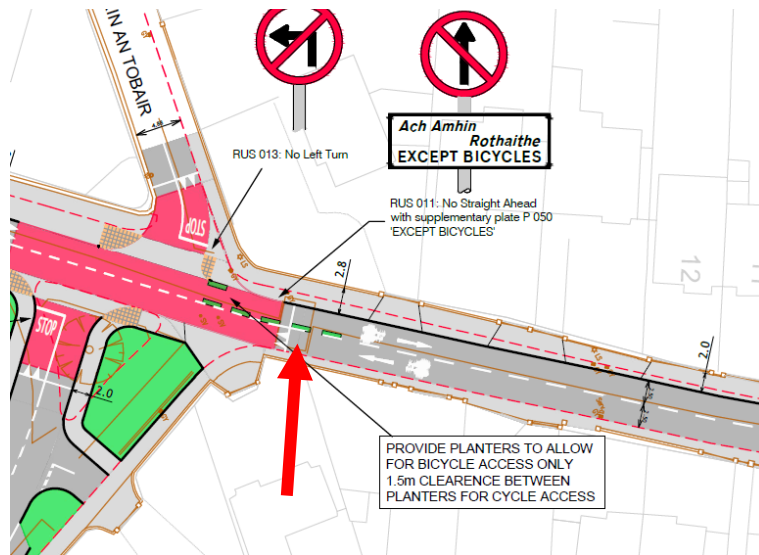
Hazard: Large southbound vehicles may strike the planter and push this into the path of oncoming cyclists.

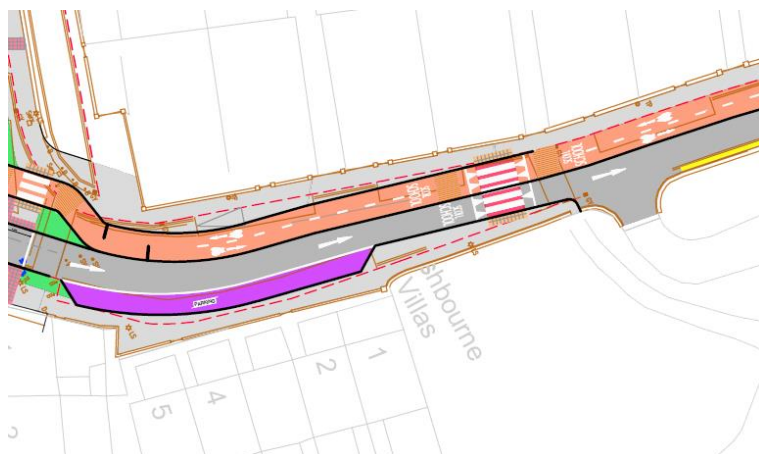
Hazard: The reduced carriageway width may result in congestion in the area and traffic backing up on the roundabout junction. Rear end shunts may result.

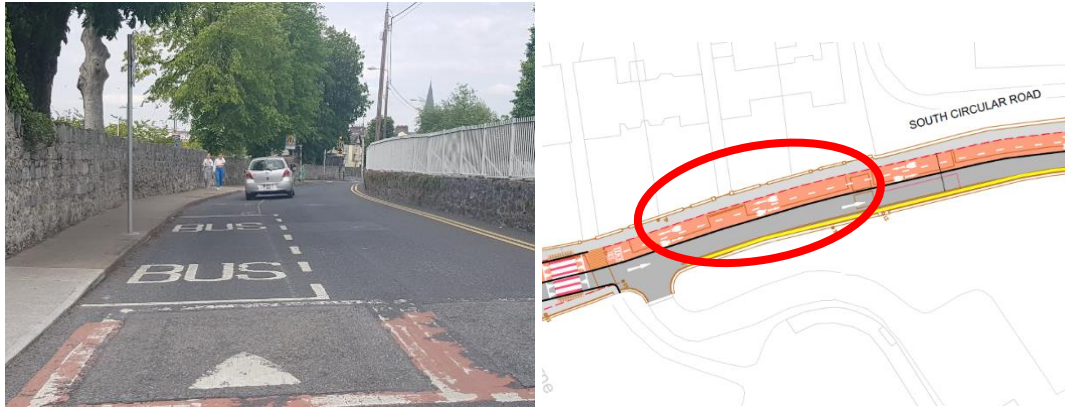
Hazard: Traffic may back up onto the roundabout. Rear end shunts may result.

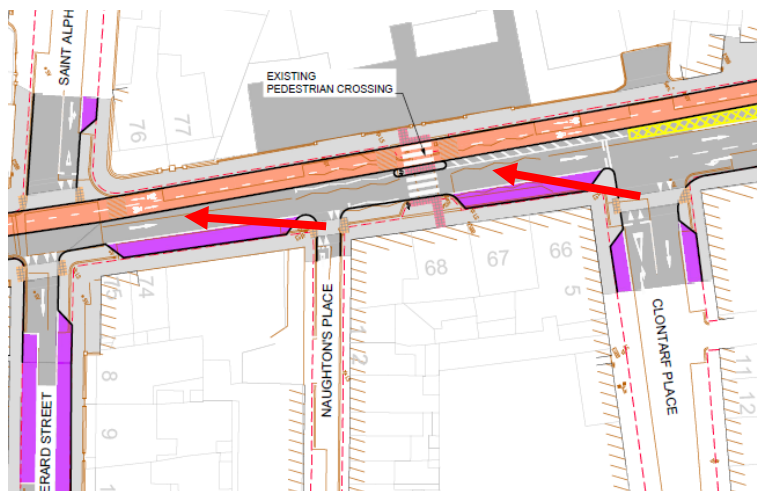
Hazard: High sided vehicles parked in the bays may restrict visibility to oncoming traffic for users attempting to exit the minor roads.

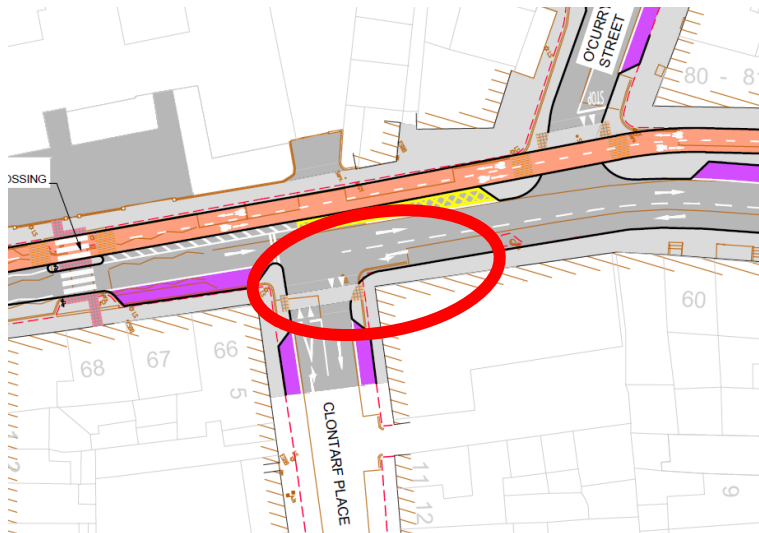
Hazard: Impact between motorists and pedestrians may result.

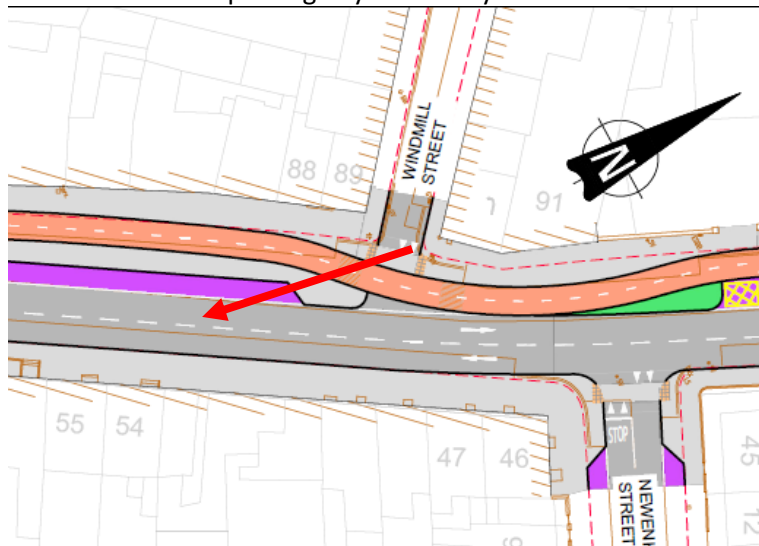
Hazard: High sided vehicles parked in the bays may restrict visibility to oncoming traffic for users attempting to exit the minor road.

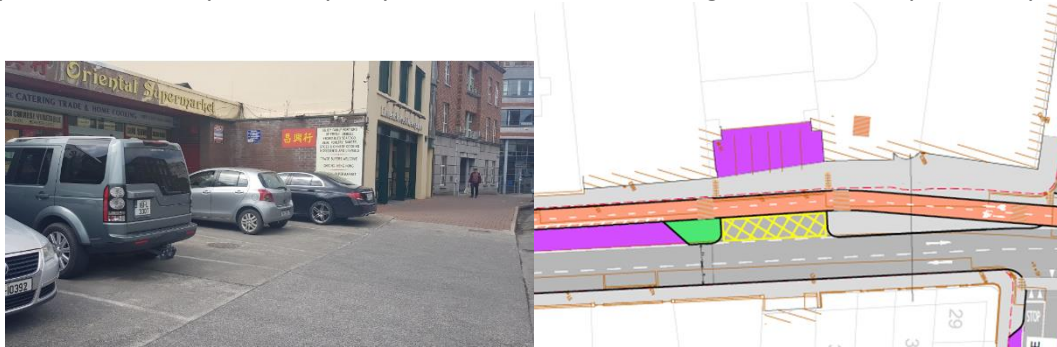
Hazard: Impact with cyclists may result.

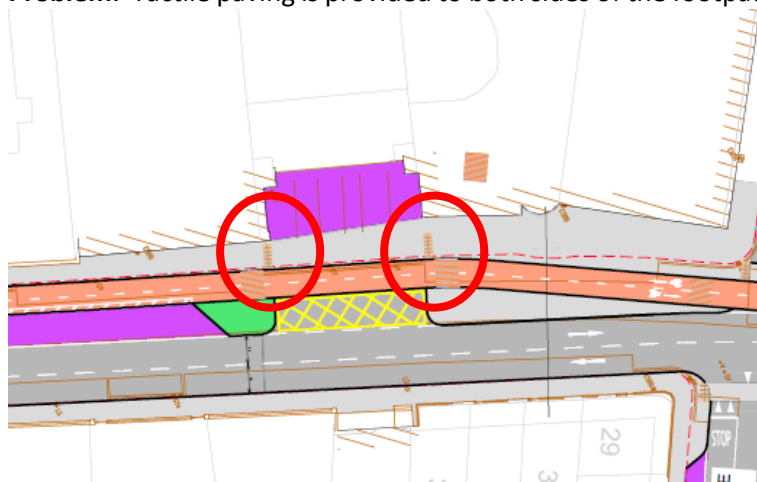
Hazard: Pedestrians are unlikely to acknowledge the tactile paving and fail to yield to entering motorists. Motorists may believe they have the right of way and fail to yield to the pedestrian. Impact between users may result.

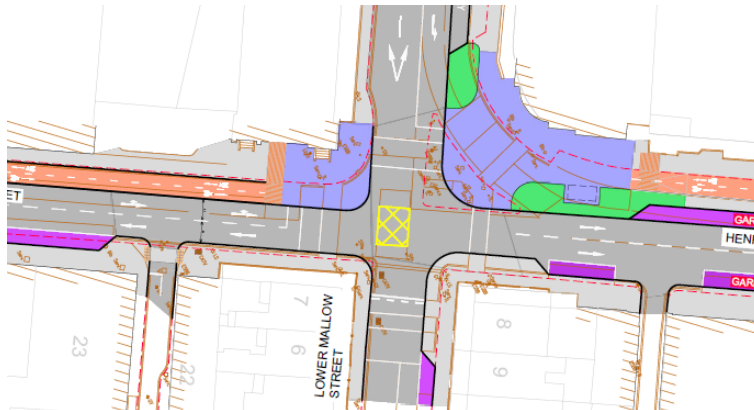
Hazard: Cyclists are likely to depart the segregated cycle path at speed and enter the shared space. Impact with pedestrians may result.

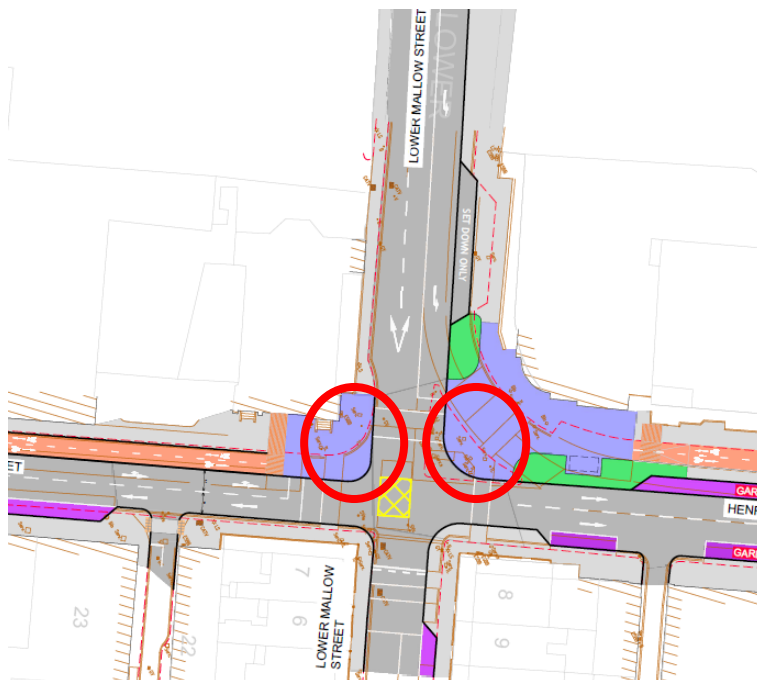
Hazard: Sight impaired users may experience difficulty in locating the push button and may errantly enter the carriageway into the path of oncoming motorists.

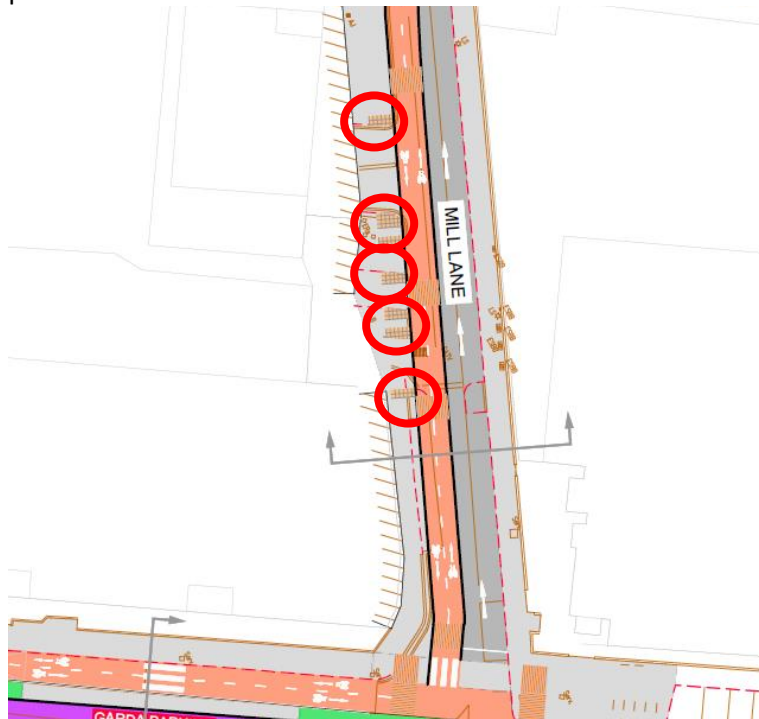
Hazard: It is unlikely sight impaired users will be able to understand if they are on a “safe” section of footpath or within a section with vehicle priority. Impact between users may result.

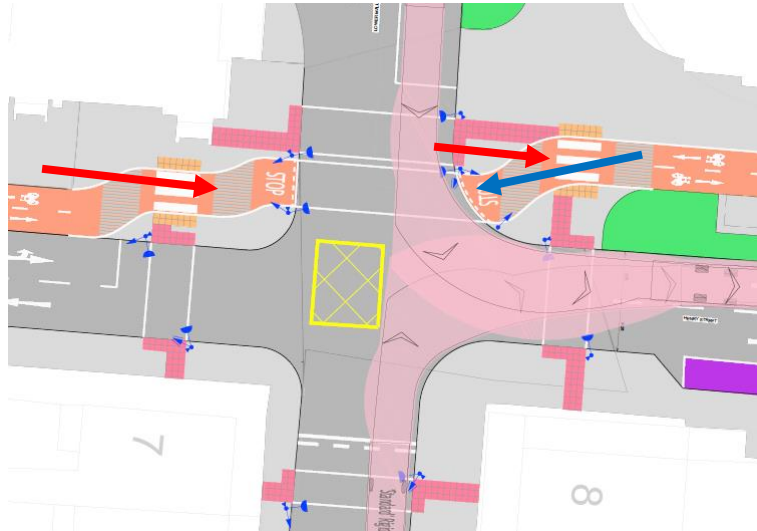
Hazard: Pedestrians are at risk of errantly entering the cycle path (red arrows). Additionally cyclists (blue arrows) are likely to take the “racing line” through the switchback bends, with the possibility of impact with opposing cyclists

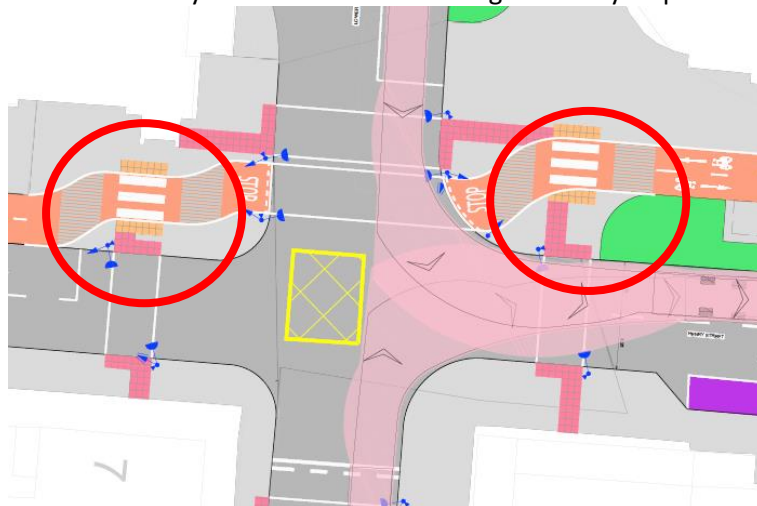
Hazard: Sight impaired users may experience difficulty in crossing the cycle path. Errant entry into the path may result in impact with cyclists.
