## Arboricultural Report

### Limerick City Street Trees at: -

Limerick City & County Council – Active Travel (Pedestrian and Cycle Scheme)

**15<sup>th</sup> September 2022**

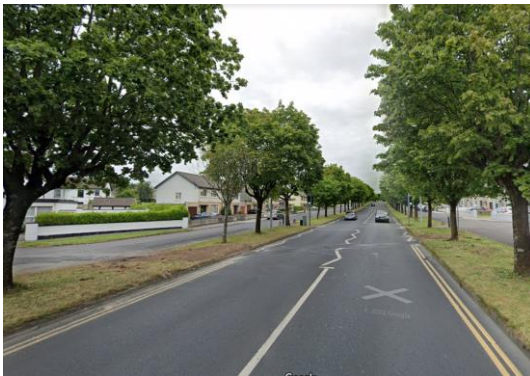
Avenue consists mostly of Norway maples in narrow, grass verges. I suspect soil and root damage from trenching has resulted in tip-dieback to the smaller rowan (Tree No.1728) in the left background.

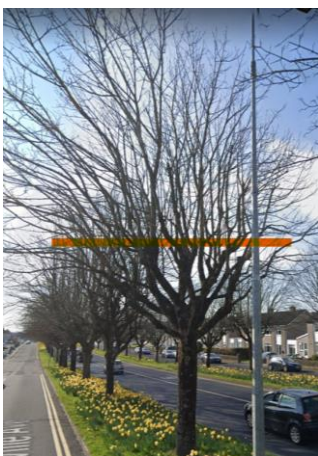
- 3.7** The trees that line the avenue have been pruned in the past at a height of c.3m, with multiple-stemmed regrowth from these pruning points. I suspect there is a pollarding cycle in place.

Red line shows where trees were pollarded in the past.

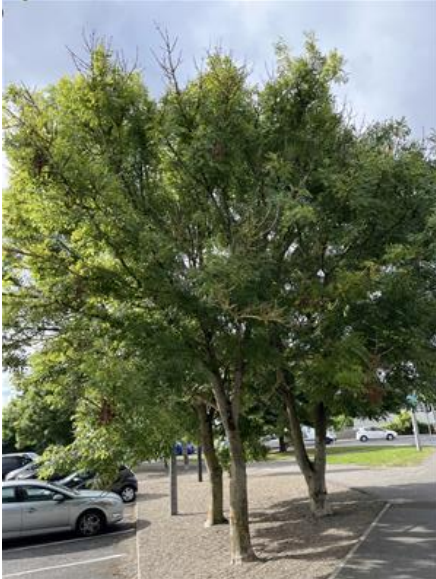
**3.9** The majority of trees are growing out of grass verges with hard surfacing around them, this will reduce their Life Expectancy. Tree Nos 1622, 1623, 1624, 1629, 1630, 1631 are in decline from ash dieback (*Hymenoscyphus fraxineus*); and Tree No.1705, an over-mature sycamore, has extensive basal decay and is within falling distance of Le Chéile National School, all of these trees have been given Category U ratings <10 years (see Tree Survey Schedule attached for management recommendations).

Tree No.1622, located at the Costcutter carpark, is infected with ash dieback.

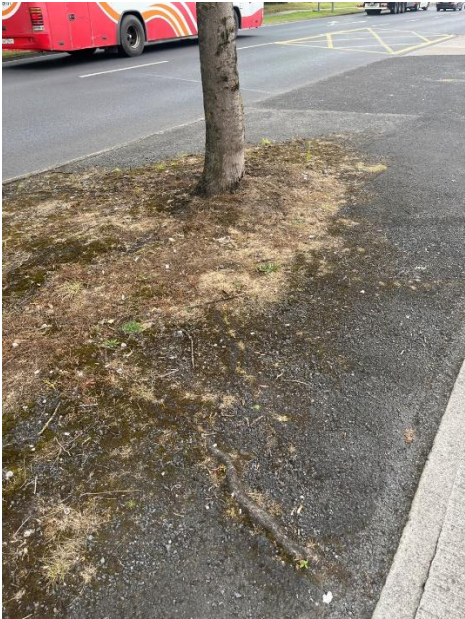
Tree No.1691 roots lifting the surrounding tarmac path next to Circle K Roxboro.

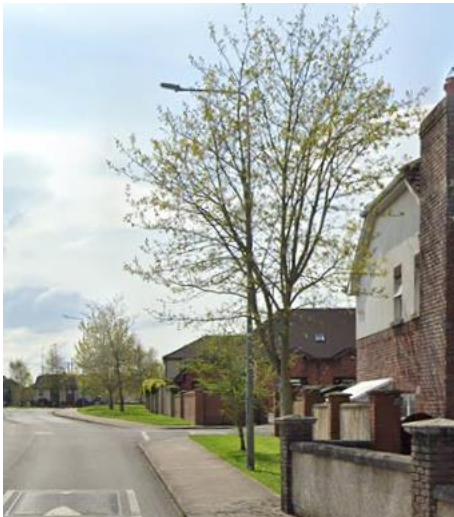
Tree No.1928, Leopoldii sycamore, beginning to interfere with house in 'The Forts'.

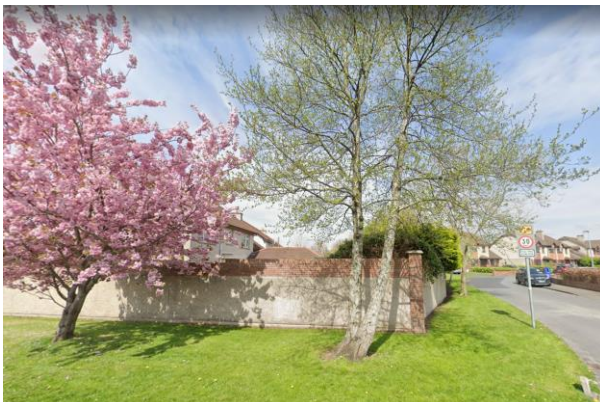
**3.17** Overall, the trees in this area are in good condition. One of the larger trees, Tree No.1944 (Italian alder), has an included bark formation between stems and would

benefit from pruning to reduce pressure on this potentially structurally weak union (see Tree Survey Schedule attached for management recommendations).

Tree No.1944 (Italian alder) on the right - located at Gallery Lane - would benefit from pruning to reduce pressure on included bark union.

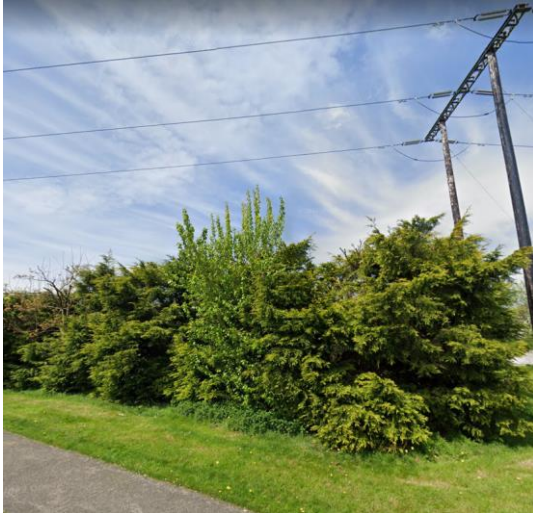
Tree No.1952, a black poplar, growing beneath the overhead utility wire out of Hedge No.2 (Lawson cypress) at Bell View. It will interfere with the wire in several growing seasons and require pruning to clear.
