Kilfinane Market House Conservation Report

20th November 2023

**Document Title: Structural condition report
231245-PUNCH-XX-XX-RP-S-001**

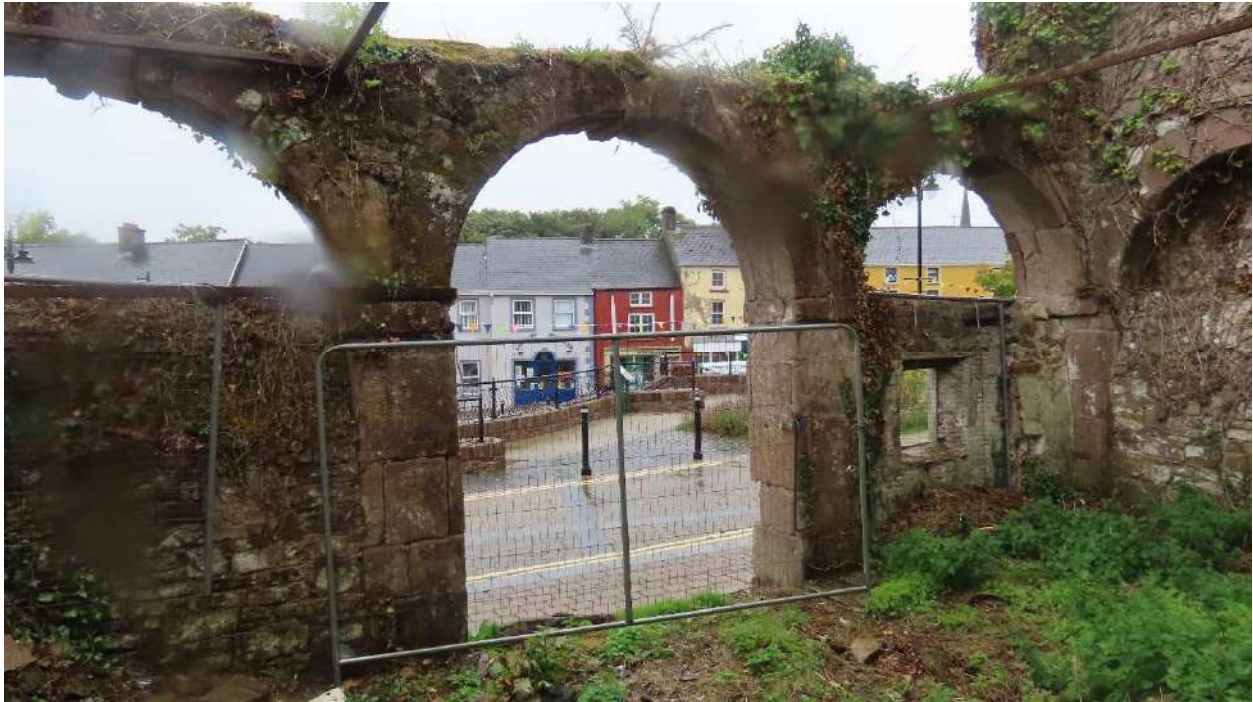
Photograph 002. Internal elevation of front North-West arch wall.

- There are some timber lintels & see photographs 002,003 & 004 Northwest, Southwest & front façade that will require replacement in timber, stone, or concrete after consultation with the conservation officer.

- Place new wall tie as outlined on SK-005 on the internal face at arch apex level with patress plates extending over the catch the face of the corners stone piers.
- Remove all vegetation growth.
- Remove all timber lintels & replace in stone lintels.
- Rebuild lose masonry in existing infill areas.
- Replace missing arch soffit stone, this may require the arch to be timber centred & a local takedown to insert missing stone, this will be reviewed on site with masons.
- Provide lime mortar pointing to all sandstone faces externally & internally, caulking all joints fully.
- Replace all missing facing stones, these new stones to match existing sand stones & maybe found on site.
- Lime mortar flaunch to top of the wall with NHL 3.5

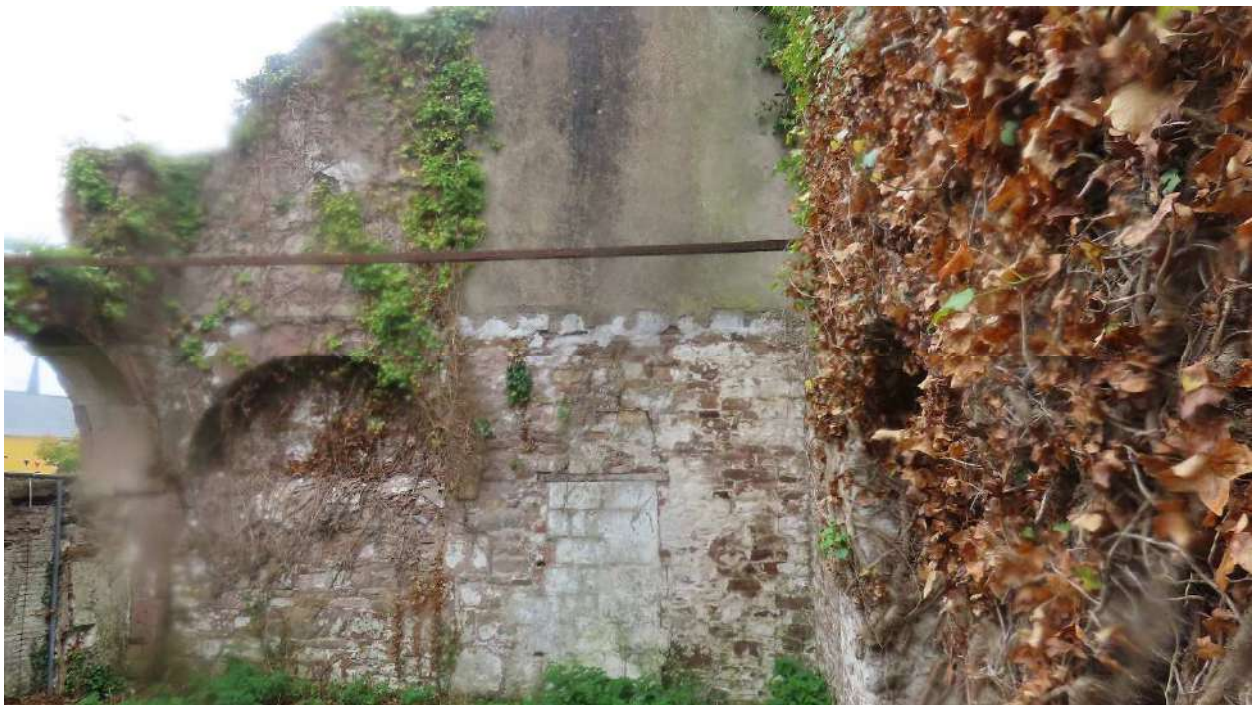
Photograph 003. Internal elevation of North-East gable wall.

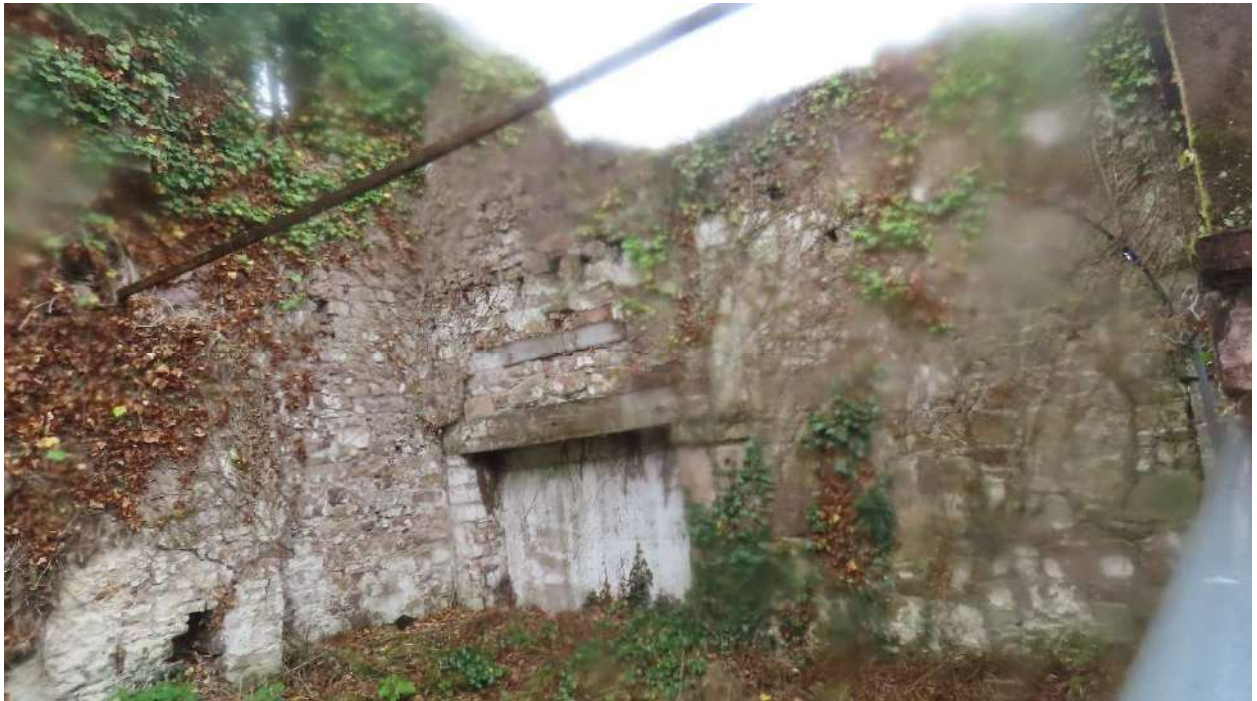
Photograph 004. Internal elevation of South-West wall.

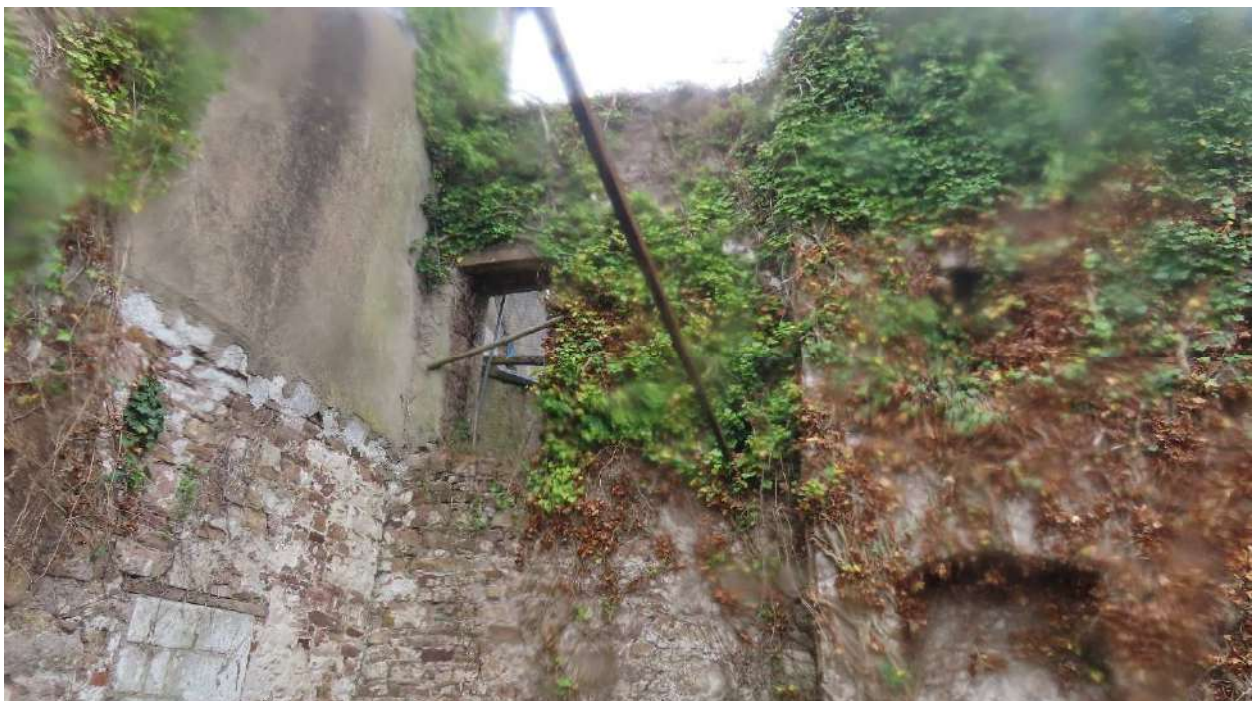
Photograph 005. Internal elevation of South-East back wall.

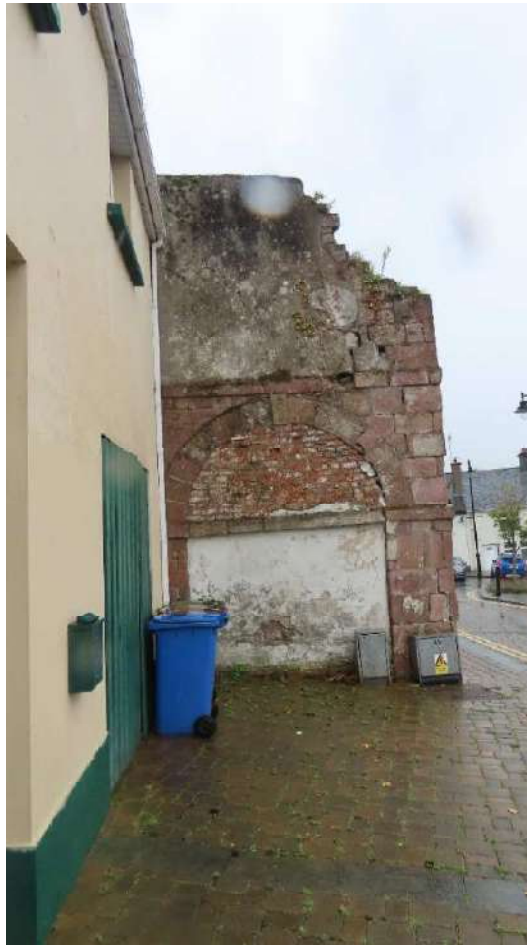
Photograph 006. Gable elevation of North-East wall.

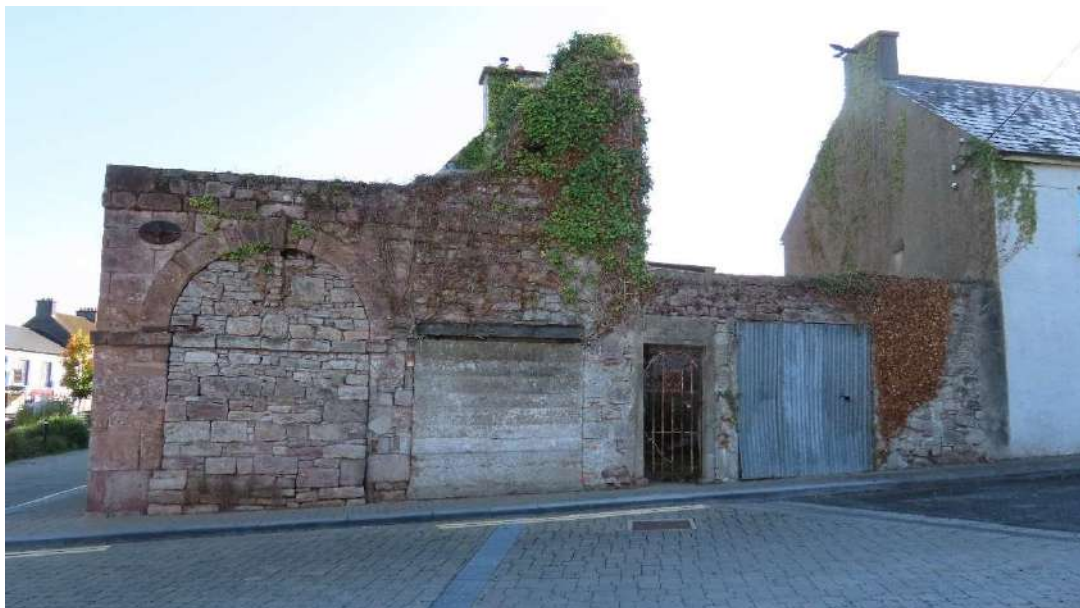
Photograph 007. Gable elevation of South-West wall.

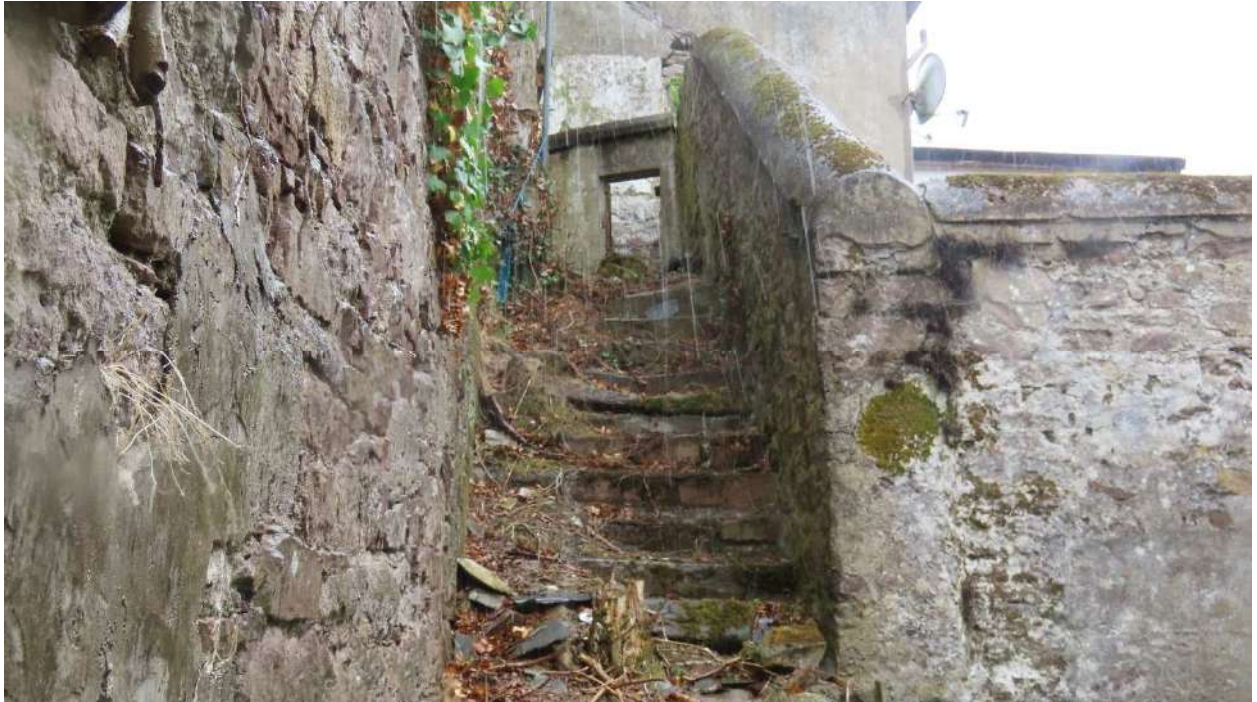
- Some of the existing stone arches openings have been infilled with sandstone masonry & in-situ concrete in other arch openings.
- The stone steps at the rear have collapsed in areas & some stone treads are broken & out of place.

Photograph 008. Back wall & stone steps at the South-East wall.

- Remove all vegetation growth including large tree stumps.
- Replace all missing or broken tread stones, all replacement stones to match existing stones.
- A review of the stone steps will need to be undertaken after the steps are fully exposed, make provision for realigning the stone treads into their original position which will require new bedding material both in stone filling & limecrete bedding.

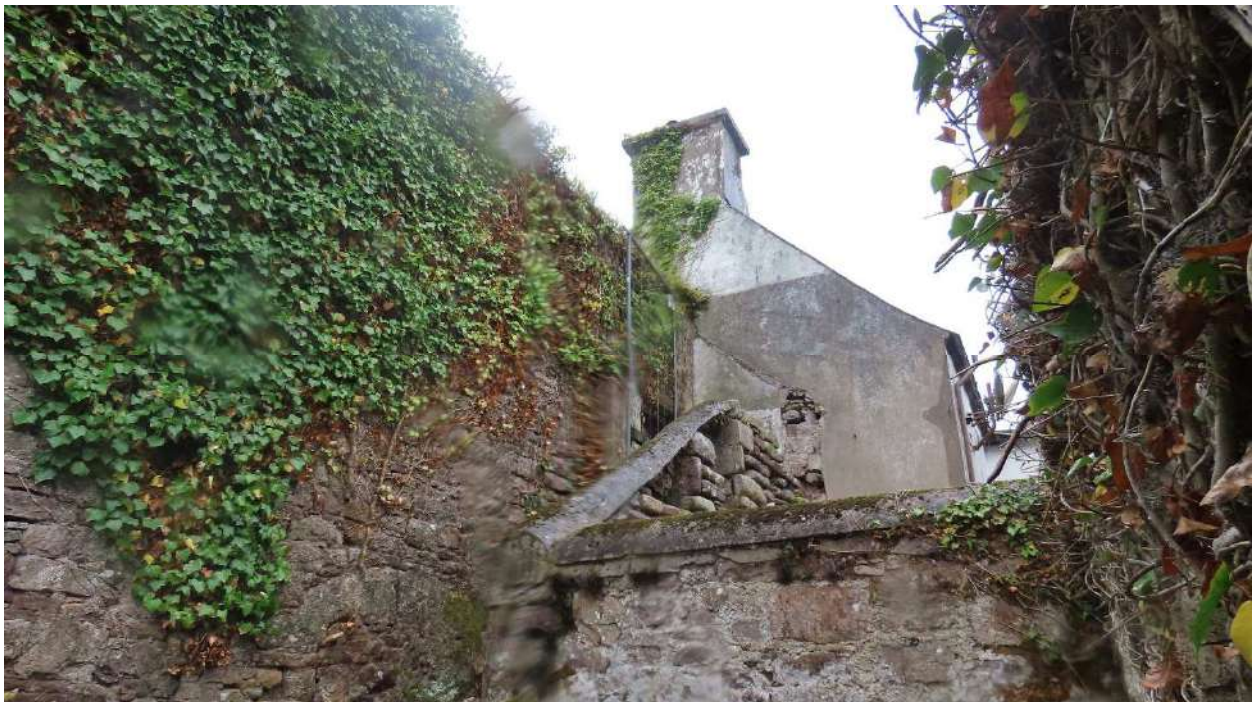
- The handrail wall to the stone stairs is in a very weak condition (see photograph 009) due to missing masonry on the adjoining property side of the stone handrail.

Photograph 009. Back wall & stone steps hand-rail wall (in very poor condition) at the South-East face.

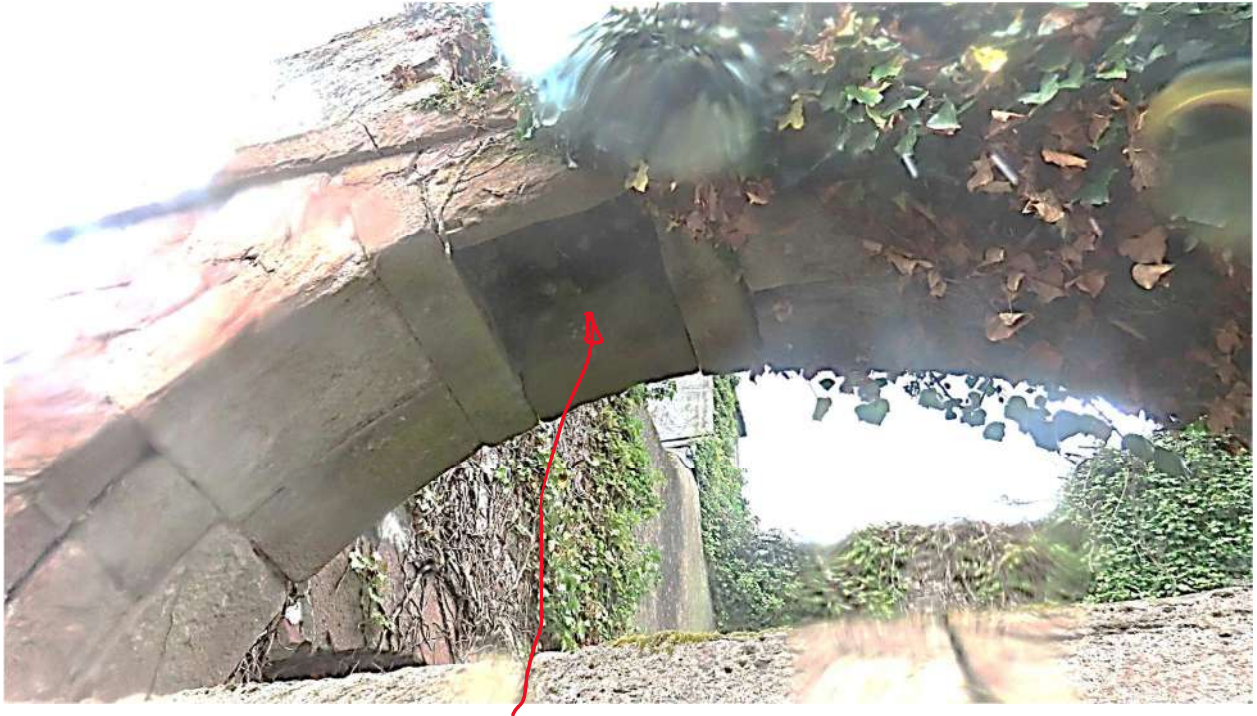
- Vegetation growth has cause structural damage by their root system entering masonry joints & heaving the surrounding stone elements.
- Within the arches there are soffit stones broken & in some cases missing, these arches were constructed using voussoirs stones (wedged stones) & the there is also a projecting key stone at the crown of the arch.

Photograph 010. Inset sand-stone missing near crown of arch, facing stone in position back & front are in place.

- Missing voussoirs stones associated with the sandstone arches would indicate that the arch must have spread or the mortar within the masonry joints has eroded to enable a wedge stone to fall out. To replace the missing soffit stone, the following works would be required. Erect a timber centre under the arch, remove the wall above the missing soffit stone, insert a new wedged soffit stone & rebuild the wall over.

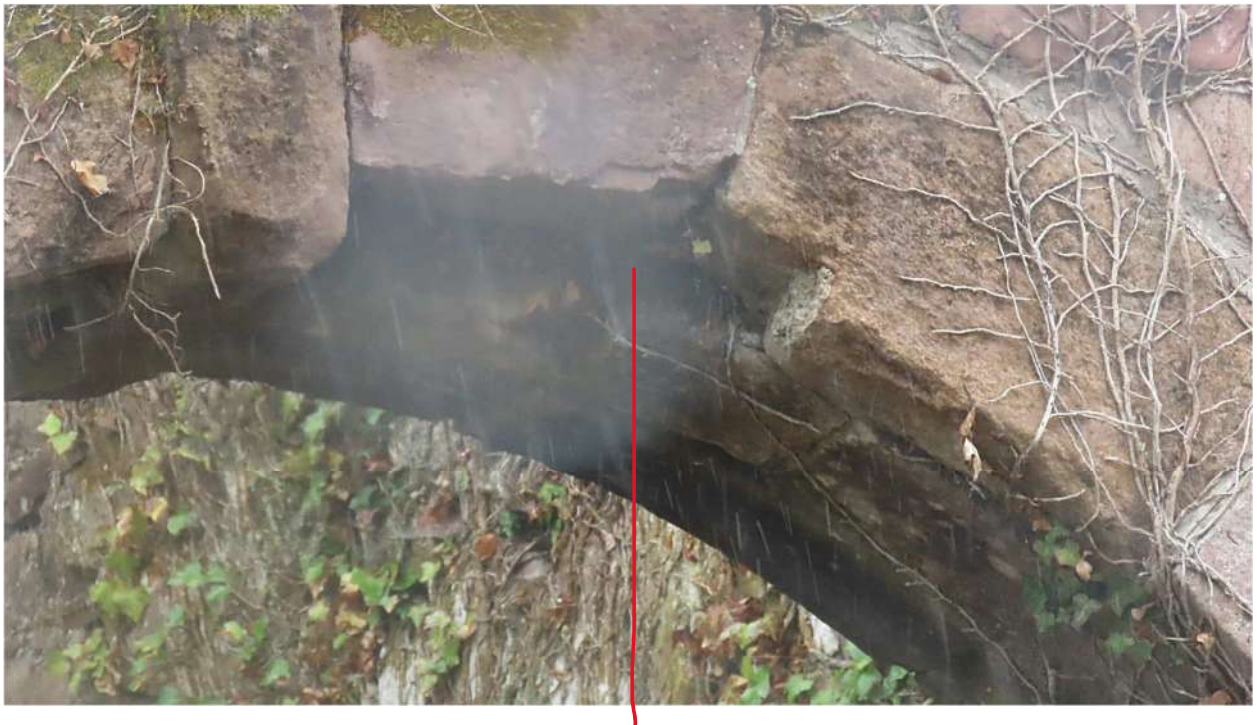
Photograph 011. Inset sand-stone missing near crown of arch, and one facing stone is broken with a missing section.

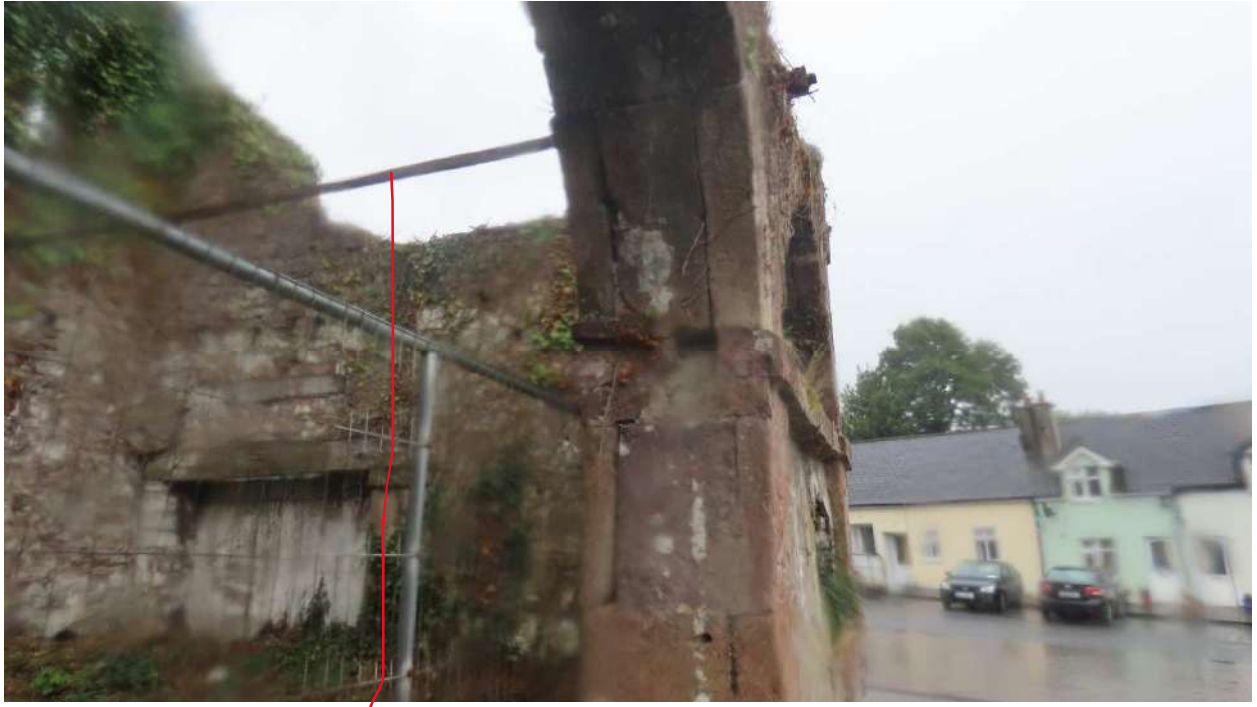
- We would recommend mortar analysis of remaining mortar before any repointing commences.
- Tie bars with Pattress plates have been placed on the front North-West & Gable South-West walls due to outward leaning of the upper part of the wall.

Photograph 012. Steel tie bars.

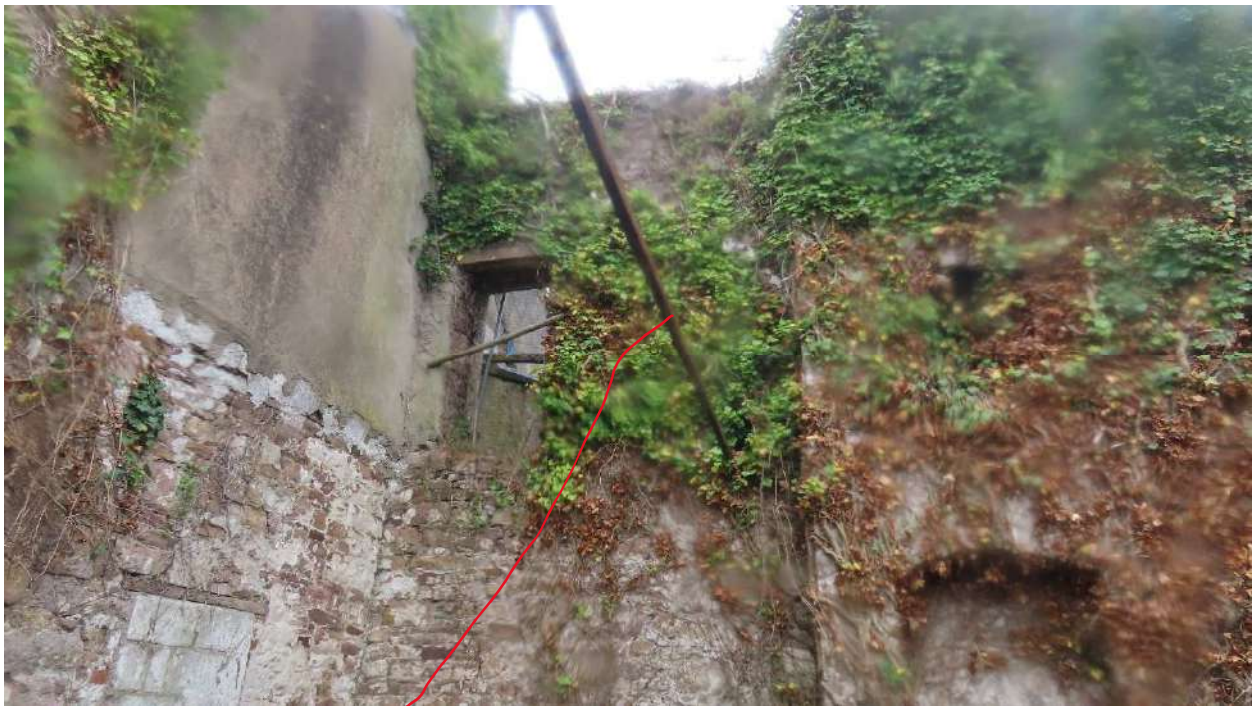
Photograph 013. Steel tie bars.

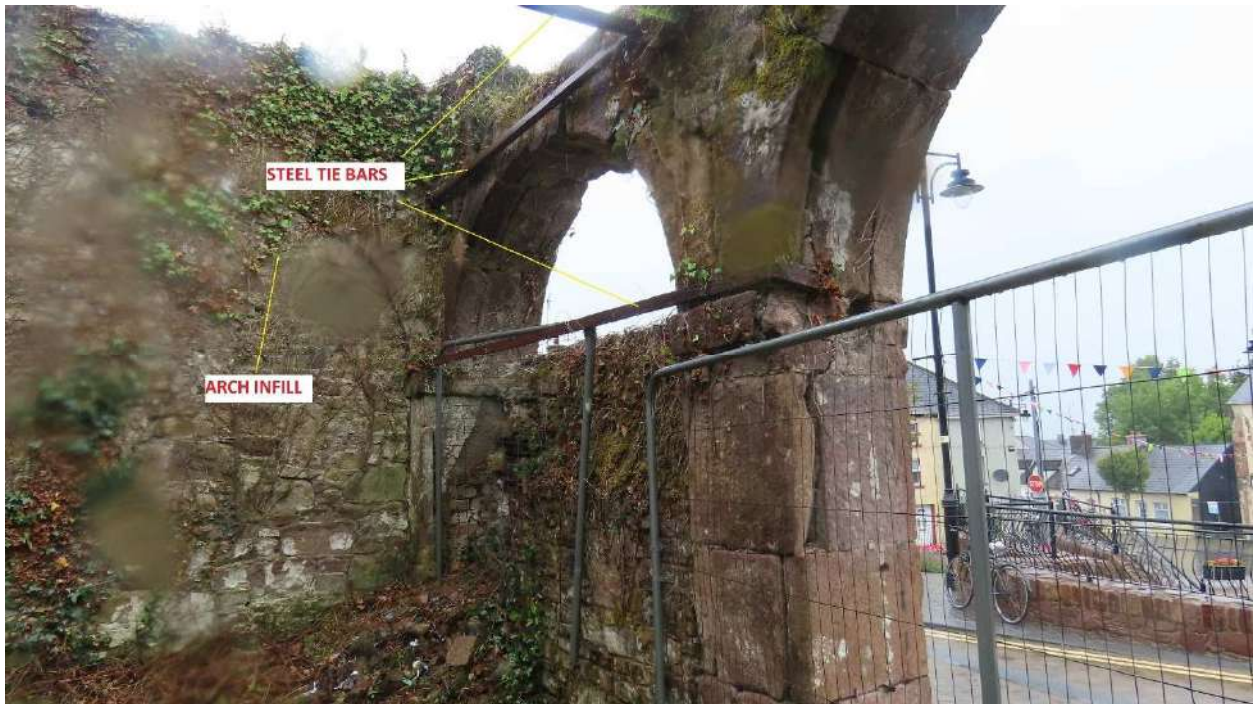
Photograph 014. Steel tie bars

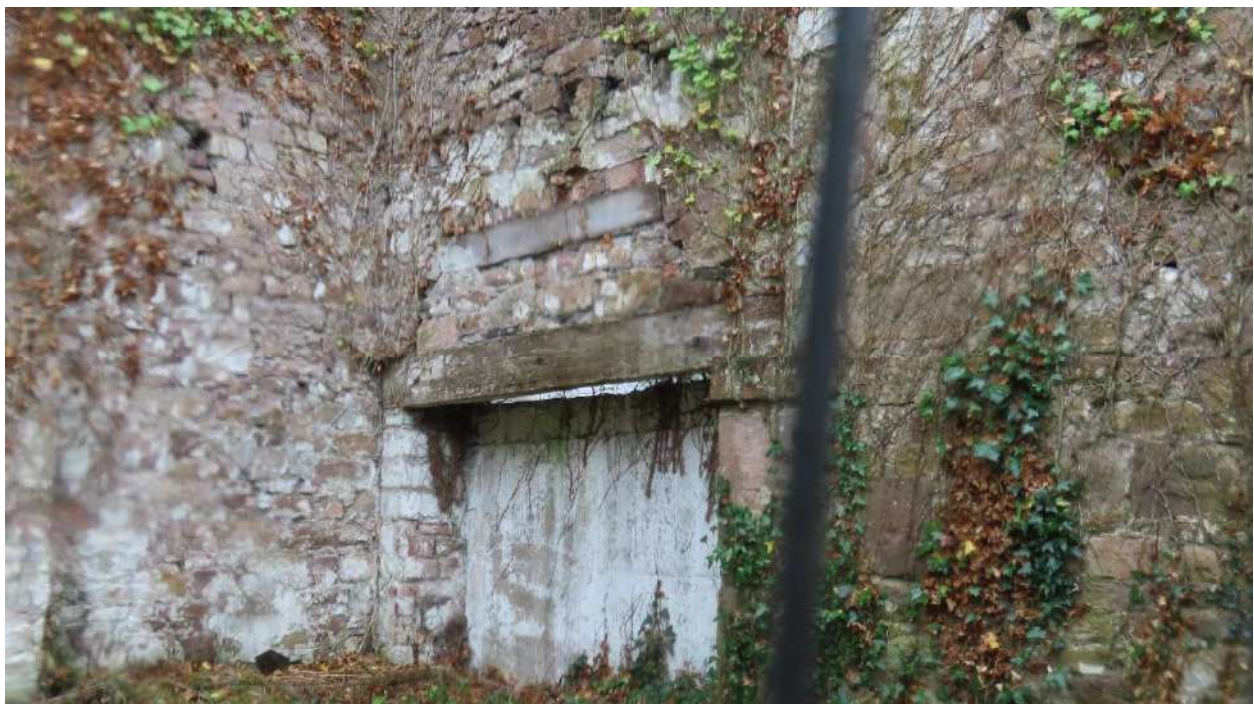
Photograph 015. Timber railway sleeper lintel over opening & concrete infill.

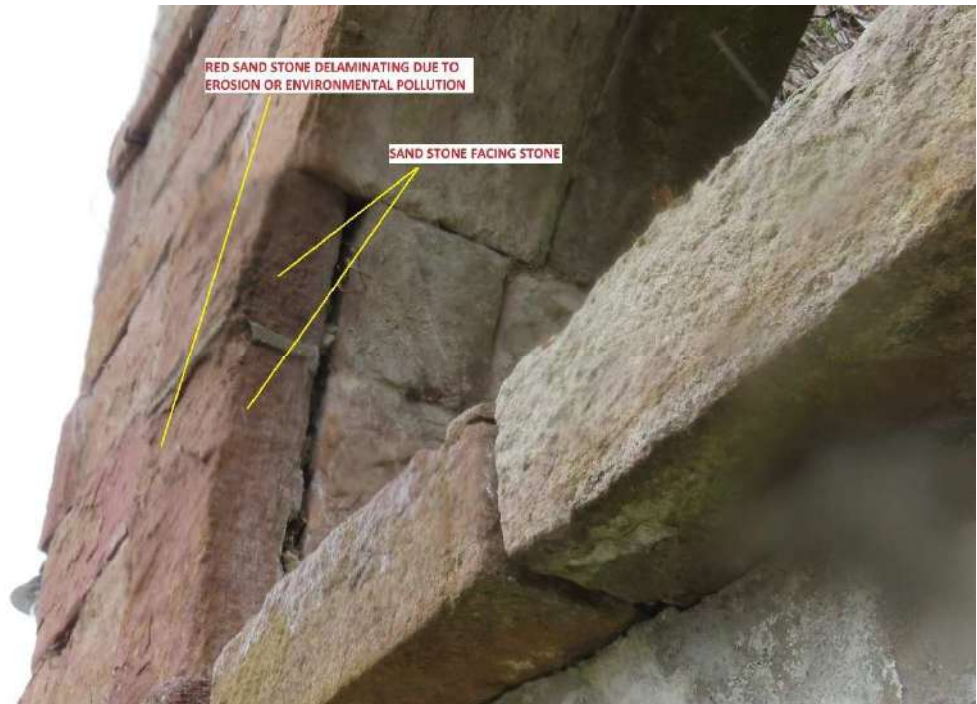
Photograph 016. Showing facing stones & sandstone delaminating (environmental pollution?)

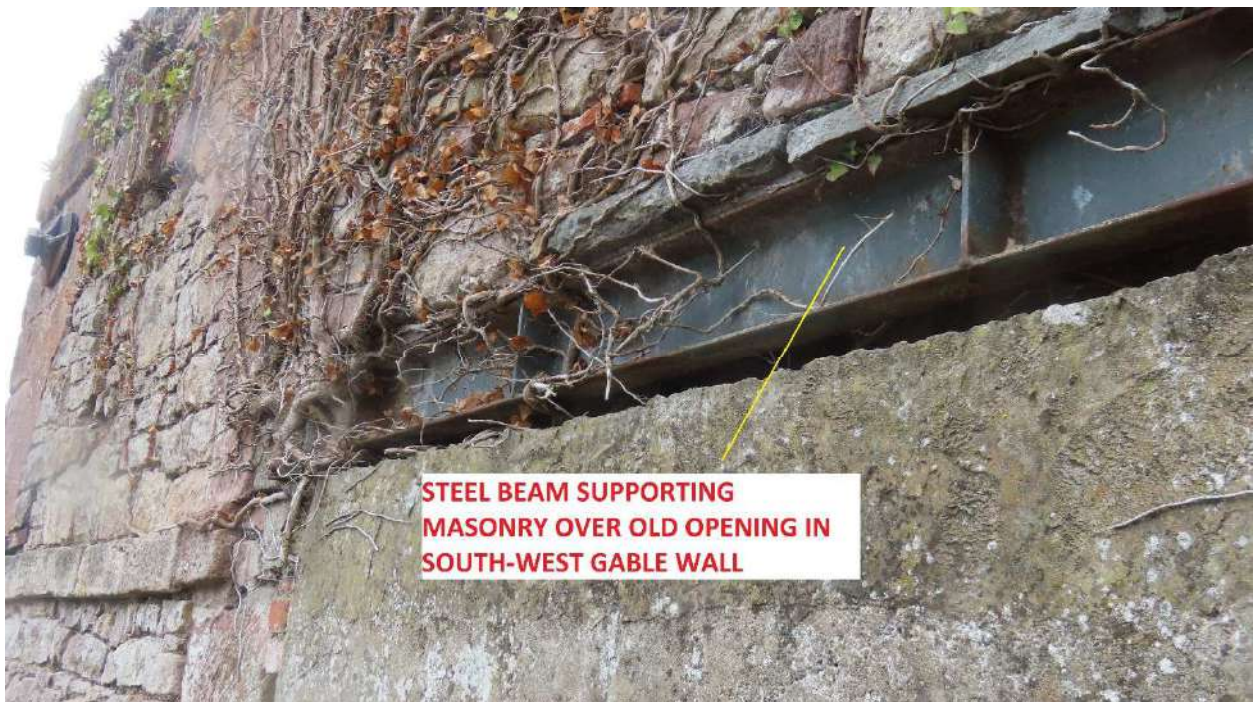
Photograph 017. Showing steel beam over old door opening on the South-West gable wall with concrete infill under & masonry infill to the original stone arch.

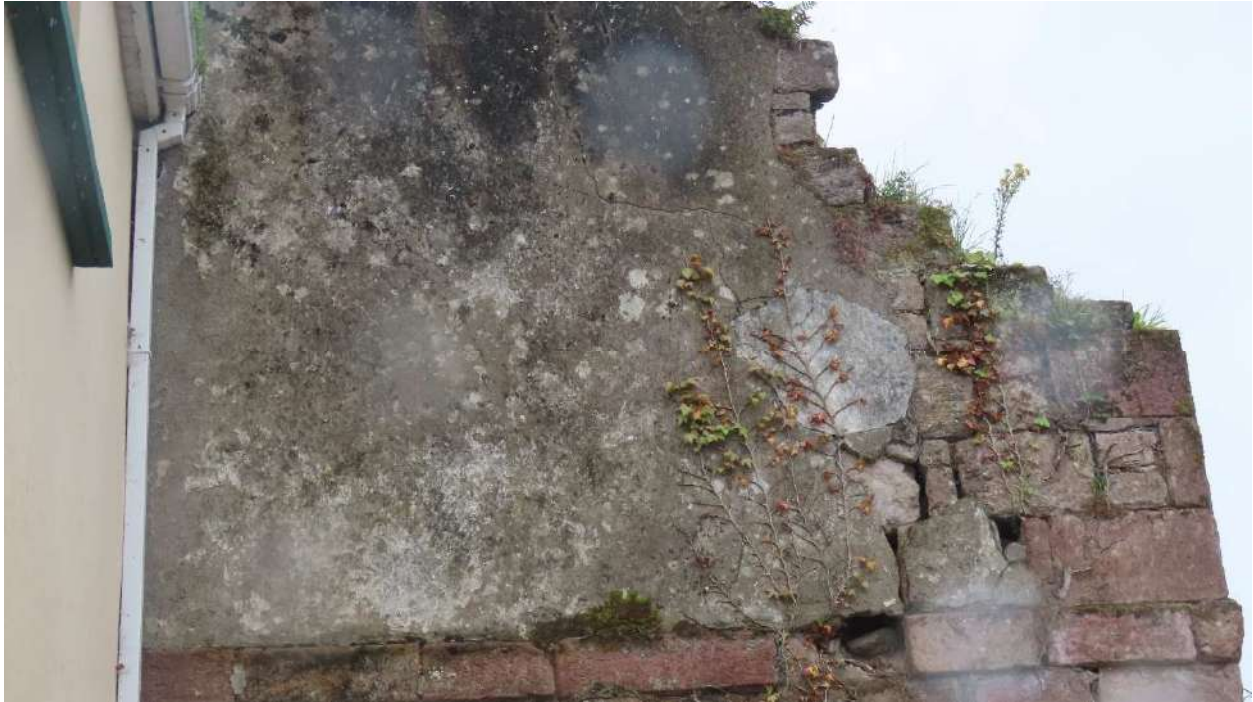
Photograph 018. Showing loose & cracked plaster on the North-East Gable.

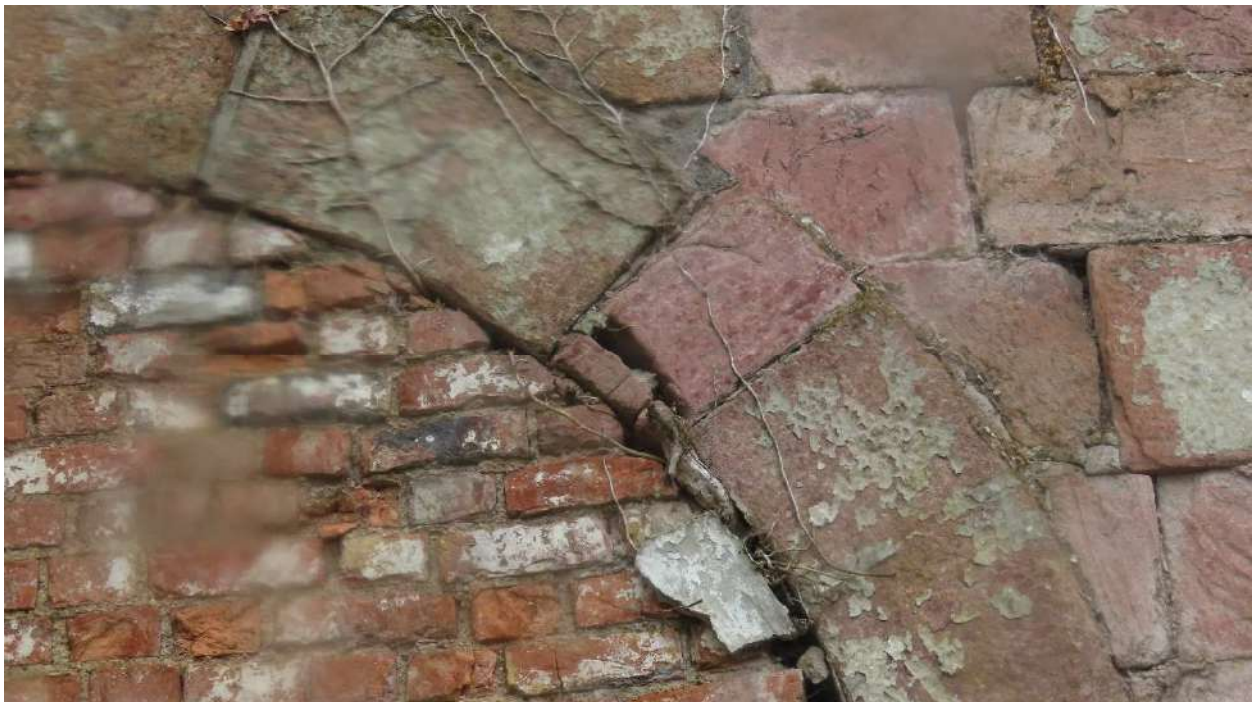
Photograph 019. Showing infilled arch using brick & broken arch stone.

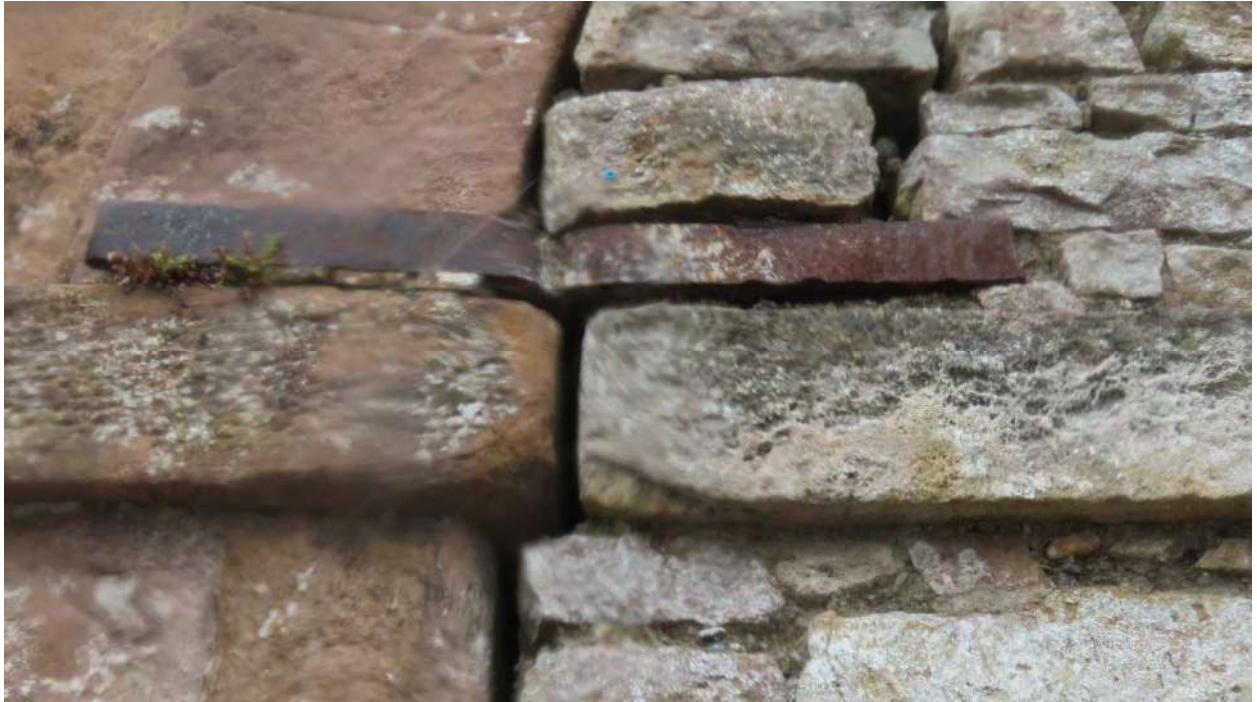
Photograph 020. Showing steel anchor for the tie bar in the South-West gable at the spring of the arch.

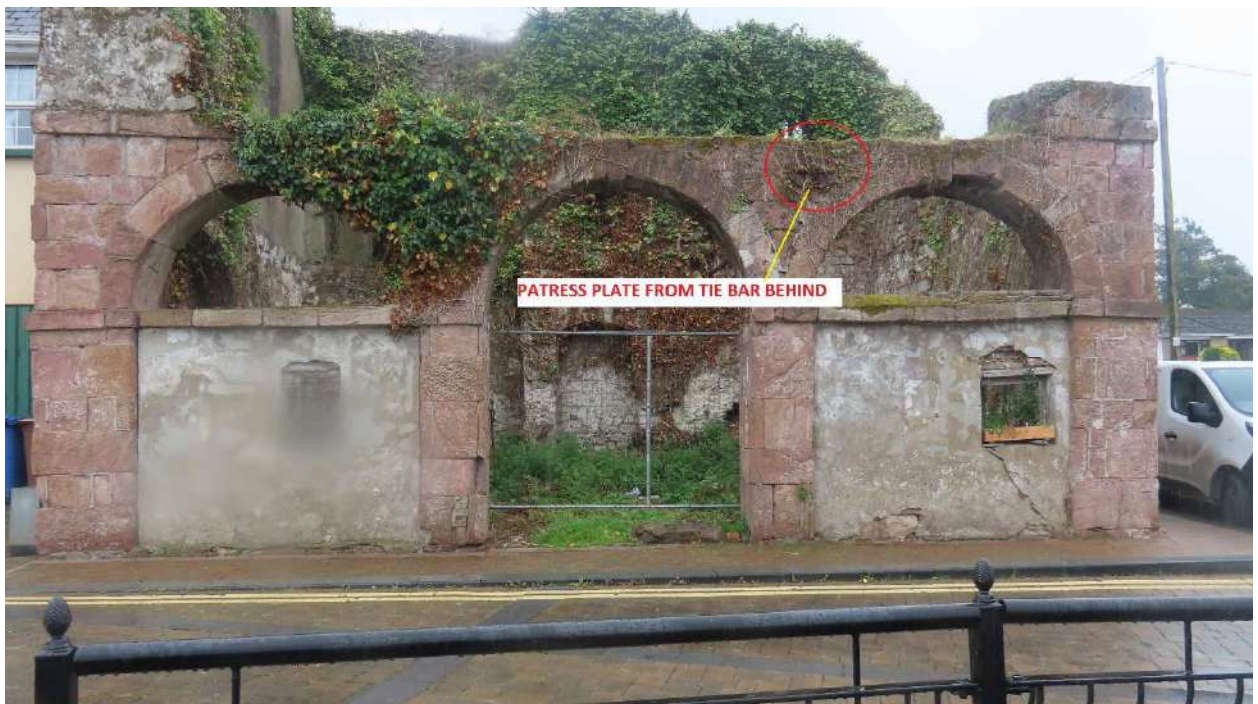
Photograph 021. Showing steel patrix plate from tie bar behind.

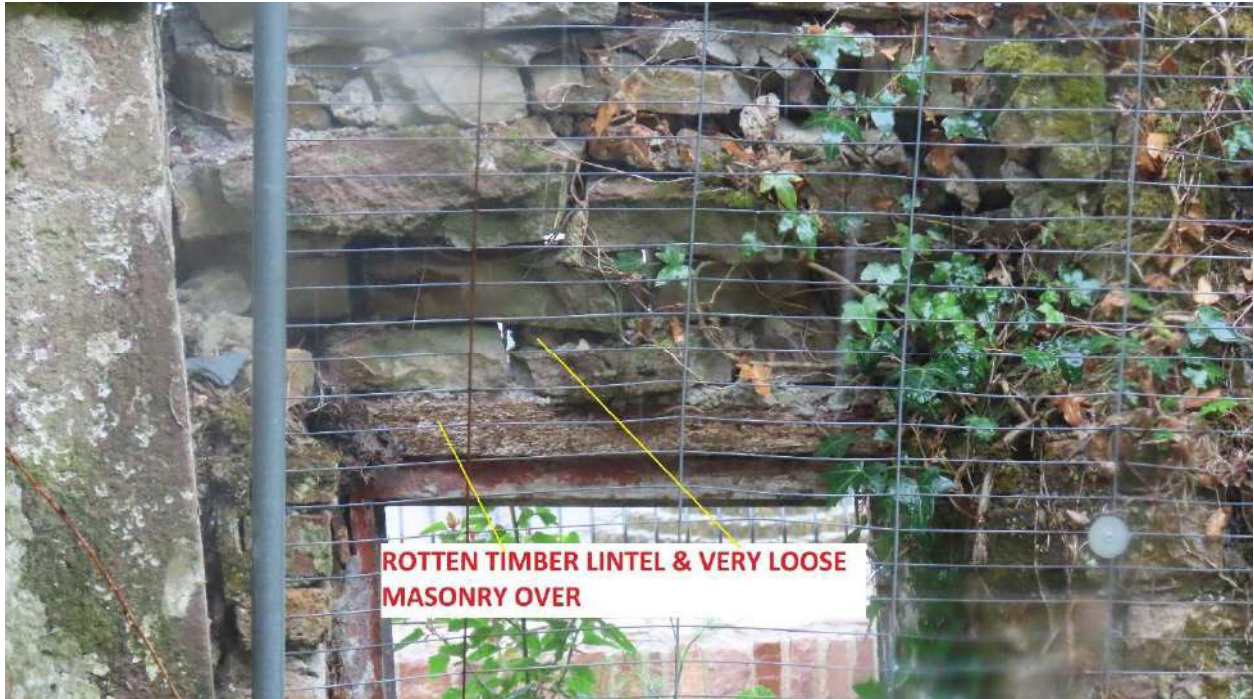
Photograph 021. Showing rotten timber lintel & very loose masonry over on the South-West gable wall.

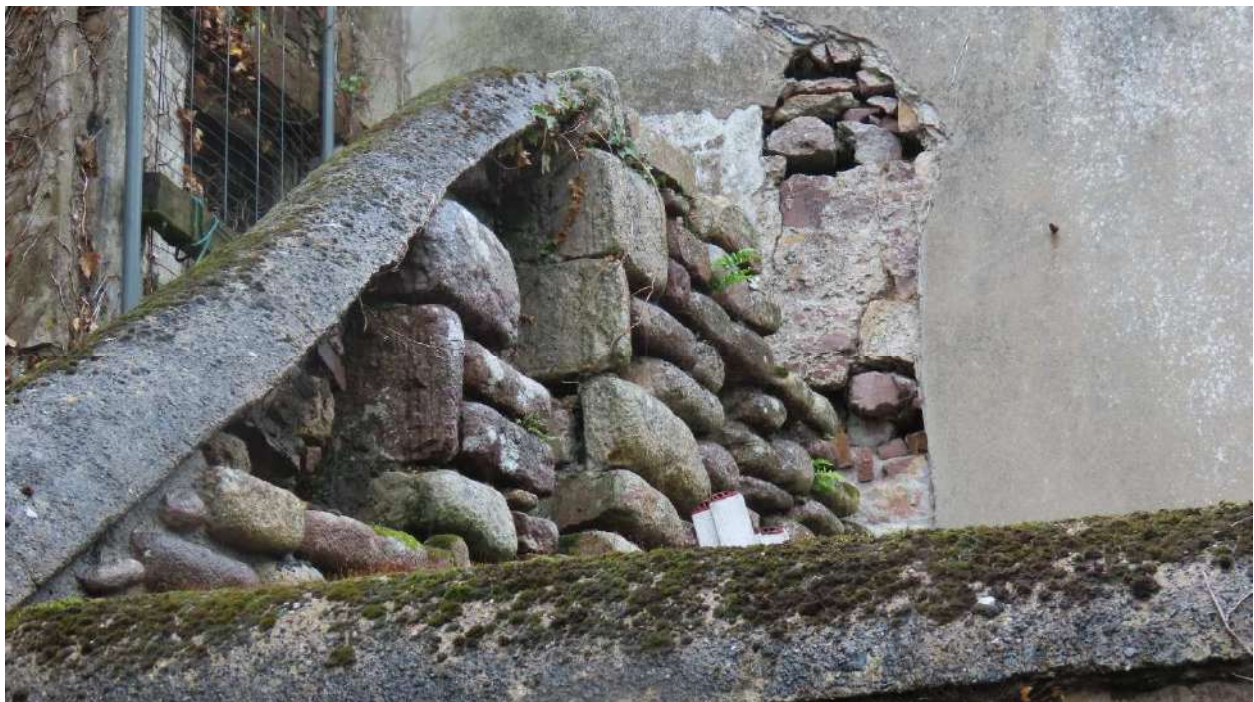
Photograph 022. Showing poor structural condition of stone steps handrail wall which is over the adjoining property backyard.

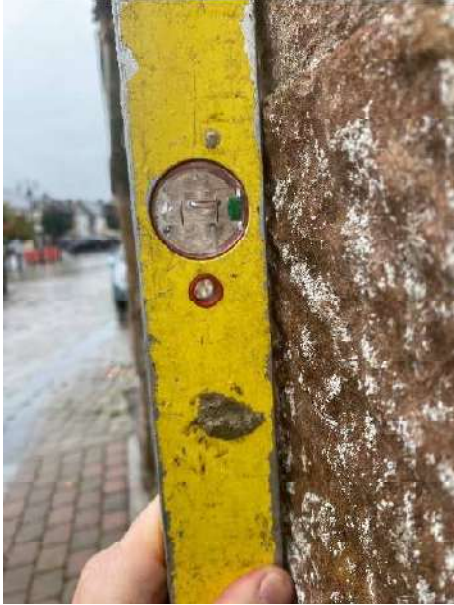
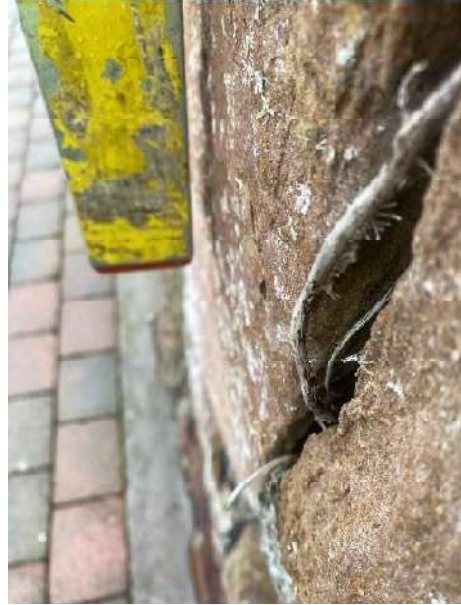
Photograph 023. Front façade facing the square the top is leaning outward slightly.

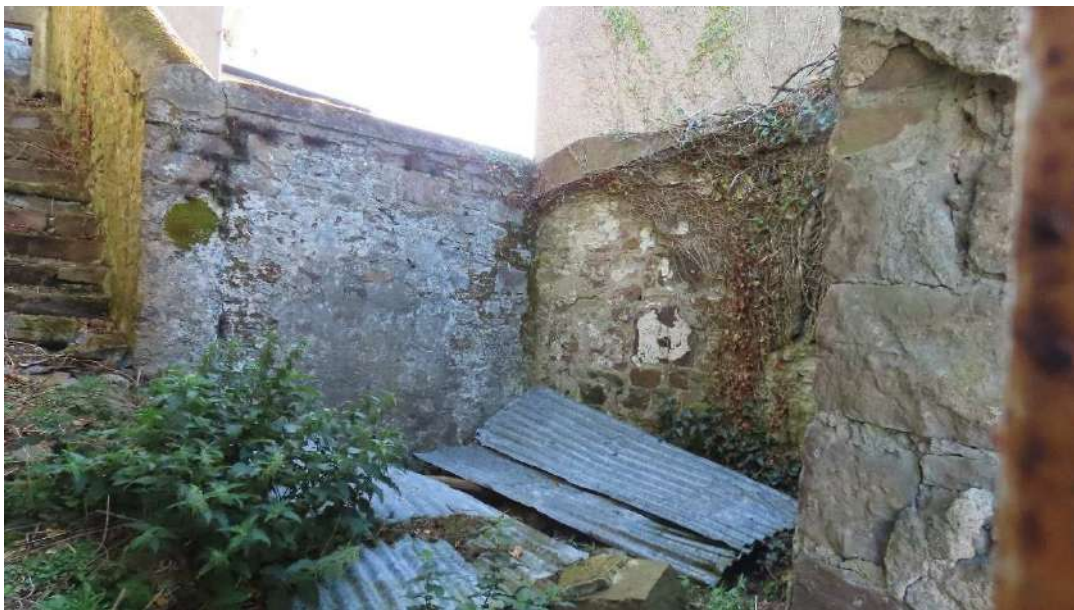
Photograph 025 Yard wall leading to stone steps.
