For: Limerick City & County Council

Adare Public Realm Upgrade Project 2026,
Adare, Co. Limerick.

STAGE 1 ROAD SAFETY AUDIT

December 2025

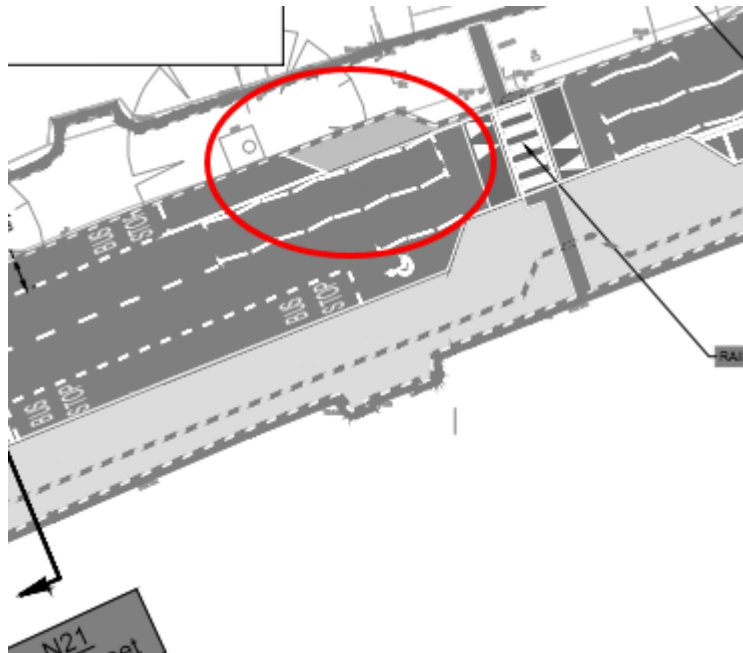
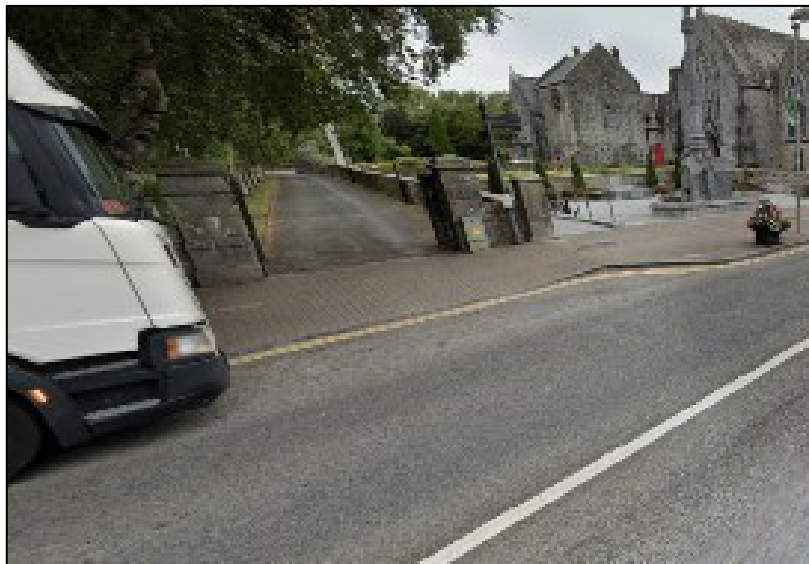
2.1 Problem 1: An existing entrance not incorporated within design

An existing vehicular entrance to the public car park does not appear to be incorporated into the proposed design. Failing to retain or incorporate existing entrances into design proposals can lead to conflicts between vehicles and pedestrians, as well as the potential removal of access. The proposed controlled pedestrian crossing, as identified, is also located in close proximity to the existing entrance.

Clarity should be provided by the design team if the identified existing entrance is being retained within the proposed design. If the existing access is being retained within the proposed scheme, the design team should consider the possibility of moving the proposed crossing away from this existing access. This measure would reduce potential conflict of traffic emerging from existing crossing and interacting with pedestrians accessing proposed crossing.

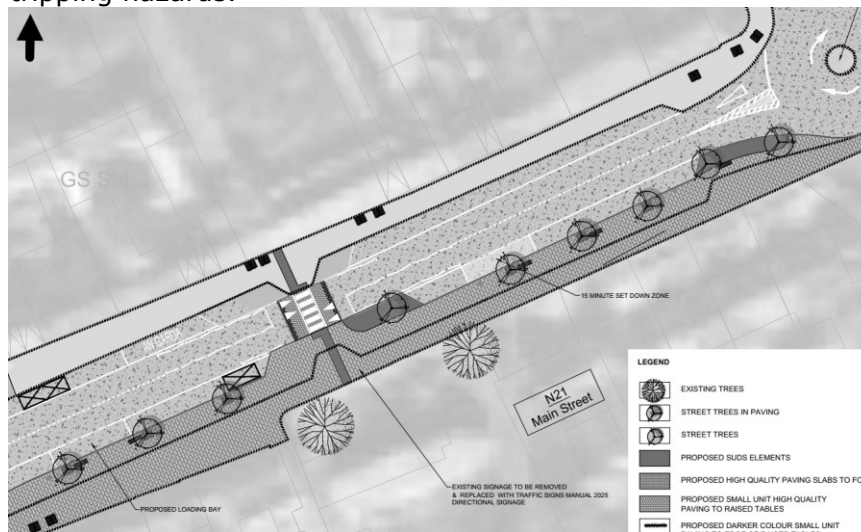
2.2 Problem 2: Potential hazard to vulnerable road users

Non-linear landscape designs along Main Street could pose a potential risk to vulnerable road users. Such irregular planting may create confusion for these users and increase the likelihood of tripping hazards.

Provide suitable landscape proposals that are designed for all road users and do not create potential hazards to vulnerable road users. Any redesign and repositioning of landscaping to the forefront of footpath should align with RSA Problem 2 listed previously.

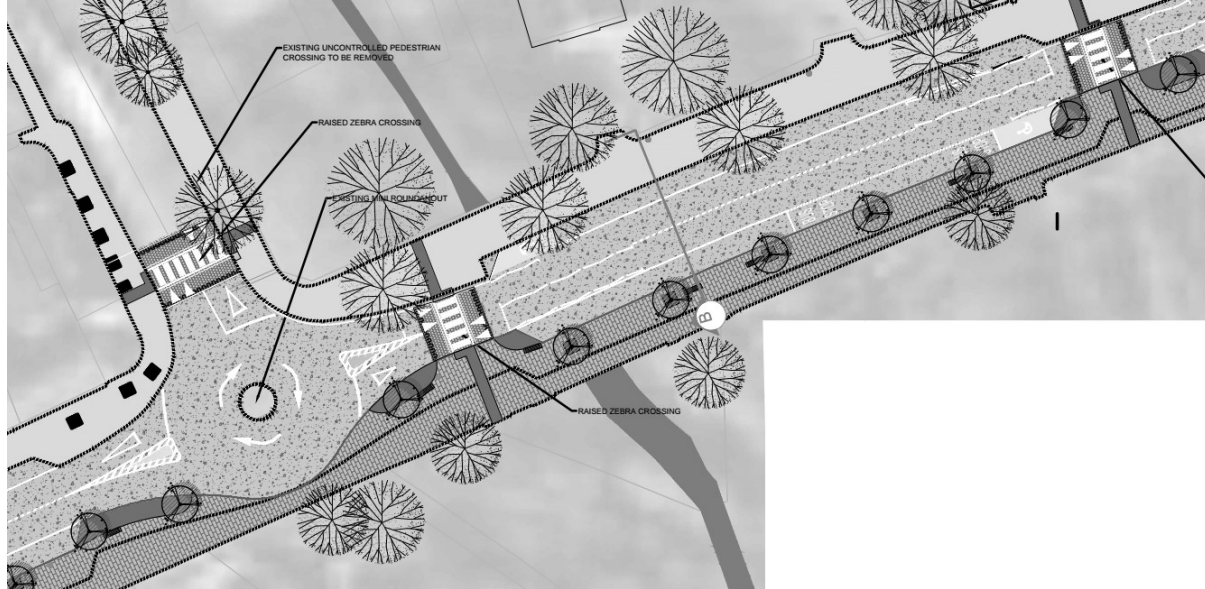
2.5 Problem 5: Forward visibility to pedestrian crossing

Proposed pedestrian locations under tree canopies can result in pedestrians not being seen by passing vehicles. Failure to have a direct and obvious line of sight to pedestrians may lead to misunderstanding between pedestrians and vehicles, which may result in a collision between pedestrians using the crossings and vehicles travelling along the main street.

Ensure that the adequate forward visibility to all pedestrian crossing have been provided throughout the scheme. All proposed and existing landscaping should not obstruct, obscure or inhibit motorists from seeing pedestrians in locations where pedestrians have priority.

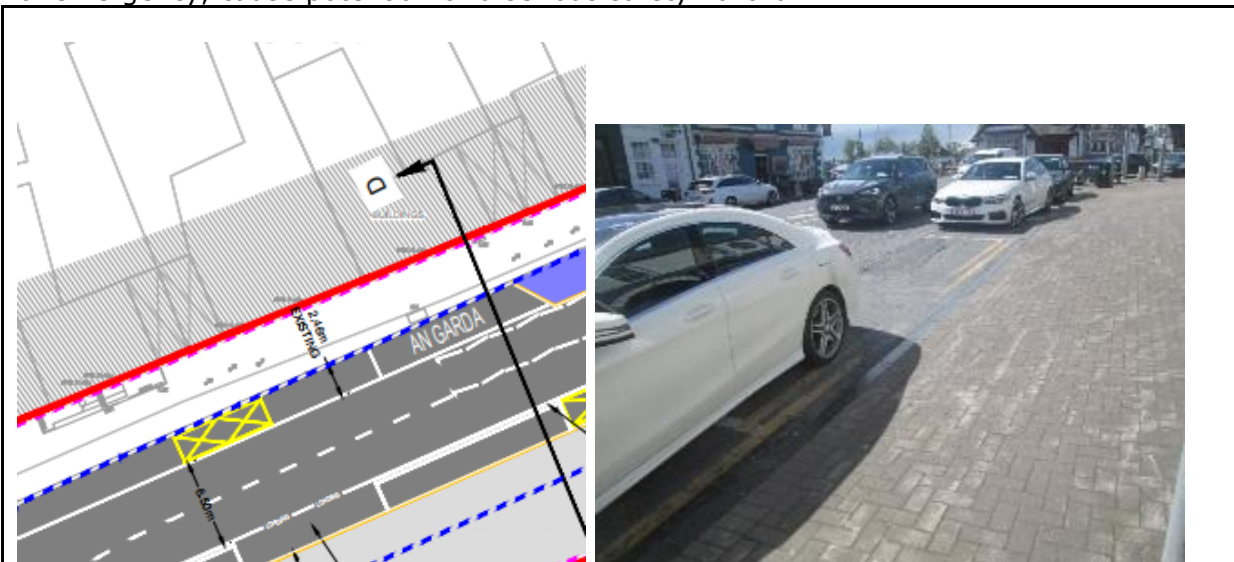
2.13 Problem 13: Double yellow line road marking on Main Street

At present there is an existing double yellow line that signifies a no parking area along Main Street as shown on the figure below. This parking control area has not been shown on proposed design layouts and has been replaced by parking spaces. Failure to provide restriction at parking areas where necessary can create traffic congestion and also in case of emergency, cause potential for a serious safety hazard.

The design team should review location along Main Street where existing parking prohibition road markings are present and confirm if they are to be retained in the proposed design.
