Mungret Residential Development
Stage 1 Road Safety Audit

Proposed Development at Dromdarrig, Mungret, Co. Limerick

January 2021

Stage 1 Road Safety Audit

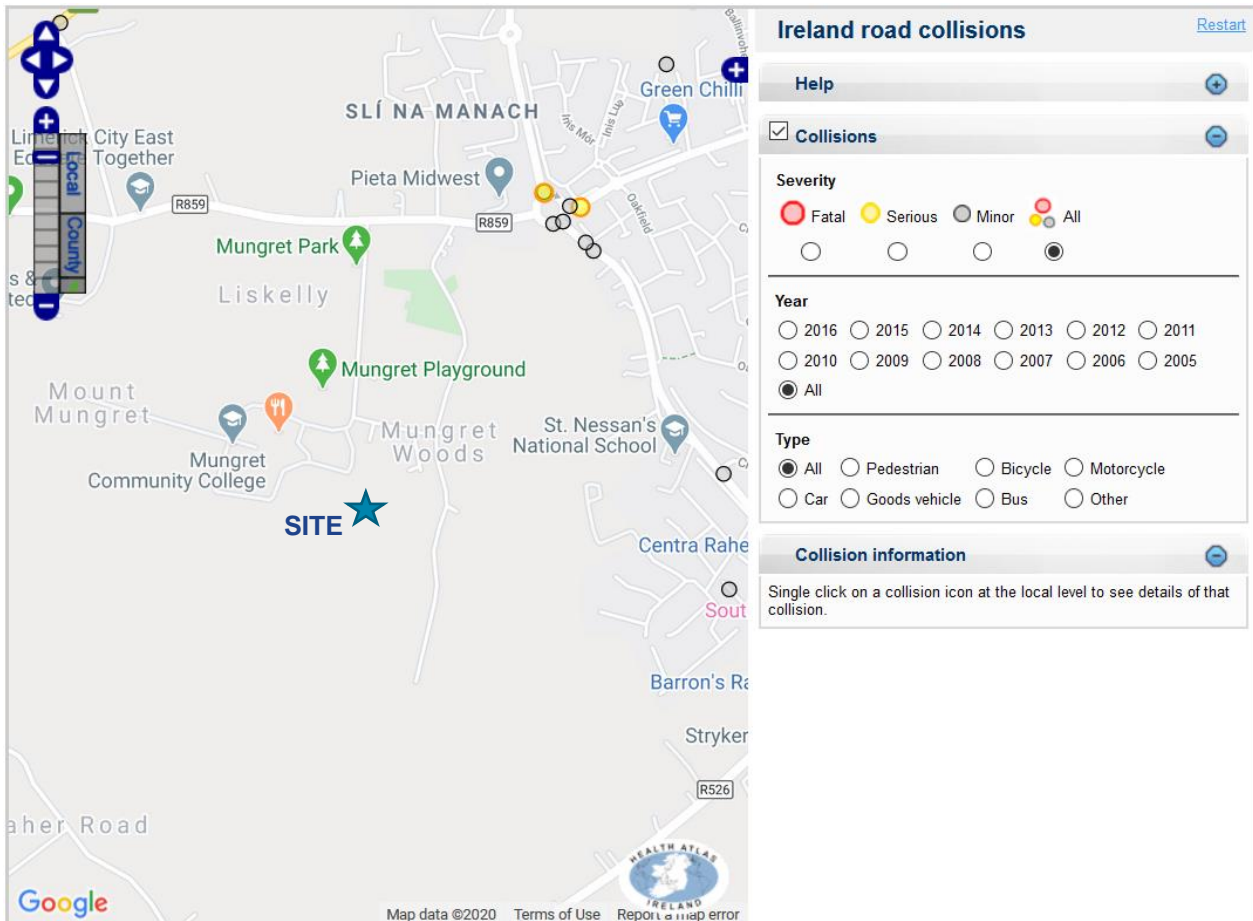
Figure 1.1: RSA collision history (2005 to 2016)

There was a cluster of 8 separate collisions at the roundabout between the R859 and the R510 regional roads. Two of these collisions were classified as serious. One involved a cyclist and the other was a head-on collision. Refer to Figure 1.1.

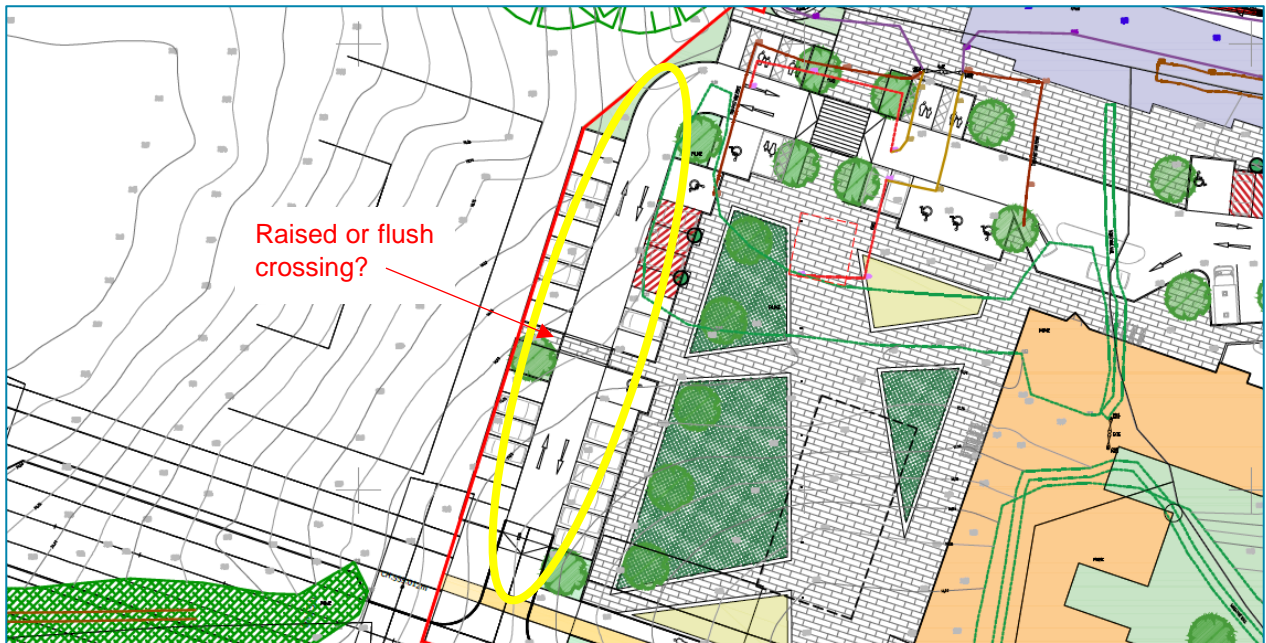
2.1 Problem: Traffic Calming

The western site access road which will provide the most direct access to the creche from the spine road has a very straight alignment which could be conducive to higher traffic speeds. It is not clear from the proposed site layout, if the crossing point located mid-way along the access road is to be raised or not. The likelihood and severity of all collisions is greatly exacerbated by higher speeds increasing the risk of a fatality and creating an unsafe environment for all road users especially pedestrians and cyclists.

Include a vertical traffic calming measure mid-way along the straight section of the access road to slow vehicles

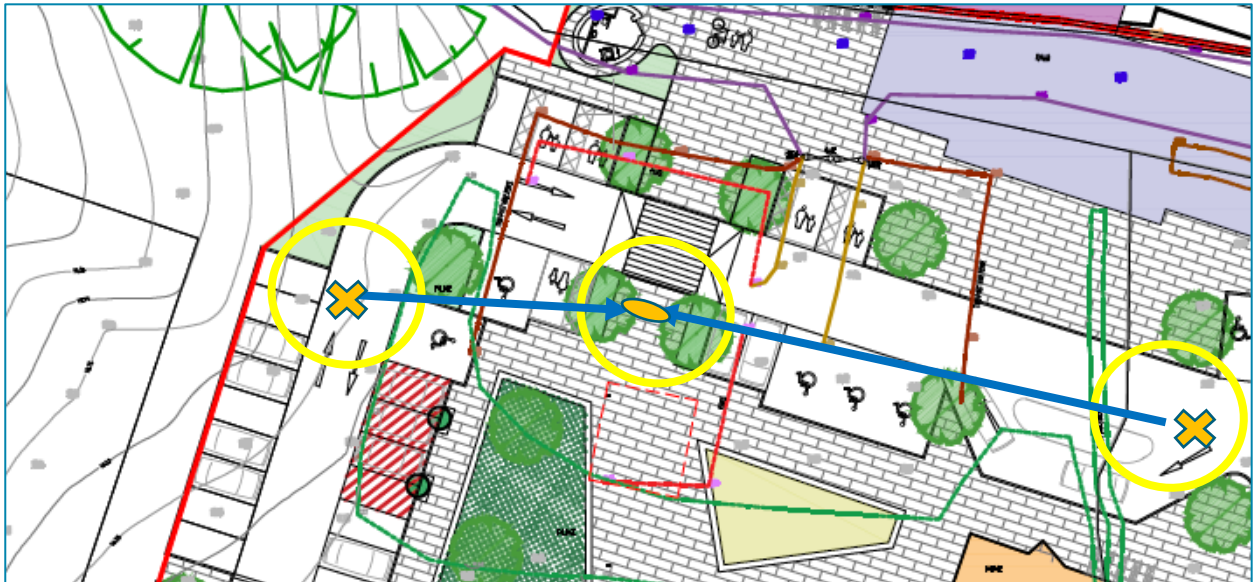
2.2 Problem: Forward Visibility

It is proposed to locate trees adjacent to the raised pedestrian crossing which provides access to the crèche. These trees will reduce the forward visibility of the crossing increasing the risk of a collision with a pedestrian. Maximising visibility is an important safety measure especially consider the adjacent sharp bend in the approaching road.

Ensure that the trees (and parking) do not reduce the forward visibility of motorists to see a pedestrian (especially a small child) about to cross. Tree types should be of a slender girth when mature and have a truck clear of side growth to a height of 1.8m. Also refer to Problem 2.3.

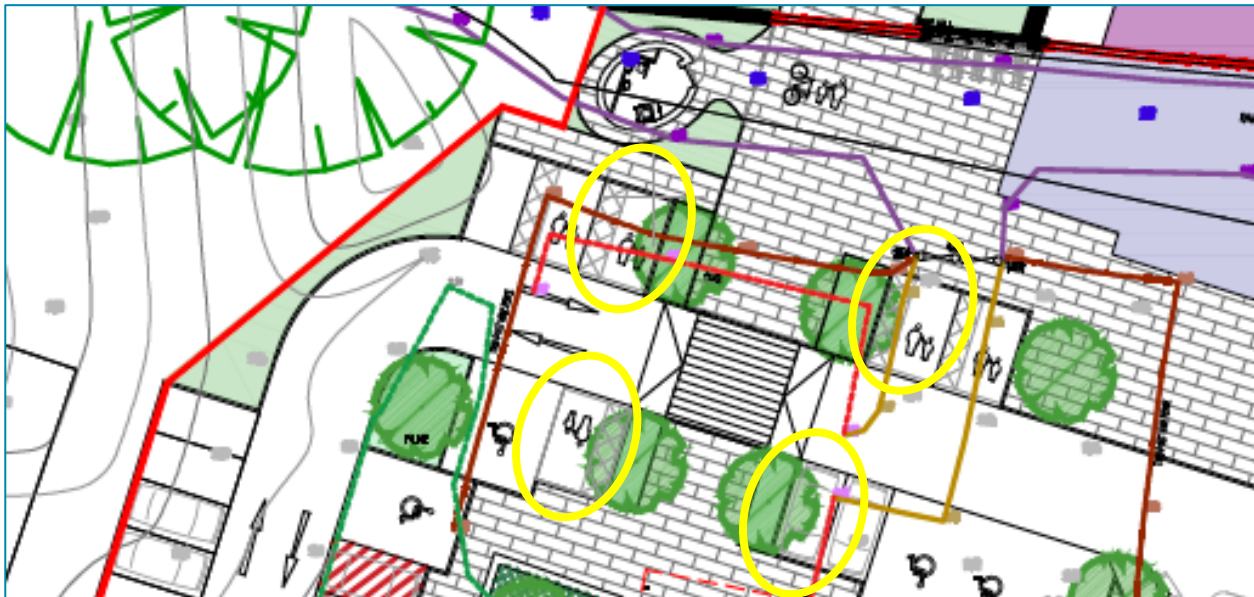
2.3 Problem: Parking close to Pedestrian Crossing

Parking bays are located very close to a significant pedestrian crossing, providing access to the creche from the set-down area. There is a danger that a motorist might need to reverse onto the crossing in order to exit a parking space increasing the risk of a collision with a pedestrian. Also, some of the parking bays to the south of the crossing may reduce the forward visibility of the crossing. Also refer to Problem 2.2.

Increase the buffer between the crossing and the adjacent parking spaces. This may require removing some of the parking bays. Remove all of the parking to the southwest of the crossing.

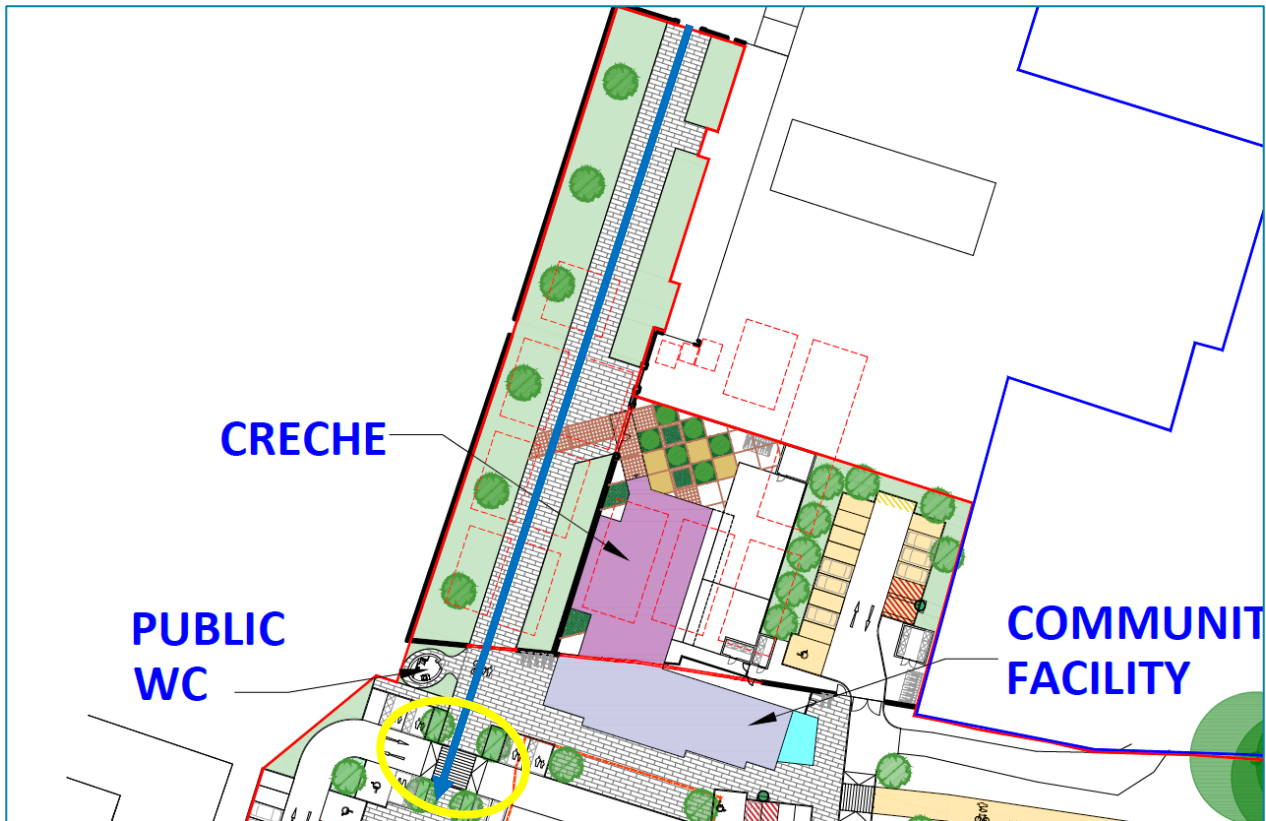
2.4 Problem: Shared Route to Creche

The shared pedestrian/cyclist route which provides access to the creche has a straight alignment, bounded by a row of trees and leads directly onto a pedestrian crossing. There is a danger that small children might run or cycle straight across the road without paying due caution to traffic. The adjacent parking spaces (refer also to Problem 2.3) form a kind of tunnel effect and reduces inter-visibility between motorists and pedestrians. This could lead a child running/cycling in front of a passing vehicle and being struck.

The Design Team should consider installing two or three bollards to encourage children to slow down and be more cautious on approach to the crossing. Ensure that different surface materials of varying contrast are used to clearly distinguish the crossing from the other shared pedestrian/cyclist areas. Ensure that the crossing is well lit with the appropriate tactile paving.

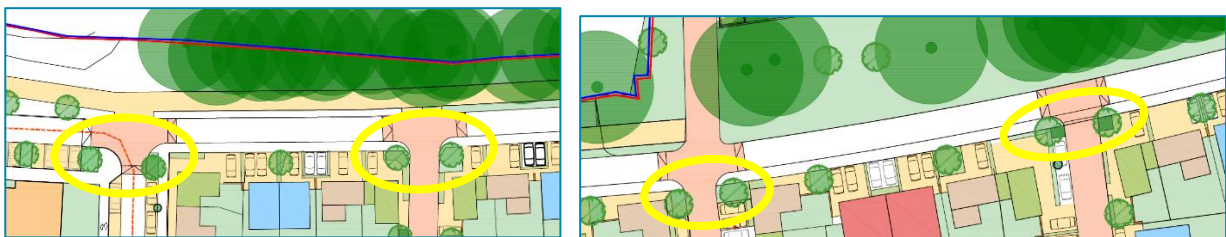
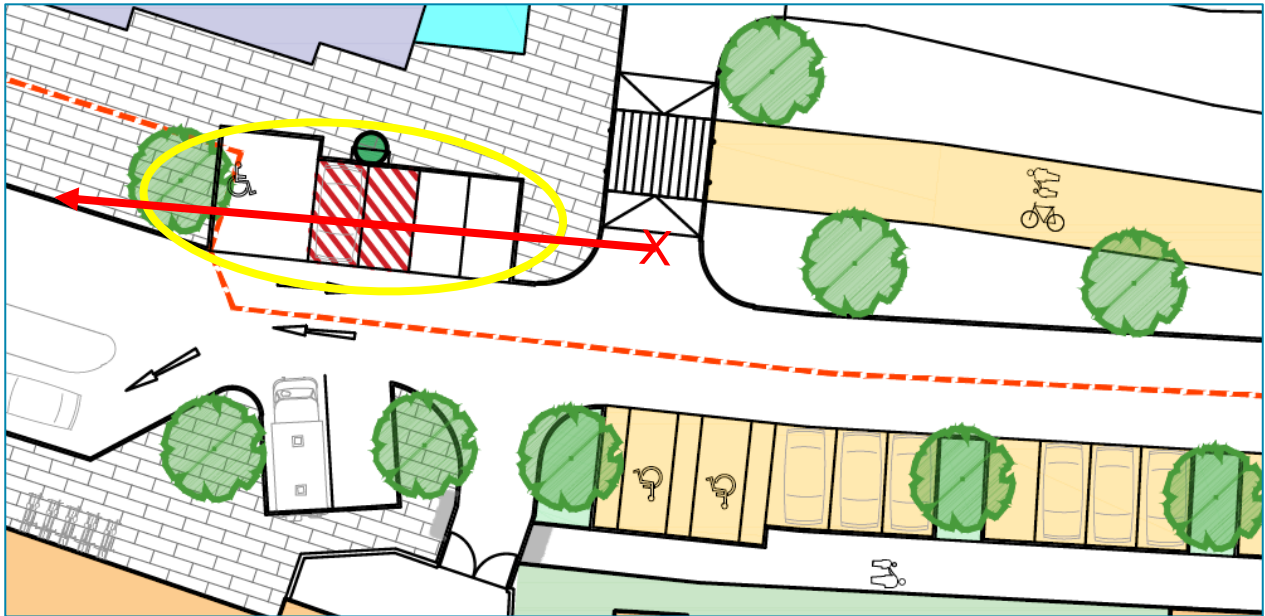
2.5 Problem: Sight Lines at Junctions

It is unclear from the scheme drawing if the necessary sight lines can be achieved at many of the internal junctions due to proposed tree planting or car parking close by. Reduced visibility increases the risk of 'side-seep' or 'rear-end shunt' type collisions.

Ensure that all internal junctions have the necessary sightlines in accordance with DMURS.

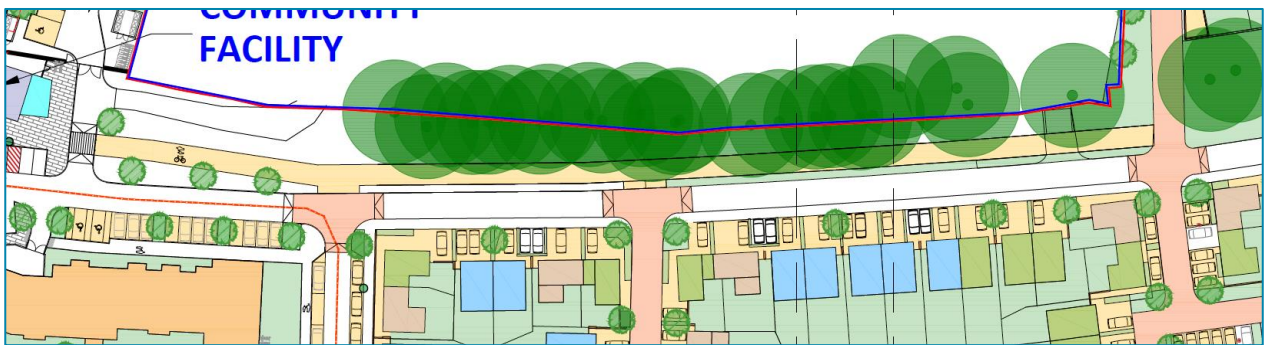
2.6 Problem: Lack of Uncontrolled Crossings

There appears to be a lack of uncontrolled crossings for pedestrians wanting to access the 'Shared Leisure Route' which runs along the northern boundary from other parts of the development. This may lead to pedestrians crossing the street at unsafe locations.

The Design Team should ensure that there is appropriate crossing points and connectivity from the development to the Shared Leisure Route.

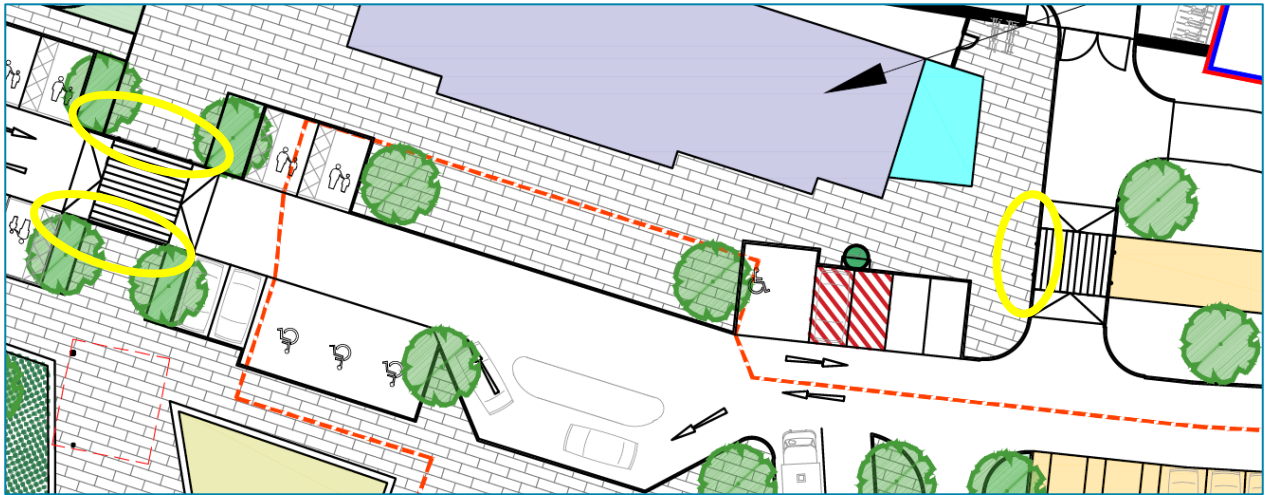
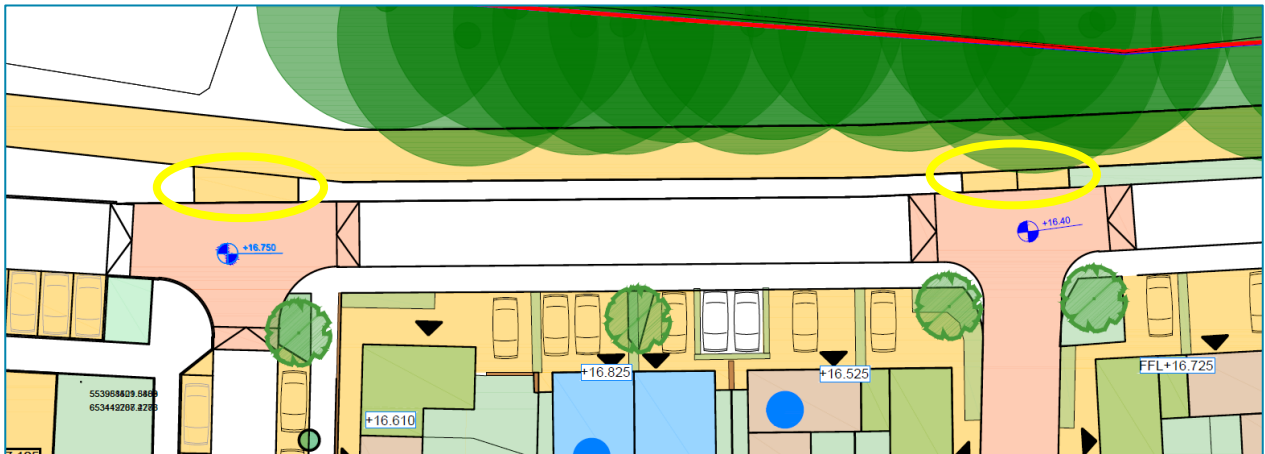
2.7 Problem: Lack of Tactile Paving at Pedestrian Crossings

No tactile paving is prescribed at pedestrian crossings which could lead to pedestrians with a visual impairment stepping out onto the carriageway and in front of a passing vehicle.

Ensure that the correct tactile paving is used at the correct location (i.e. on the desire line) at each pedestrian crossing for the entire scheme.

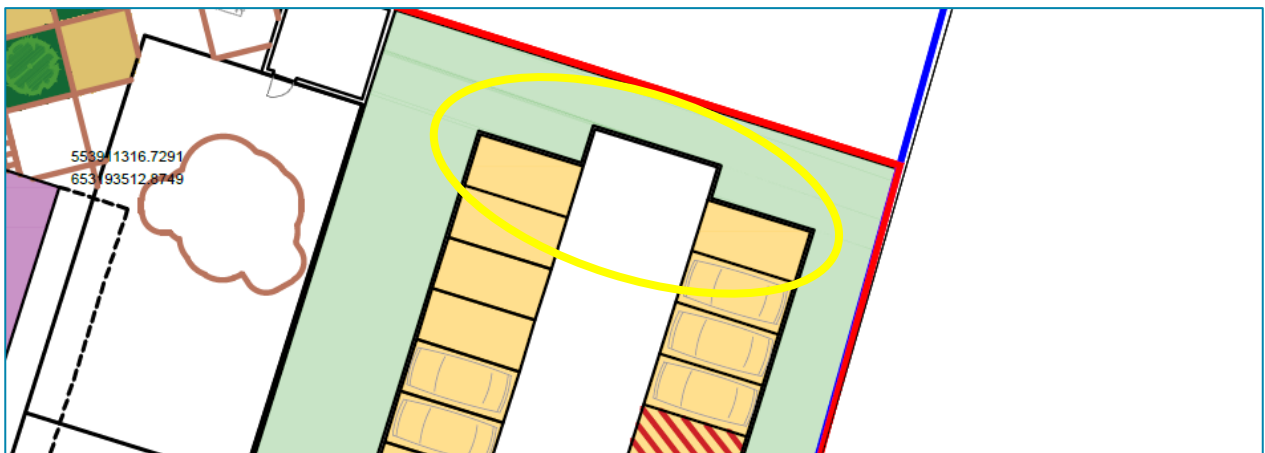
2.8 Problem: Turning Area in Carpark

It is not clear if motorists can safely egress from the end parking spaces when all other parking spaces are occupied by a vehicle. This could lead to an increased risk of collision with another vehicle.

Carry out a vehicle path sweep assessment to ensure that motorists can safely park and vacate the end parking spaces and if not, design accordingly.

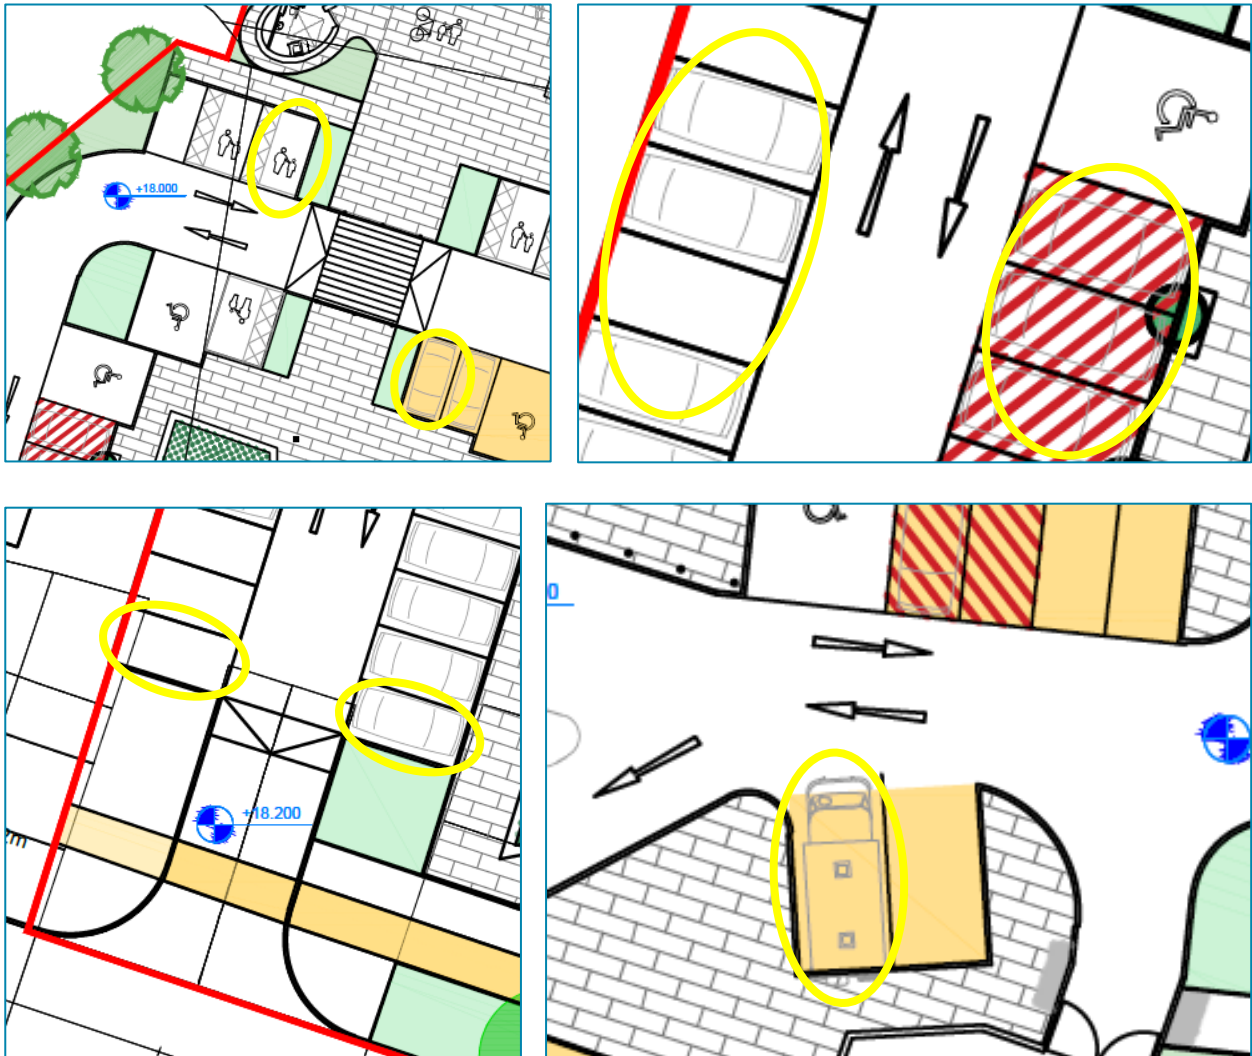
2.9 Problem: General Parking Movements

It is not clear from the drawings, if there is sufficient space for vehicles to carry out the required movements, particularly for parking. Some parking spaces appear tight and may take several movements to access/egress the spaces. Parking spaces which are difficult to use may increase the risk of an incident.

Review all of the parking areas within the site. Carry out a swept path analysis to illustrate that all spaces can be accessed and egressed safely. Consider keeping parking spaces away from junctions and raised tables / pedestrian crossings to increase safety and manoeuvrability.

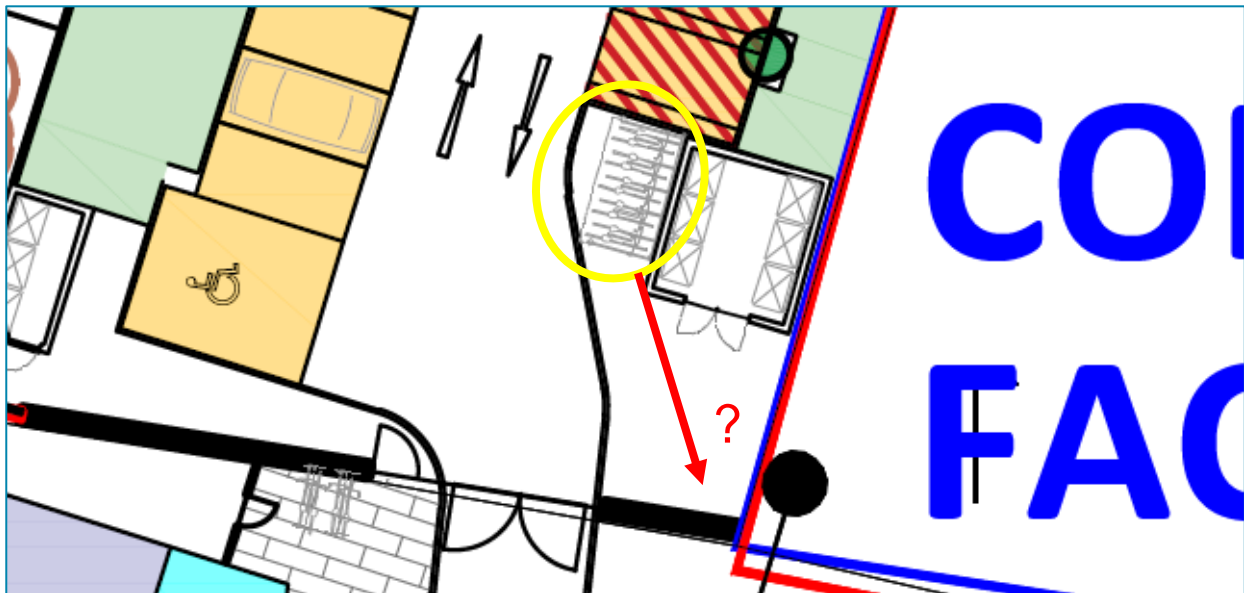
2.10 Problem: Unsafe Bike Stand Location

The location of the bike parking area within the carpark has little space for cyclists to stand when using the bike-stand which could lead to a cyclist being struck by a vehicle within the carpark.

Relocate the bike parking area to a safe space with more room.

2.10	Yes	Yes	The bike stands will be moved	Yes
------	-----	-----	-------------------------------	-----
