PRELIMINARY CONSERVATION REVIEW OF PROPOSED WORKS TO EXISTING STRUCTURES AT THE FORMER RATHKEALE GOODS SHED

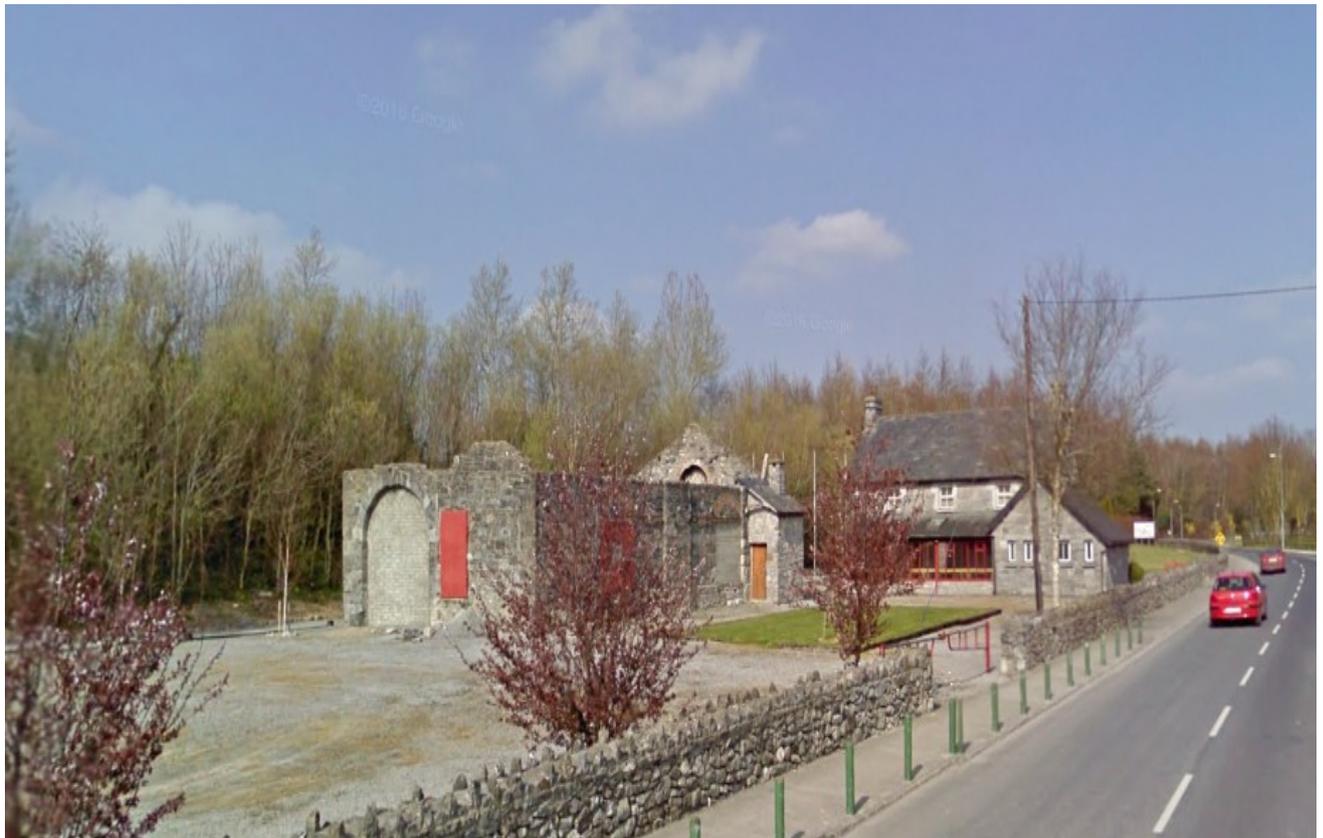
Current view of goods shed and former station house (Google Maps)
Note missing masonry on western gable.

Recent built up external ground levels need to be resolved to provide straightforward access to finished floor level. Western gable needs to be re built and loose masonry elsewhere made good.

Take down and re build defective stonework to gables and arched openings.

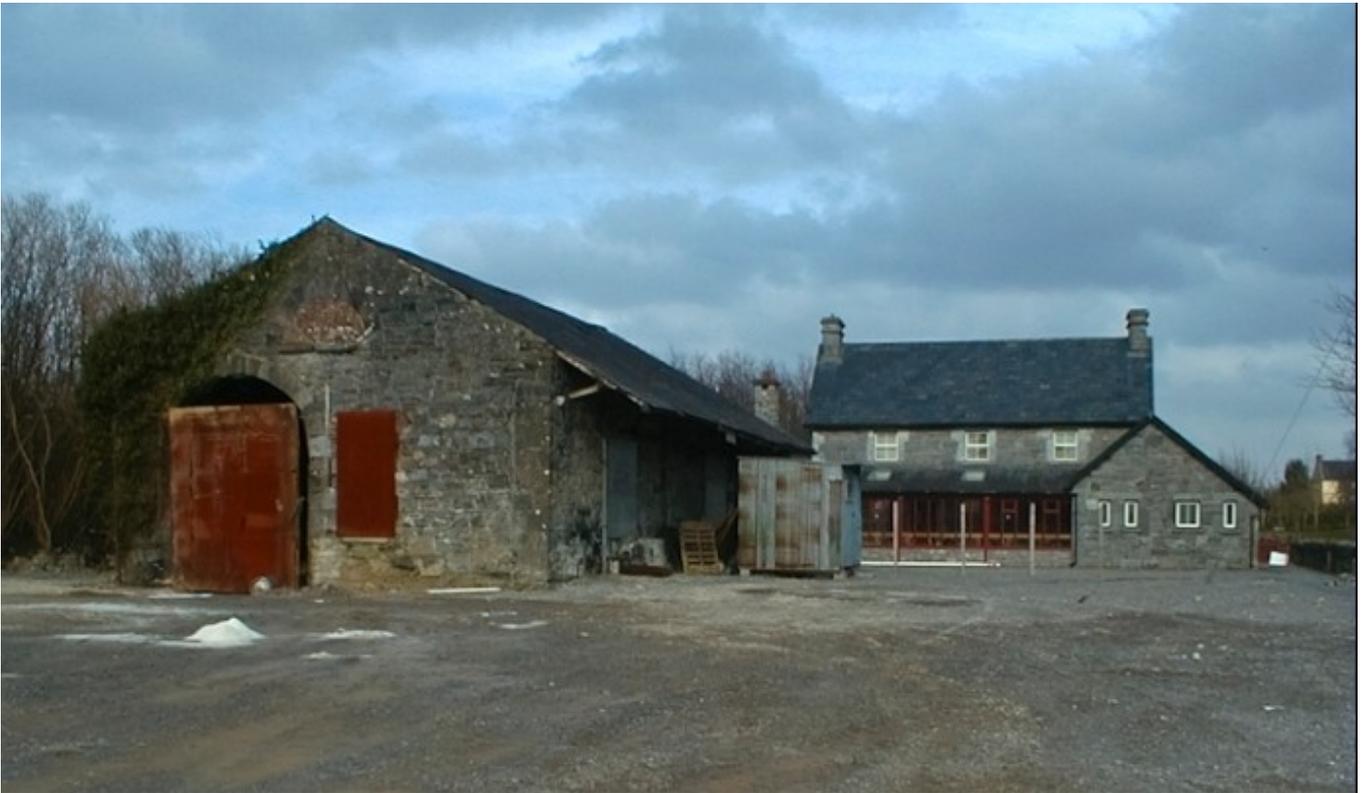
Archive photograph of Rathkeale station house and goods shed (Ciaran Cooney/Eirtrains)
Note the overhanging canopy in front of the former goods delivery doorways.

Reinstatement of an open roof canopy on south side flanking the former sliding goods doorways. This arrangement will allow new sliding doorways to act as service counters to the cafe and office and cover for outside dining. Sliding door gear is extant and should be re used.

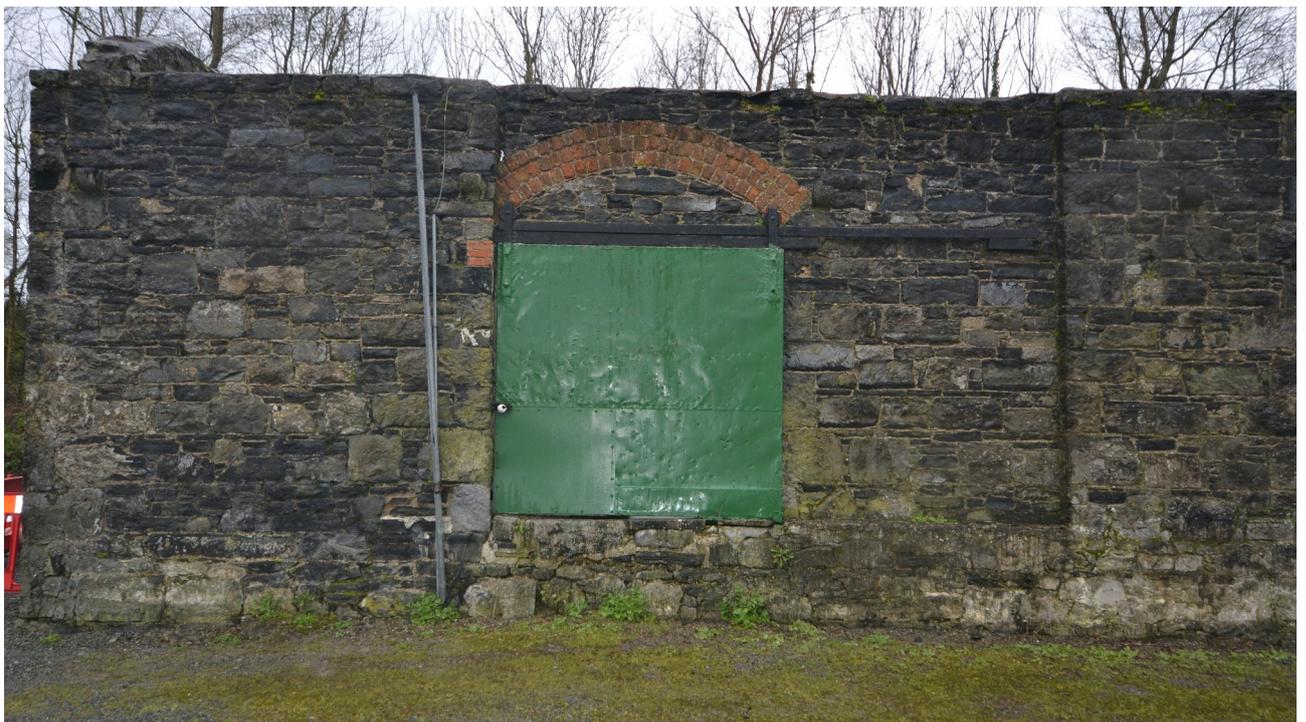
South elevation -Brick relieving arches & sliding door gear are in place. Masonry in good condition

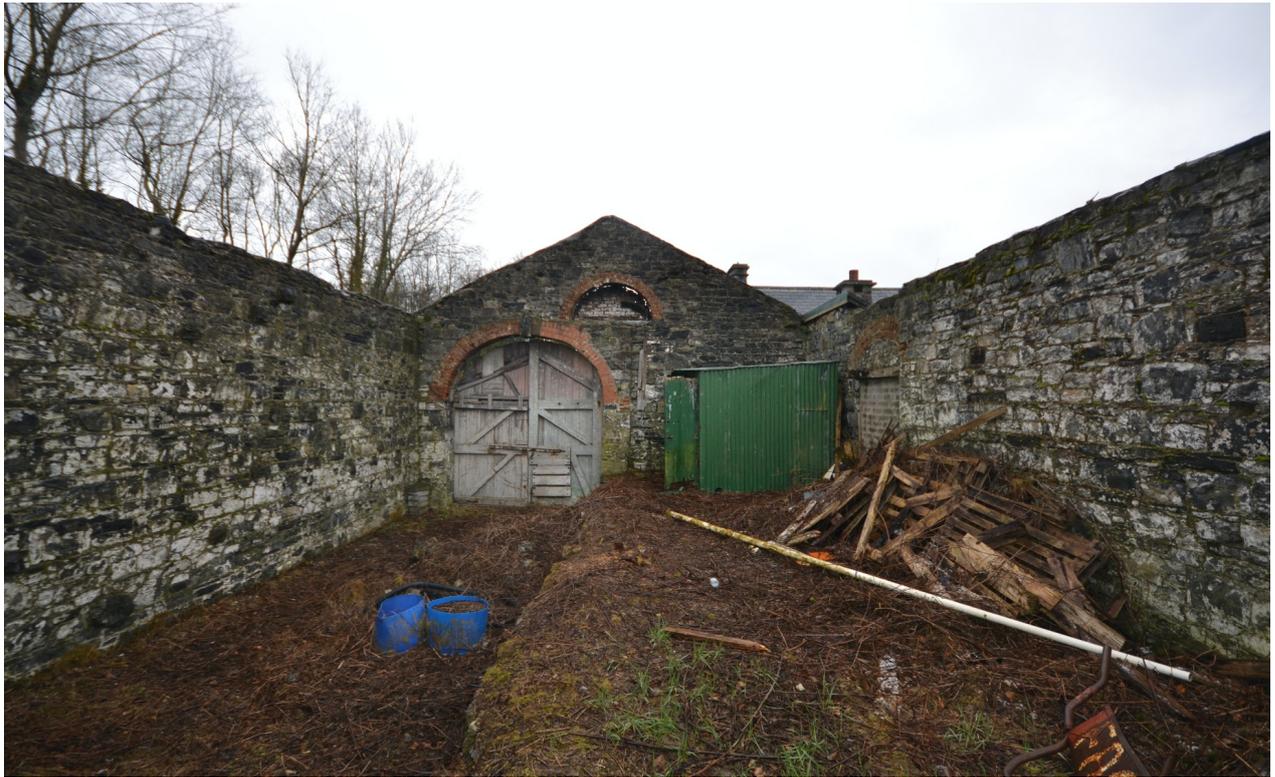
Internal view showing wooden doors to former trackway and retaining wall structure to form former goods platform loading area.

Remove portion of former internal goods platform area to facilitate barrier free access and safe public circulation. Platform retaining wall to be left in place and used to support columns and beams forming new bicycle storage/maintenance loft area.

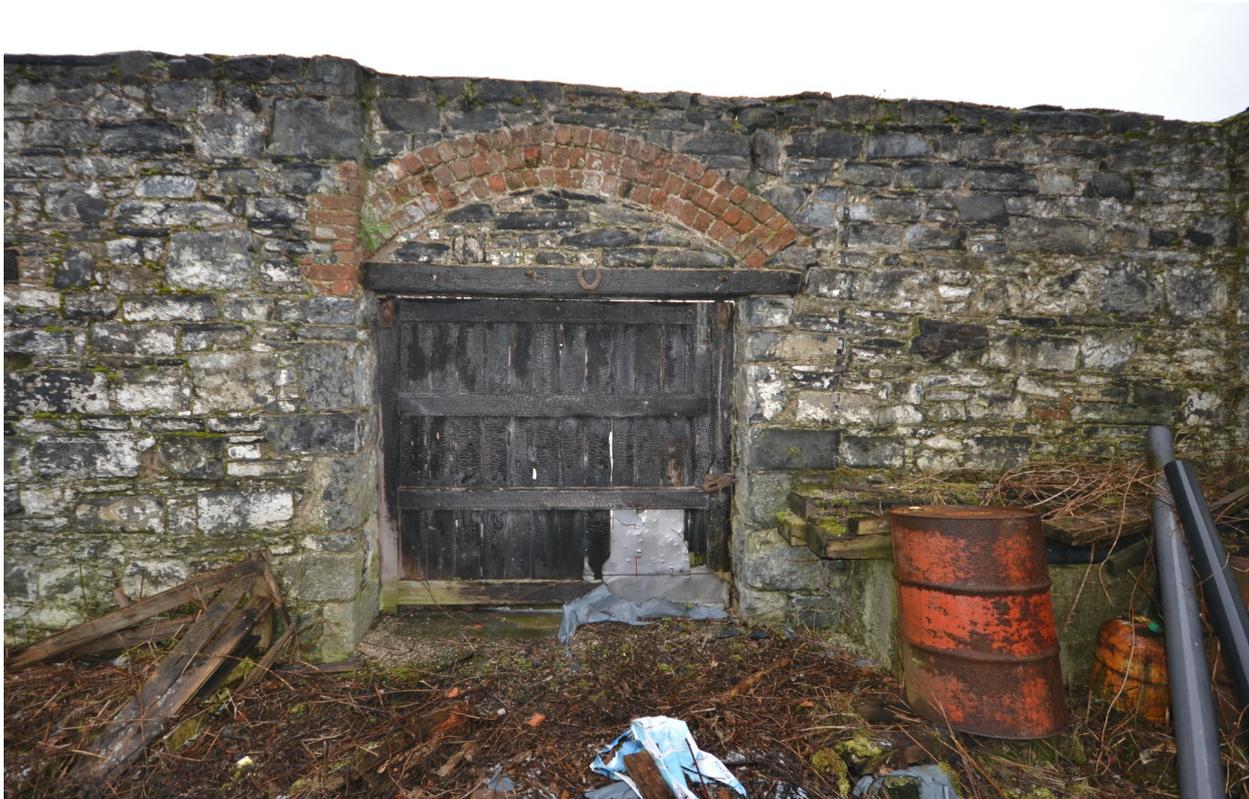
previously noted the roof has been missing for many years and no internal fabric of any significance remains apart from the sliding goods door openings formed with brick relieving arch and timber lintels. The timber doors are also worthy of record for replacement if beyond repair.

Demolish modern blockwork in door openings retaining original sliding and arched doors in storage for reference.
