# Independent Tree Surveys Ltd

## Tree Survey Report LIT-City Centre Cycle Scheme Limerick City Co. Limerick

June 2022

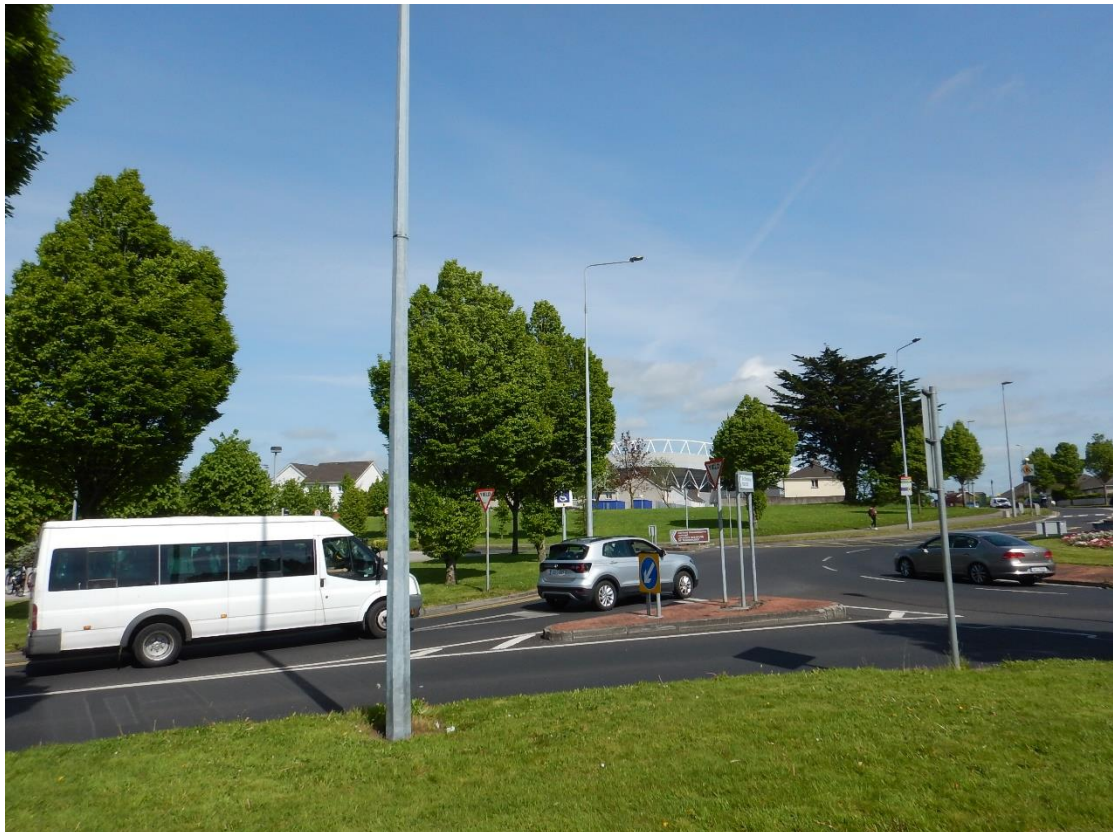
1. Trees (T1-12, 19-21, 89-90) in verges and green open space close to LIT and the Cratloe Road roundabout

| Type | No. | Species | Age | Ht m | Dbh mm | St | Cr | N | S | E | W | ERC | Phys Cond | Structural Condition/Comments | Preliminary Recommendations | RPA m | Cat |
|---|---|--|---|---|---|---|---|---|---|---|---|---|---|--|---|---|---|
| T | 11 | Carpinus betulus (Hornbeam) | EM | 8 | 210 | 1 | 2 | 1.5 | 2 | 2 | 1 | 10+ | Fair | Fair. Smaller sized tree. Slight lean to stem. Some bark wounds to stem base. Slower to leaf out than neighbouring trees. | No urgent works needed. Monitor tree condition. | 2.52 | C2 |
| T | 12 | Cupressus macrocarpa (Monterey Cypress) | M | 16 | 950 | 1 | 5 | 8 | 8 | 8 | 6 | 10+ | Poor | Fair/Poor. Larger tree in green open space. Ivy restricts view of main branch unions. Some storm damaged branches hanging in crown. Minor deadwood in crown. Dieback in crown consistent with Coryneum canker. | Target prune broken/damaged branches. Monitor tree condition. | 11.4 | C2 |

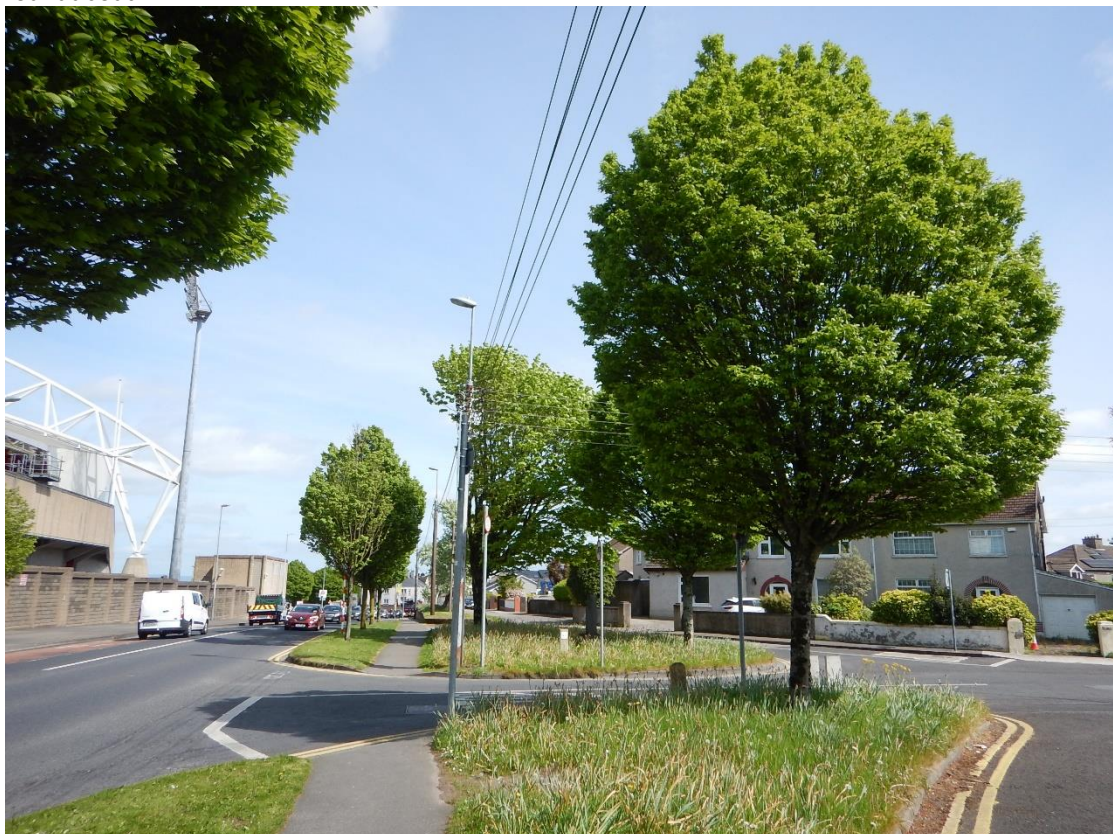
2. Street trees (Hornbeam, Sorbus and Maple (T23-31) opposite Thomond Park stadium

| Type | No. | Species | Age | Ht<br>m | Dbh<br>mm | St | Cr | N | S | E | W | ERC | Phys Cond | Structural Condition/Comments | Preliminary Recommendations | RPA<br>m | Cat |
|---|---|---|---|---|---|---|---|---|---|---|---|---|---|--|--|---|---|
| T | 27 | Carpinus betulus<br>(Hornbeam) | SM | 6 | 200 | 1 | 2 | 2 | 1 | 1 | 1 | <10 | Poor | Fair/Poor. Smaller sized street tree. Dieback in crown. Some bark wounds to stem base. Limited potential. | Consider removal and replacement as part of good management. | 2.4 | U |
| T | 29 | Carpinus betulus<br>(Hornbeam) | EM | 9 | 265 | 1 | 2 | 2.5 | 3 | 2.5 | 2 | 20+ | Good | Fair. Medium sized street tree. Some bark wounds to stem base. Small decay pocket at stem base. | No urgent works needed. | 3.18 | B2 |

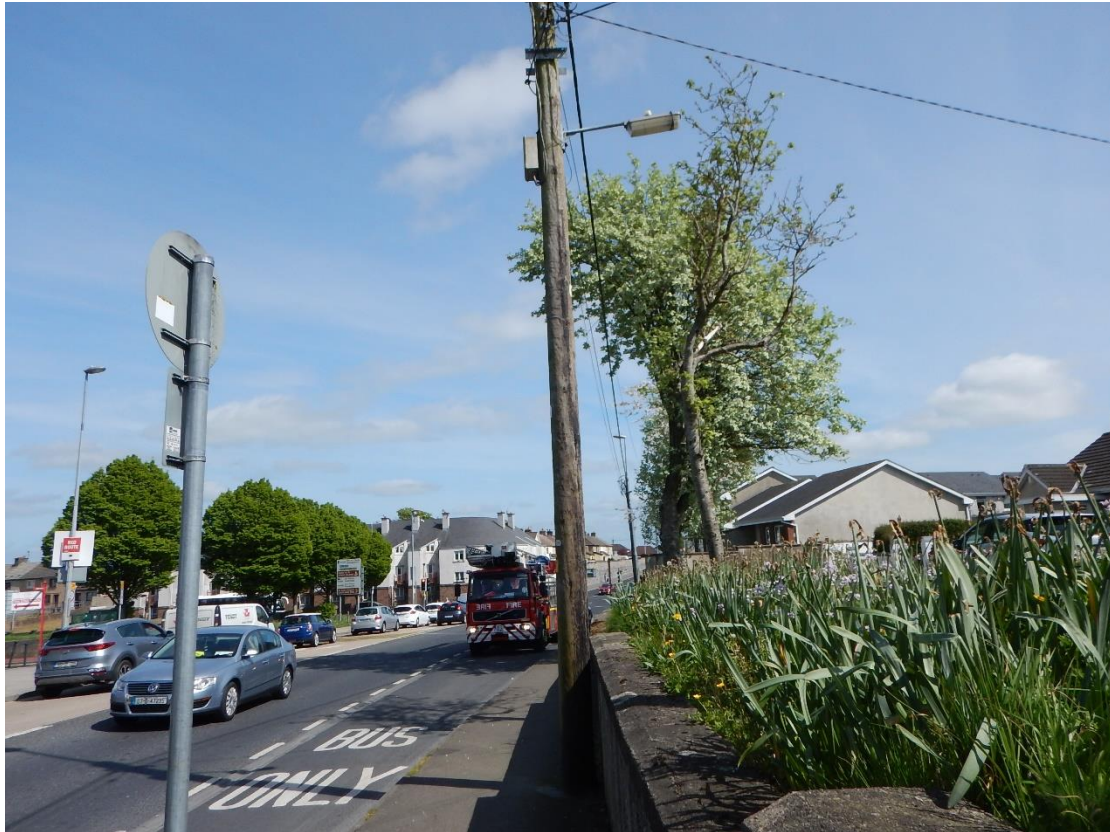
3. Trees (Hornbeam T37-42 and Sorbus spp T33-36.) at the eastern end of Cratloe Road, just west of the Shelbourne Road junction

| Type | No. | Species | Age | Ht<br>m | Dbh<br>mm | St | Cr | N | S | E | W | ERC | Phys Cond | Structural Condition/Comments | Preliminary Recommendations | RPA<br>m | Cat |
|---|---|---|---|---|---|---|---|---|---|---|---|---|---|--|--|---|---|
| T | 33 | Sorbus aucuparia<br>(Rowan) | M | 5.5 | 200 | 1 | 2 | 1 | 3.5 | 2 | 1 | <10 | Poor | Fair/Poor. Smaller sized tree. Poor shape & form. Unbalanced crown shape. Dieback in crown. Epicormic shoots on branching throughout crown. | Consider removal and replacement as part of good management. | 2.4 | U |
| T | 35 | Prunus spp<br>(Flowering Cherry) | M | 8 | 350 | 1 | 3 | 2 | 4 | 4 | 5 | <10 | Poor | Poor. Smaller sized tree. Poor shape & form. Unbalanced crown shape. Recent loss of major limb leaving large tear-out wound. | Consider removal and replacement as part of good management. | 4.2 | U |

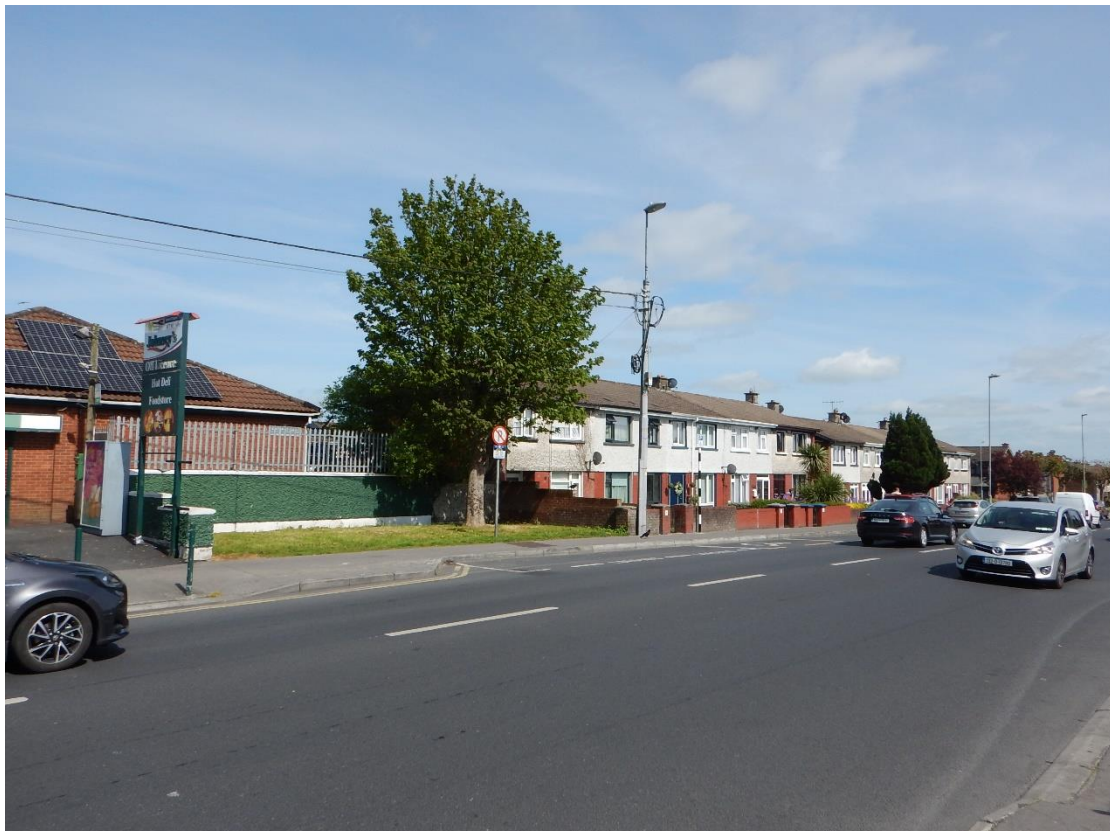
4. Sycamore tree T44 outside convenience store on Sexton Street North, with other trees(T45-50) along the street to the east

Where the existing hard surfacing within the RPAs of tree is being replaced with new materials, there is potential to damage the roots of the adjacent trees. In these instances, the existing sub-base should be left intact wherever possible. This may be an issue close to trees T18, T26, T44, T51, T53, and T83.

| Type | No. | Species | Age | Ht m | Dbh mm | St | Cr | N | S | E | W | ERC | Phys Cond | Structural Condition/Comments | Preliminary Recommendations | RPA m | Cat |
|---|---|---|---|---|---|---|---|---|---|---|---|---|---|---|---|---|---|
| T | 44 | Acer pseudoplatanus (Sycamore) | M | 9 | 470 | 1 | 2 | 5 | 4 | 3 | 4 | 10+ | Good | Fair/Poor. Good vitality. Medium sized tree in small open green space. Large decay cavity on main stem. Previously topped. | Prune periodically to maintain as smaller tree. | 5.64 | C2 |

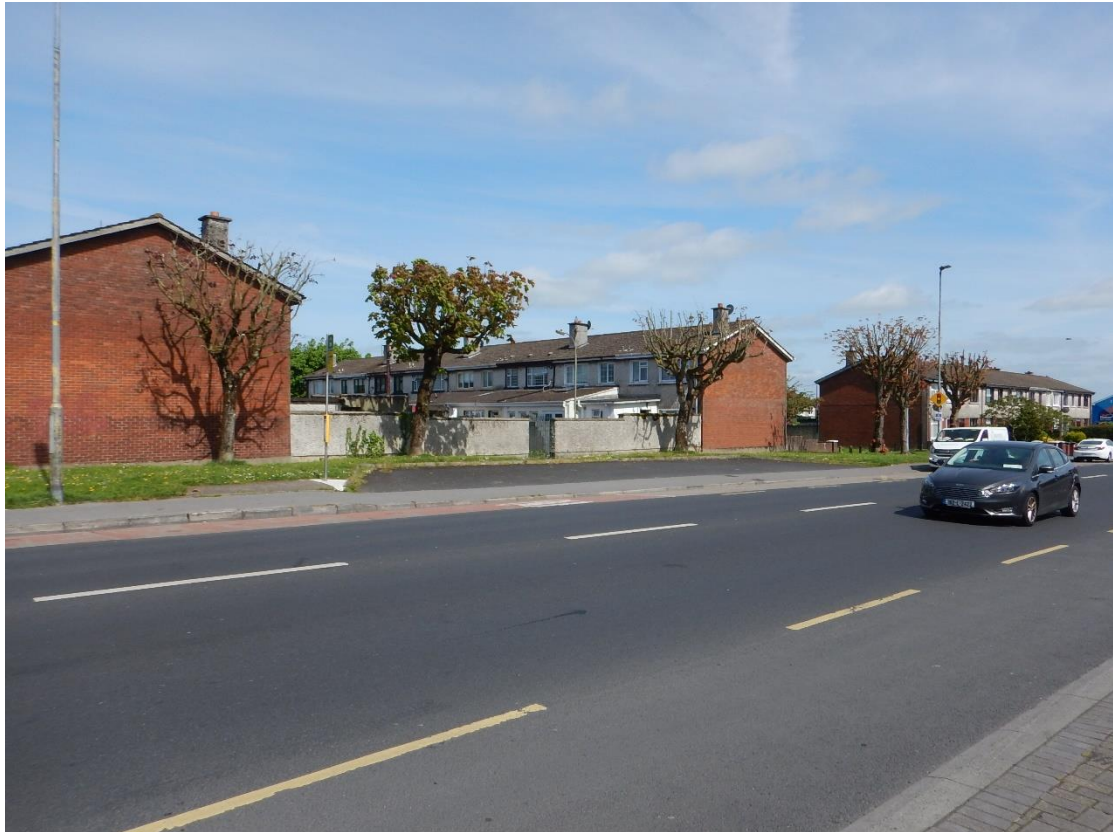
5. Recently topped Maple trees (T48-53) along Sexton Street North

| Type | No. | Species | Age | Ht m | Dbh mm | St | Cr | N | S | E | W | ERC | Phys Cond | Structural Condition/Comments | Preliminary Recommendations | RPA m | Cat |
|---|---|---|---|---|---|---|---|---|---|---|---|---|---|---|---|---|---|
| T | 49 | Acer platanoides (Norway Maple) | EM | 6.5 | 470 | 1 | 3 | 3 | 3 | 3.5 | 2.5 | 20+ | Fair | Fair. Medium sized tree in wide grassed verge. Small decay pocket at stem base. Recently topped. | No urgent works needed. | 5.64 | B2 |

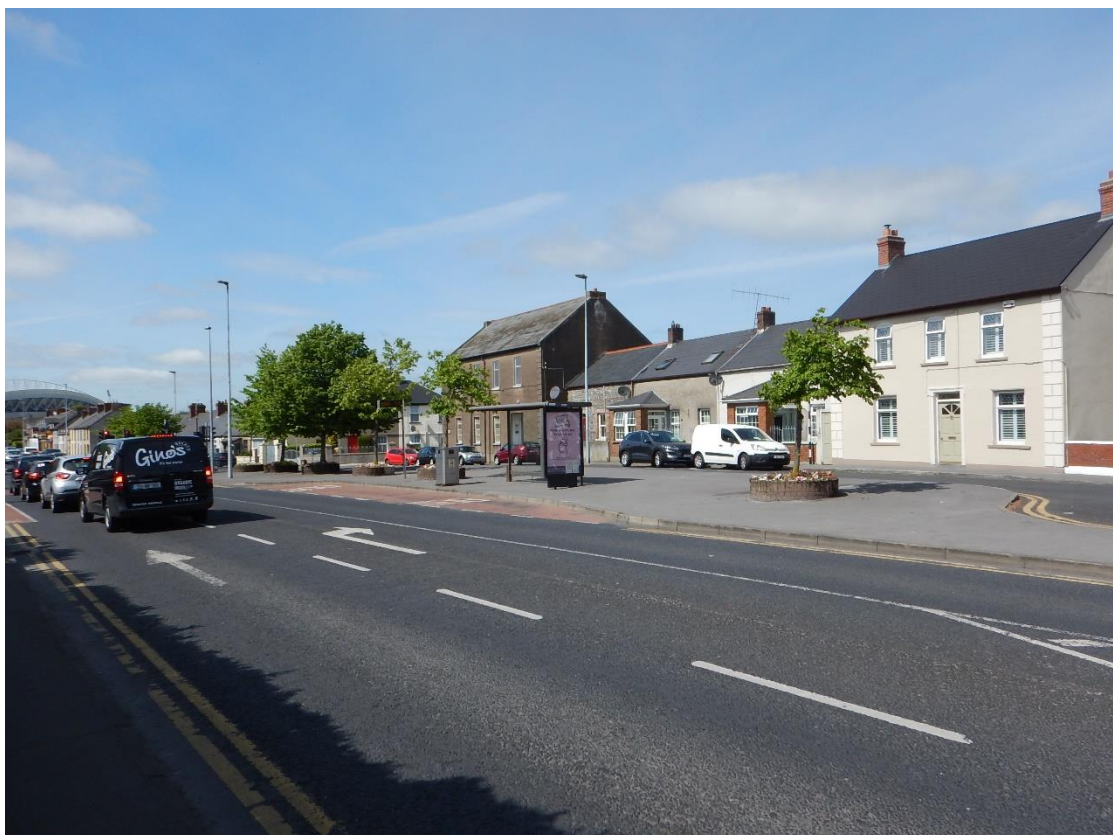
6. Young Lime trees (T56-63) planted into a series of raised beds/planters along High Road

| Type | No. | Species | Age | Ht<br>m | Dbh<br>mm | St | Cr | N | S | E | W | ERC | Phys Cond | Structural Condition/Comments | Preliminary Recommendations | RPA<br>m | Cat |
|---|---|---|---|---|---|---|---|---|---|---|---|---|---|--|--|---|---|
| T | 62 | Tilia spp. (Lime) | SM | 4 | 100 | 1 | 2 | 2 | 1.5 | 1 | 1 | 10+ | Fair | Fair. Smaller sized street tree growing within raised bed. Major bark wounding on stem. | Monitor tree condition. | 1.2 | C2 |

The 25 trees labelled T9-11, 13, 19-23, 27-30, 41-42, 56-64 and 70, will be felled/removed. The trees to be removed are indicated on the Tree Protection Plan drawing 22027\_TPP. The stumps of trees T10, 11, 13, 23, 27, 28, 41 and 42 will be removed by stump grinder rather than digger/excavator.

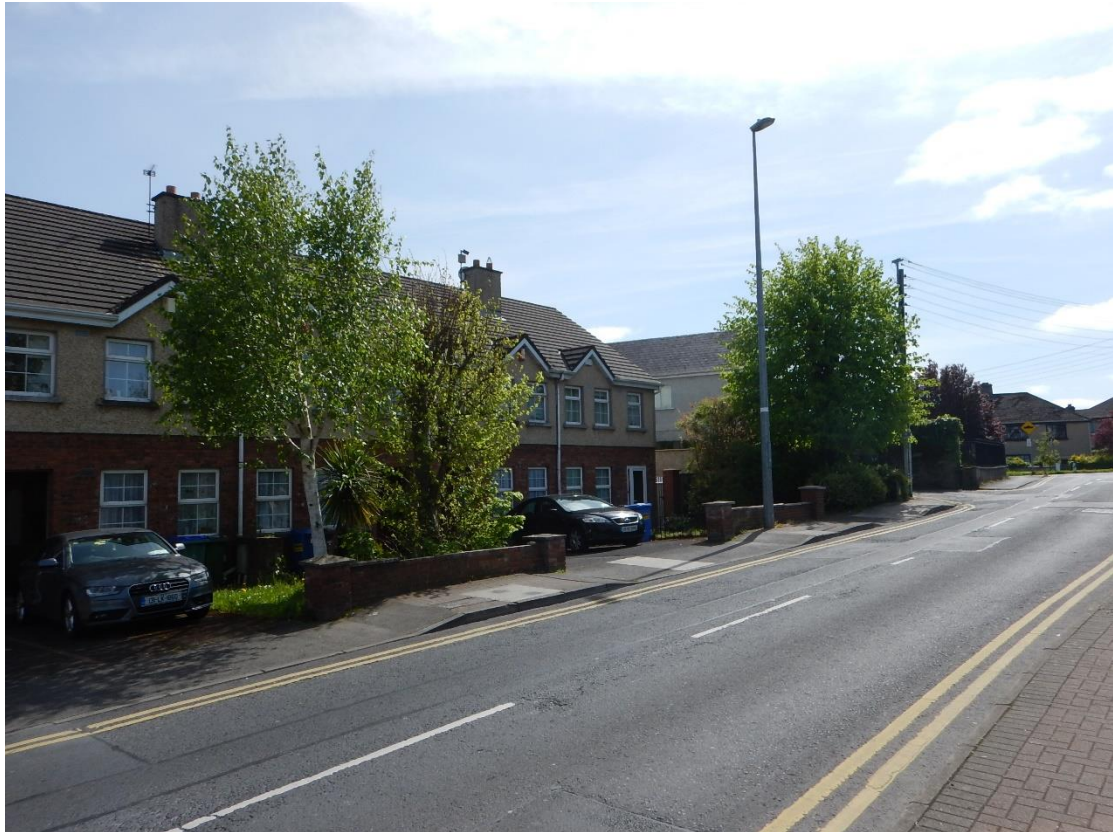
7. Birch and Lime trees(T67-69) in gardens along Belfield Court

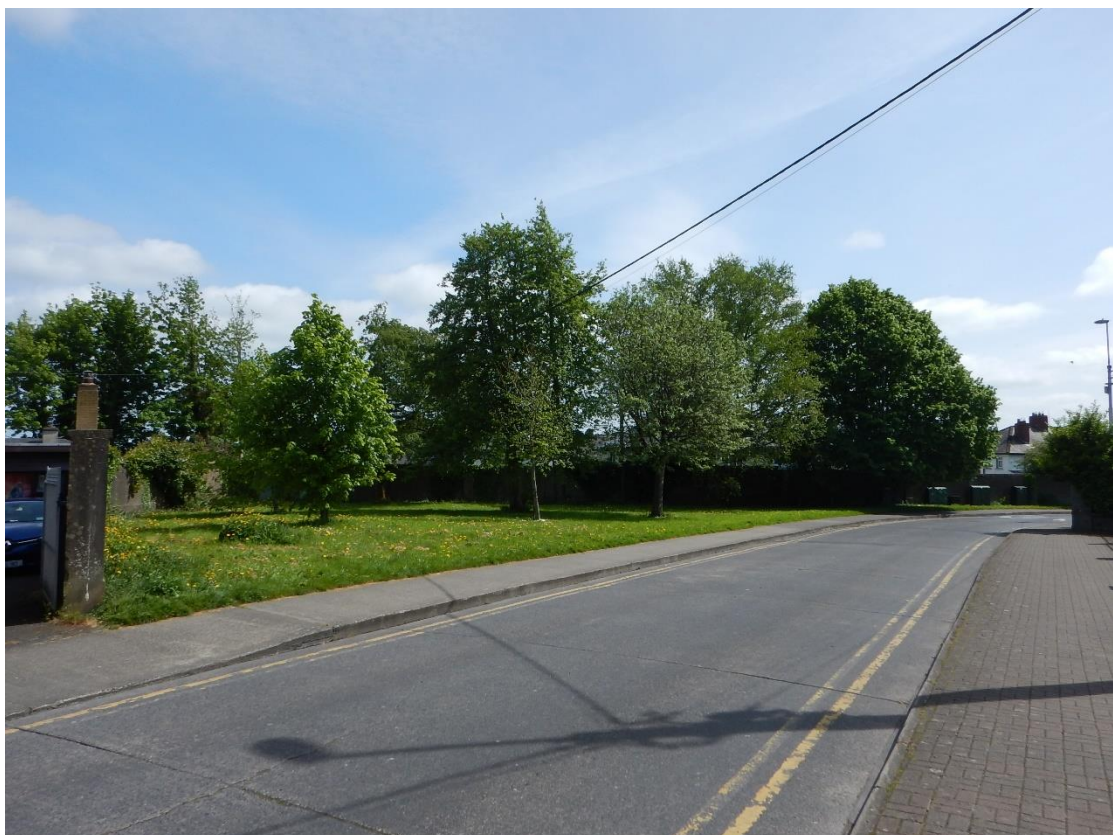
8. Cluster of trees T76-83) in the small park area off Bellefield Gardens
