ASBESTOS DEMOLITION SURVEY REPORT

21 West Square,

Askeaton,

Co Limerick

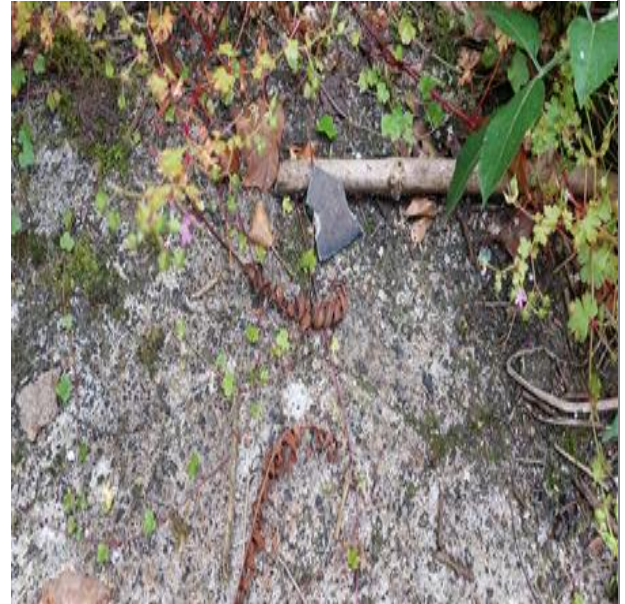
Type of Product	Quantity	Condition	Surface Treatment	Asbestos Type	Sample No.	Confirmation	MA	Recommendations
Asbestos Cement	2 m2	High Damage	Asbestos Cement	Chrysotile		Strongly presumed	6	Priority 1 : Remove ACM's Prior to Refurbishment or Demolition.

Score	Risk Rating
Asbestos Type : Chrysotile	1	High Risk
Type Of Product : Asbestos Cement	1	Medium Risk
Condition : High Damage	3	Low Risk
Surface Treatment : Asbestos Cement	1	Very Low Risk
Quantity : 2 m2		
Material Assessment Score :	6	Low Risk

Priority 1 : Remove ACM's Prior to Refurbishment or Demolition.

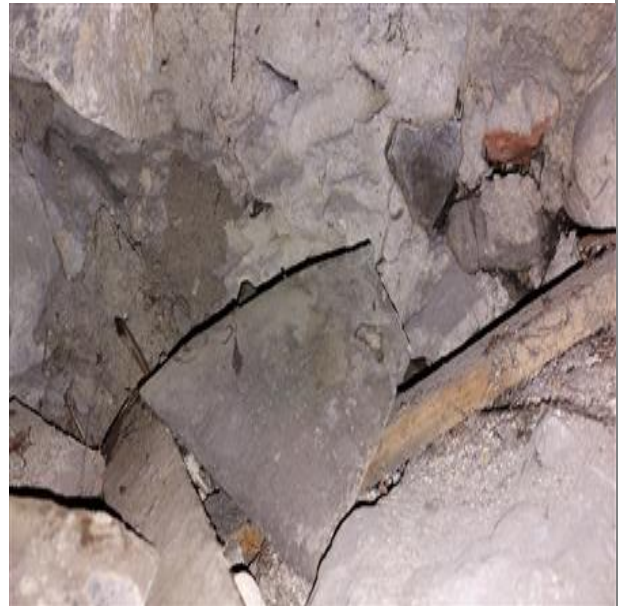
Type of Product	Quantity	Condition	Surface Treatment	Asbestos Type	Sample No.	Confirmation	MA	Recommendations
Asbestos Cement	15 m2	Medium Damage	Asbestos Cement	Chrysotile	RGB20220617006	Sample Taken	5	Priority 1 : Remove ACM's Prior to Refurbishment or Demolition.

Score	Risk Rating
Asbestos Type : Chrysotile	1	High Risk
Type Of Product : Asbestos Cement	1	Medium Risk
Condition : Medium Damage	2	Low Risk
Surface Treatment : Asbestos Cement	1	Very Low Risk
Quantity : 15 m2		
Material Assessment Score :	5	Low Risk

Priority 1 : Remove ACM's Prior to Refurbishment or Demolition.

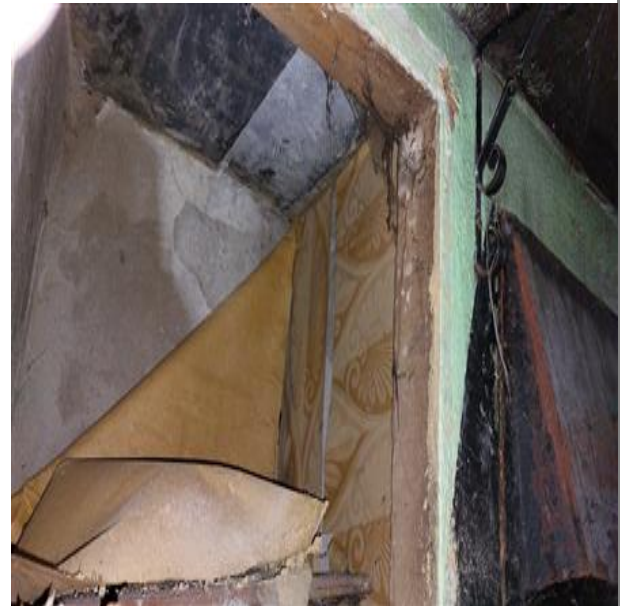
Type of Product	Quantity	Condition	Surface Treatment	Asbestos Type	Sample No.	Confirmation	MA	Recommendations
Asbestos Cement	1 m2	Low Damage	Asbestos Cement	Chrysotile		Strongly presumed	4	Priority 1 : Remove ACM's Prior to Refurbishment or Demolition.

Score	Risk Rating
Asbestos Type : Chrysotile	1	High Risk
Type Of Product : Asbestos Cement	1	Medium Risk
Condition : Low Damage	1	Low Risk
Surface Treatment : Asbestos Cement	1	Very Low Risk
Quantity : 1 m2		
Material Assessment Score :	4	Very Low Risk

Priority 1 : Remove ACM's Prior to Refurbishment or Demolition.

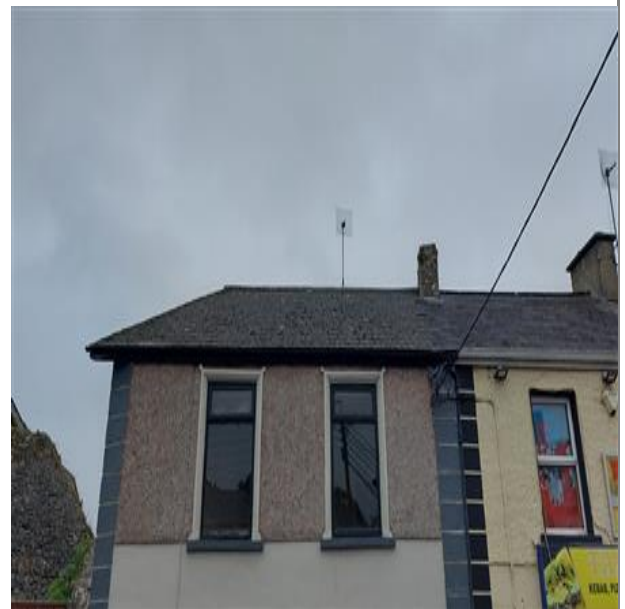
Type of Product	Quantity	Condition	Surface Treatment	Asbestos Type	Sample No.	Confirmation	MA	Recommendations
Asbestos Cement	40 m2	Low Damage	Asbestos Cement	Chrysotile		Strongly presumed	4	Priority 1 : Remove ACM's Prior to Refurbishment or Demolition.

Score	Risk Rating
Asbestos Type : Chrysotile	1	High Risk
Type Of Product : Asbestos Cement	1	Medium Risk
Condition : Low Damage	1	Low Risk
Surface Treatment : Asbestos Cement	1	Very Low Risk
Quantity : 40 m2		
Material Assessment Score :	4	Very Low Risk

Priority 1 : Remove ACM's Prior to Refurbishment or Demolition.

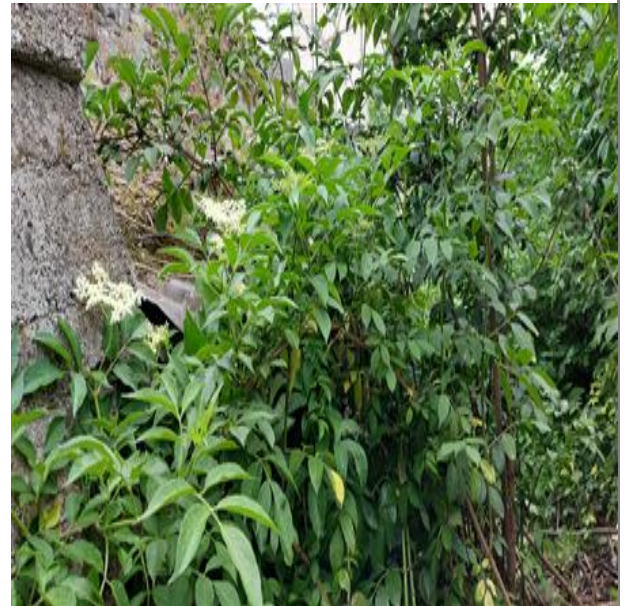
Risk Assessment	453763	Location	RA:453763 21 West Square External - Outbuildings Limited access - Overgrown					
Type of Product	Quantity	Condition	Surface Treatment	Asbestos Type	Sample No.	Confirmation	MA	Recommendations
--N\A--	--N\A--	--N\A--	--N\A--	Presumed ACM Present		Presumed	6	--N\A--

Score	Risk Rating
Asbestos Type : Presumed ACM Present	6	High Risk
Type Of Product : --N\A--	0	Medium Risk
Condition : --N\A--	0	Low Risk
Surface Treatment : --N\A--	0	Very Low Risk
Quantity : --N\A--		
Material Assessment Score :	6	Low Risk

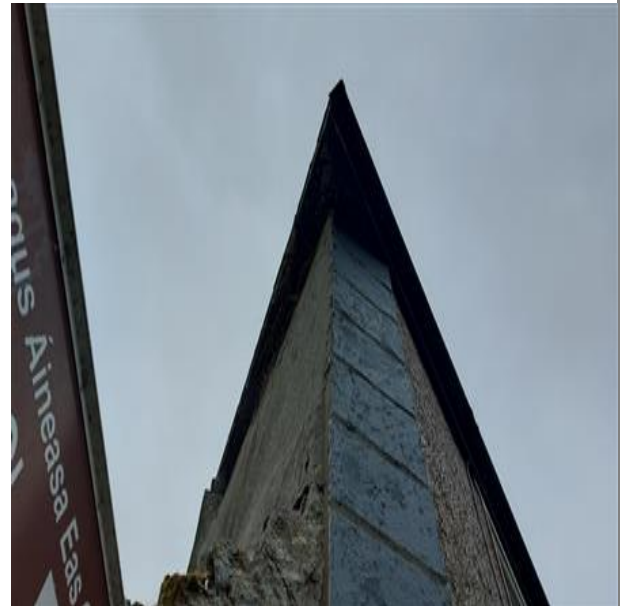
Risk Assessment	453765	Location	RA:453765 21 West Square External High Level Externals					
Type of Product	Quantity	Condition	Surface Treatment	Asbestos Type	Sample No.	Confirmation	MA	Recommendations
--N\A--	--N\A--	--N\A--	--N\A--	Presumed ACM Present		Presumed	6	--N\A--

Score	Risk Rating
Asbestos Type : Presumed ACM Present	6	High Risk
Type Of Product : --N\A--	0	Medium Risk
Condition : --N\A--	0	Low Risk
Surface Treatment : --N\A--	0	Very Low Risk
Quantity : --N\A--		
Material Assessment Score :	6	Low Risk

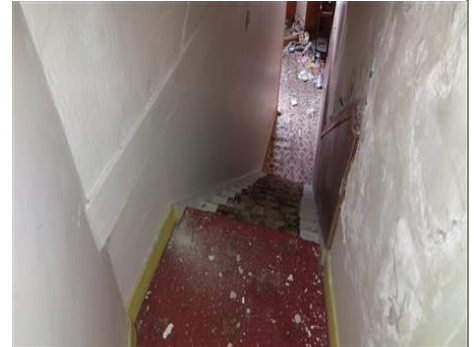
Location Details 453751 No Asbestos Found

Building/Area : 21 West Square
 Room/Section : Landing
 Location : All Walls, Floor and Ceiling
 Description : Solid, Wood and Plasterboard
 Sample No. :
 Confirmation : --N\A--
 Access : Full Access
 Normal Use :
 Recommendations :

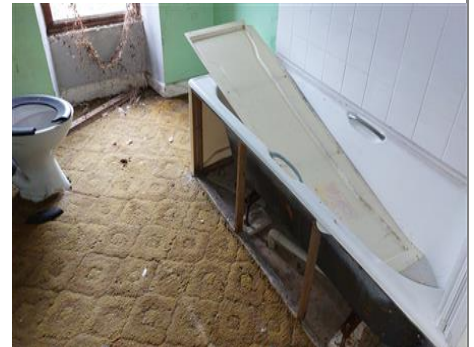
Location Details 453752 No Asbestos Found

Building/Area : 21 West Square
 Room/Section : Bathroom
 Location : All Walls, Floor and Ceiling
 Description : Solid, Wood and Plasterboard
 Sample No. :
 Confirmation : --N\A--
 Access : Full Access
 Normal Use :
 Recommendations :

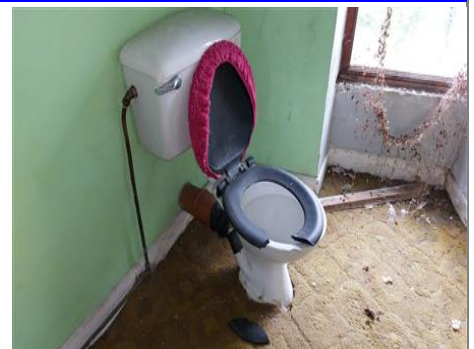
Location Details 453753 No Asbestos Found

Building/Area : 21 West Square
 Room/Section : Bathroom
 Location : Toilet Seat
 Description : Bakelite
 Sample No. : RGB20220617004
 Confirmation : Sample Taken
 Access : Full Access
 Normal Use :
 Recommendations :

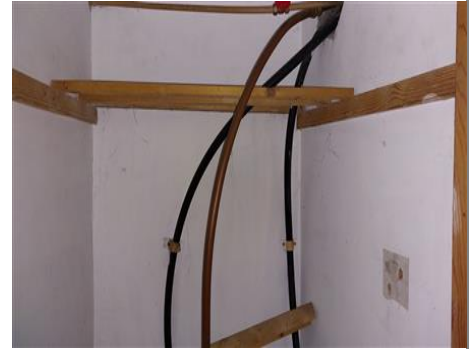
Location Details 453754 No Asbestos Found

Building/Area : 21 West Square
Room/Section : Hot Press
Location : All Walls, Floor and Ceiling
Description : Solid, Wood and Plasterboard
Sample No. :
Confirmation : --N\A--
Access : Full Access
Normal Use :
Recommendations :

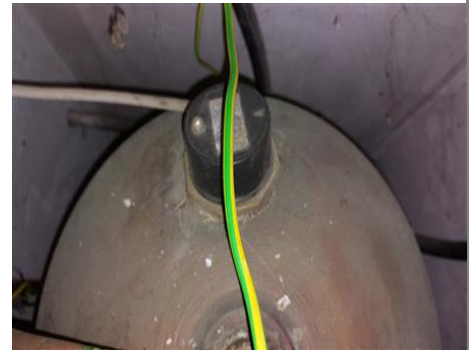
Location Details 453755 No Asbestos Found

Building/Area : 21 West Square
Room/Section : Hot Press
Location : Immersion Heater
Description : Compressed Gasket
Sample No. : RGB20220617005
Confirmation : Sample Taken
Access : Full Access
Normal Use :
Recommendations :

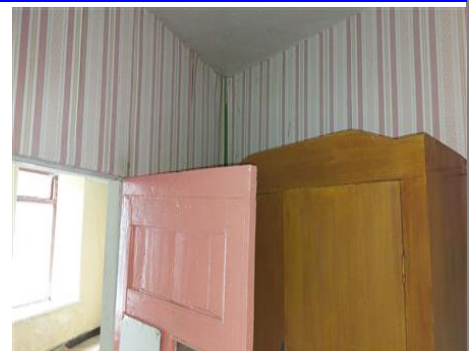
Location Details 453756 No Asbestos Found

Building/Area : 21 West Square
Room/Section : Bedroom
Location : All Walls, Floor and Ceiling
Description : Solid, Wood and Plasterboard
Sample No. :
Confirmation : --N\A--
Access : Full Access
Normal Use :
Recommendations :

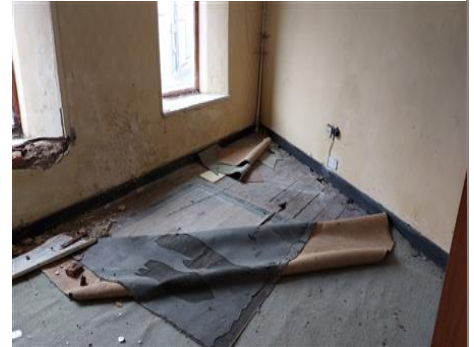
Location Details 453757 No Asbestos Found

Building/Area : 21 West Square
 Room/Section : Bedroom
 Location : All Walls, Floor and Ceiling
 Description : Solid, Wood and Plasterboard
 Sample No. :
 Confirmation : --N\A--
 Access : Full Access
 Normal Use :
 Recommendations :

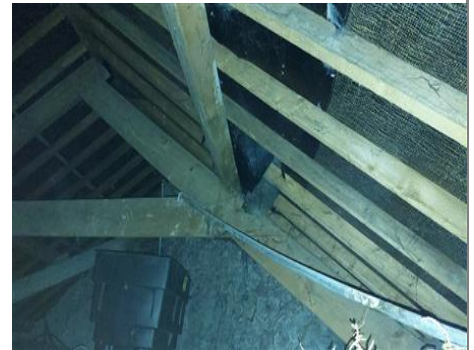
Location Details 453758 No Asbestos Found

Building/Area : 21 West Square
 Room/Section : Attic
 Location : All Walls and Roof
 Description : Solid, Plaster and Modern Felt
 Sample No. :
 Confirmation : --N\A--
 Access : Full Access
 Normal Use :
 Recommendations :

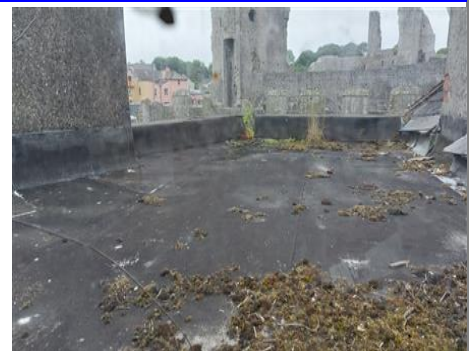
Location Details 453760 No Asbestos Found

Building/Area : 21 West Square
 Room/Section : External
 Location : Flat Roof
 Description : Felt and Bitumen
 Sample No. : RGB20220617007
 Confirmation : Sample Taken
 Access : Full Access
 Normal Use :
 Recommendations :

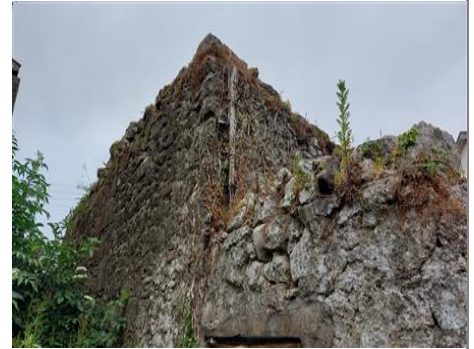
Location Details 453762 No Asbestos Found

Building/Area : 21 West Square
 Room/Section : External - Outbuildings
 Location : All Walls, Floor and Roofs
 Description : Solid and Metal
 Sample No. :
 Confirmation : --N\A--
 Access : Full Access
 Normal Use :
 Recommendations :

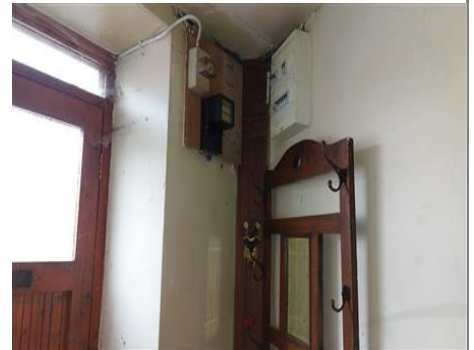
Location Details 453744 No Asbestos Found

Building/Area : 21 West Square
 Room/Section : Hall
 Location : All Walls and Ceiling
 Description : Solid and Plasterboard
 Sample No. :
 Confirmation : --N\A--
 Access : Full Access
 Normal Use :
 Recommendations :

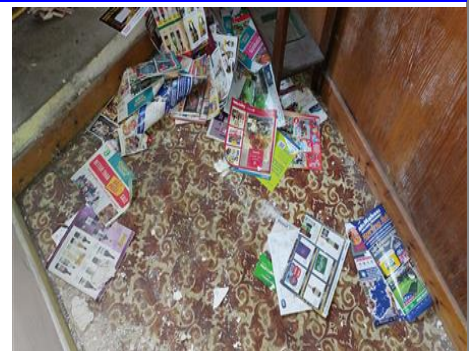
Location Details 453745 No Asbestos Found

Building/Area : 21 West Square
 Room/Section : Hall
 Location : Floor
 Description : Vinyl
 Sample No. : RGB20220617003
 Confirmation : Sample Taken
 Access : Full Access
 Normal Use :
 Recommendations :

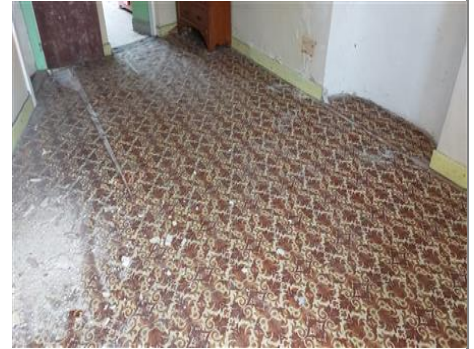
Location Details 453746 No Asbestos Found

Building/Area : 21 West Square
 Room/Section : Sitting Room
 Location : Floor
 Description : Vinyl
 Sample No. :
 Confirmation : Strongly presumed
 Access : Full Access
 Normal Use :
 Recommendations :

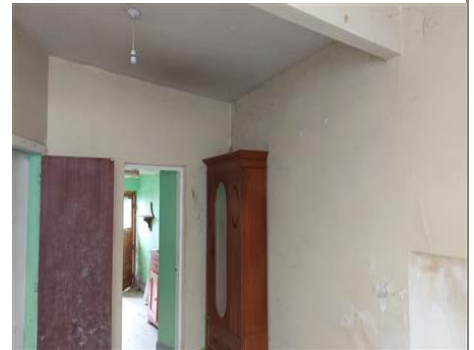
Location Details 453747 No Asbestos Found

Building/Area : 21 West Square
 Room/Section : Sitting Room
 Location : All Walls and Ceiling
 Description : Solid and Plasterboard
 Sample No. :
 Confirmation : --N\A--
 Access : Full Access
 Normal Use :
 Recommendations :

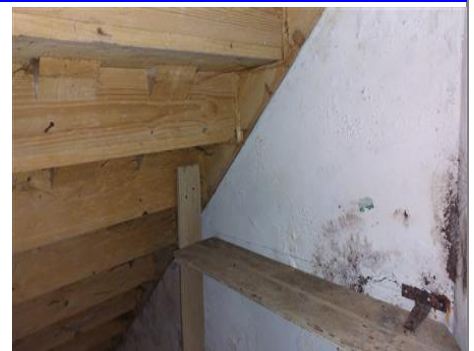
Location Details 453748 No Asbestos Found

Building/Area : 21 West Square
 Room/Section : Stair Cupboard
 Location : All Walls, Floor and Ceiling
 Description : Solid and Plasterboard
 Sample No. :
 Confirmation : --N\A--
 Access : Full Access
 Normal Use :
 Recommendations :

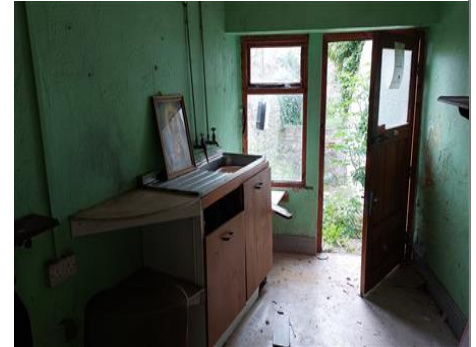
Location Details 453749 No Asbestos Found

Building/Area : 21 West Square
 Room/Section : Kitchen
 Location : All Walls, Floor and Ceiling
 Description : Solid and Plasterboard
 Sample No. :
 Confirmation : --N\A--
 Access : Full Access
 Normal Use :
 Recommendations :
