ASBESTOS SURVEY REPORT

(Refurbishment / Demolition Survey)

**Location: 8 Old Church Street,
Abbeyfeale, Co. Limerick**

Report No. PE23-129

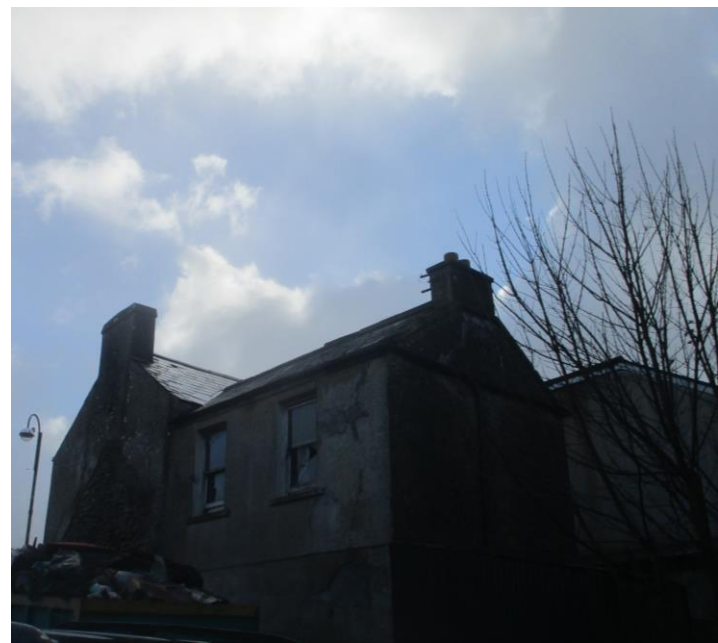
MATERIAL ASSESSMENT		PRIORITY ASSESSMENT
Product type	Cement slates (presumed)	Normal occupant activity	N/A
Extent of damage	Low	Likelihood of disturbance	N/A
Surface treatment	Unsealed	Human exposure potential	N/A
Asbestos type	Crocidolite (presumed)	Maintenance activity	N/A
	Material assessment score: N/A	TOTAL SCORE: N/A	Priority assessment score: N/A

The cement slates on the rear roof of 8 Old Church Street were presumed to contain Crocidolite (blue) asbestos fibres. Asbestos cement products generally contain 10 to 15% asbestos fibres, bound in Portland cement

The asbestos cement slates may be left in situ and managed in place. However, if the forthcoming refurbishment works are likely to disturb the roof areas, the asbestos cement slates should be removed by an asbestos removal contractor and disposed of as asbestos waste before the refurbishment works commence

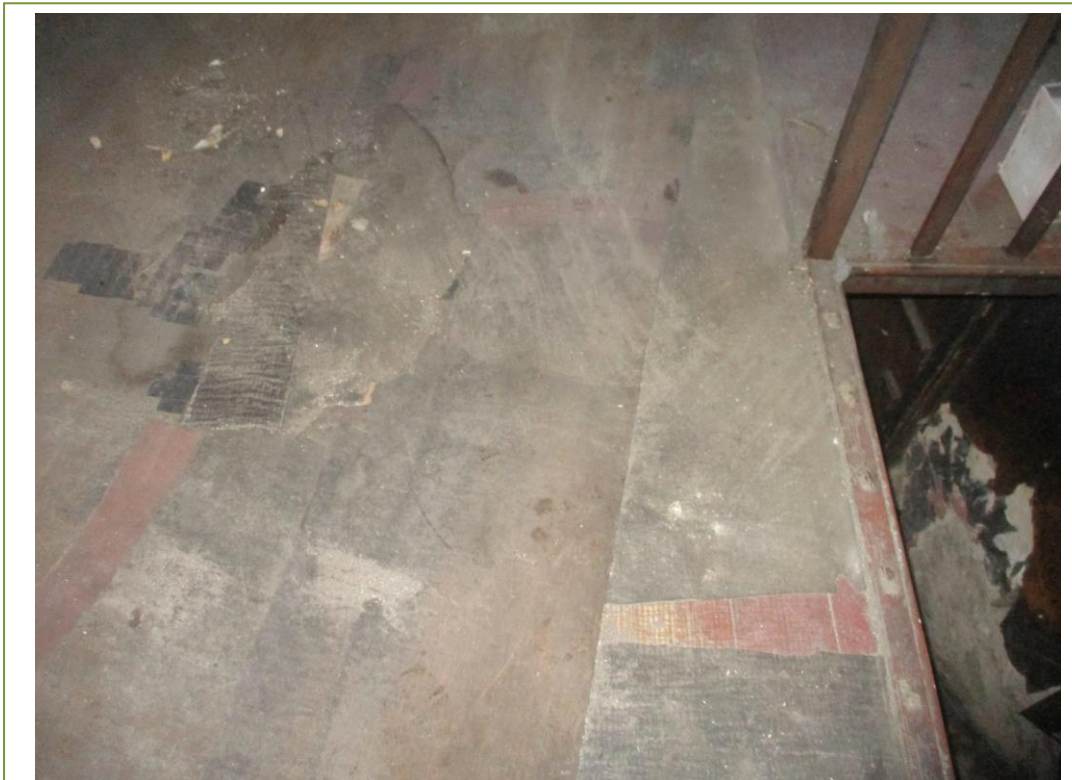
Floor covering on the 1st floor

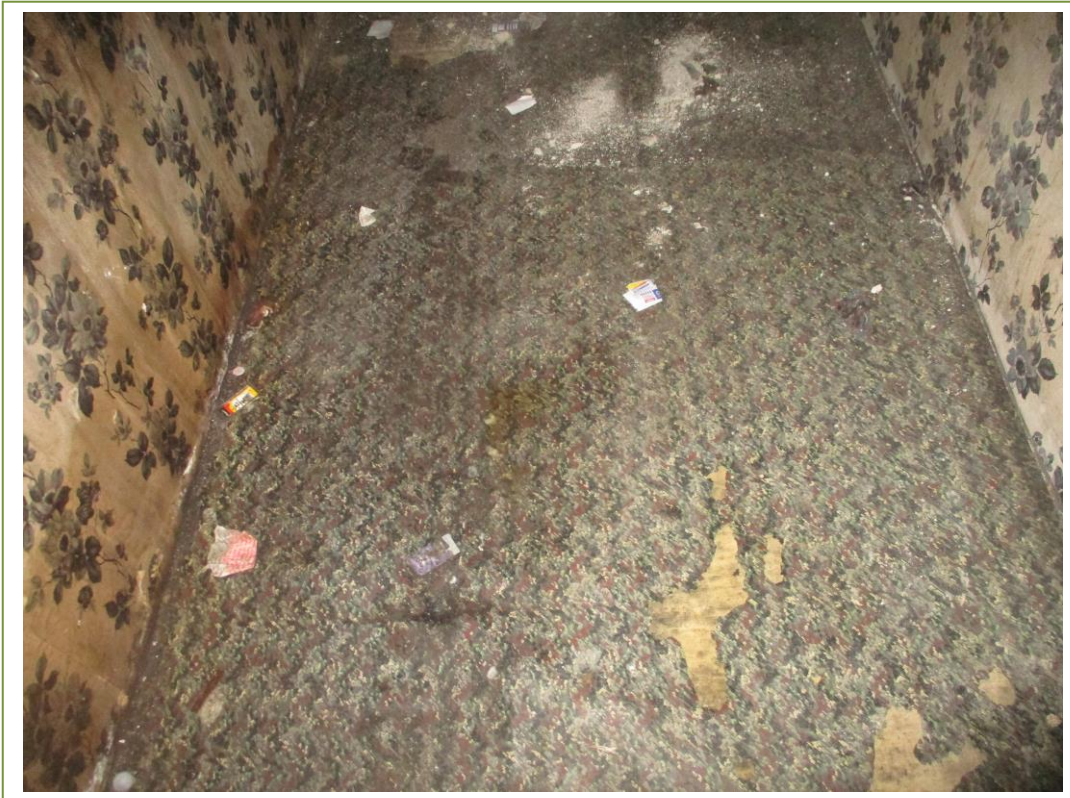
Floor covering on the 1st floor

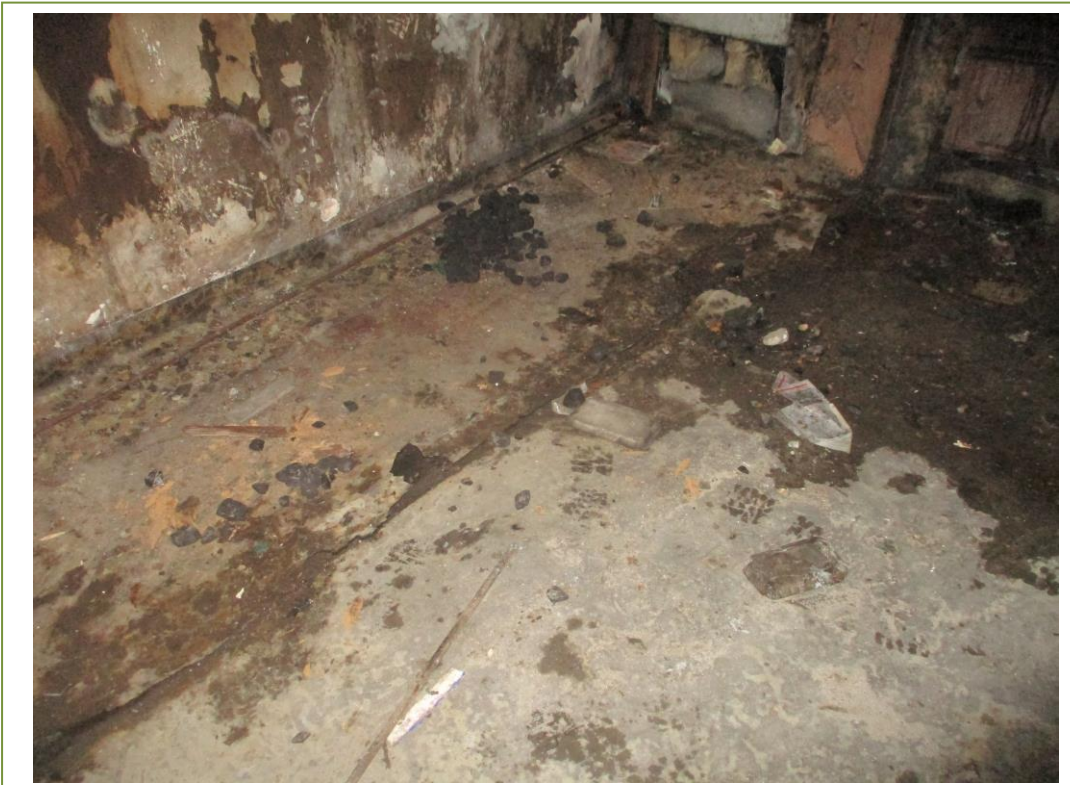
Site Ref	Lab Ref	Description	Analysis Result	Classification
S1	BS198064	GF - Kitchen - Lino & adhesive	No Asbestos Detected	Not Applicable

Floor covering in the ground floor kitchen

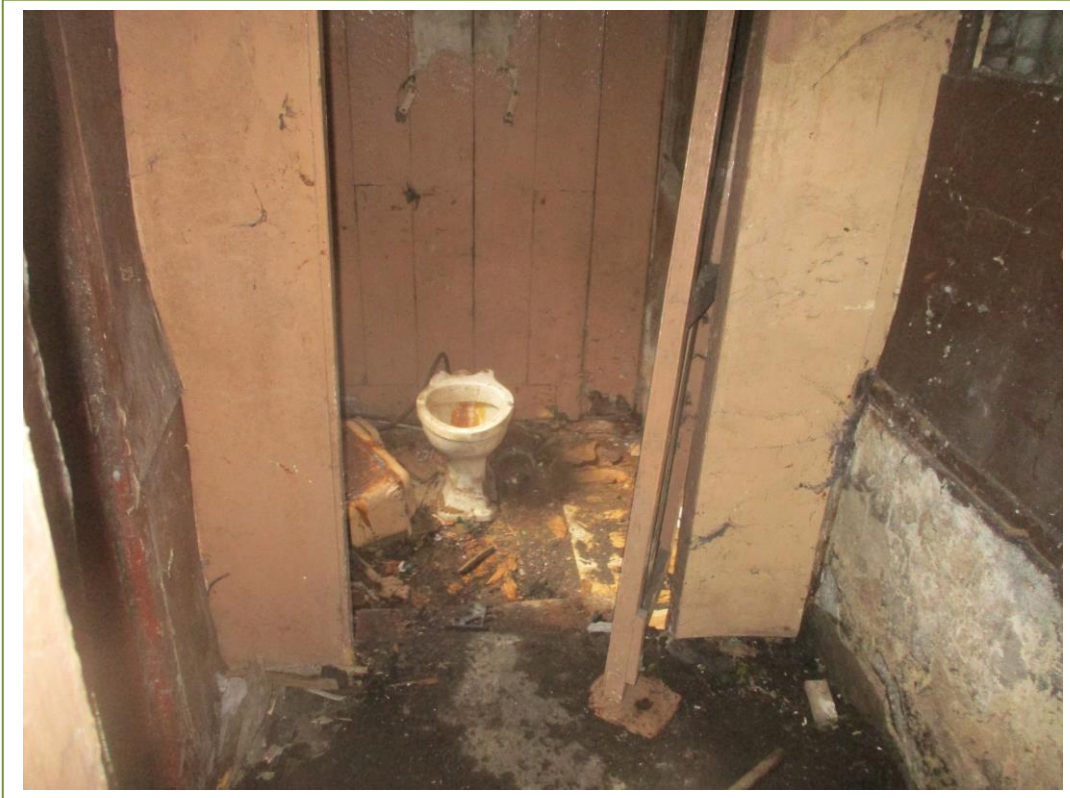
Toilet cistern in the ground floor W/C

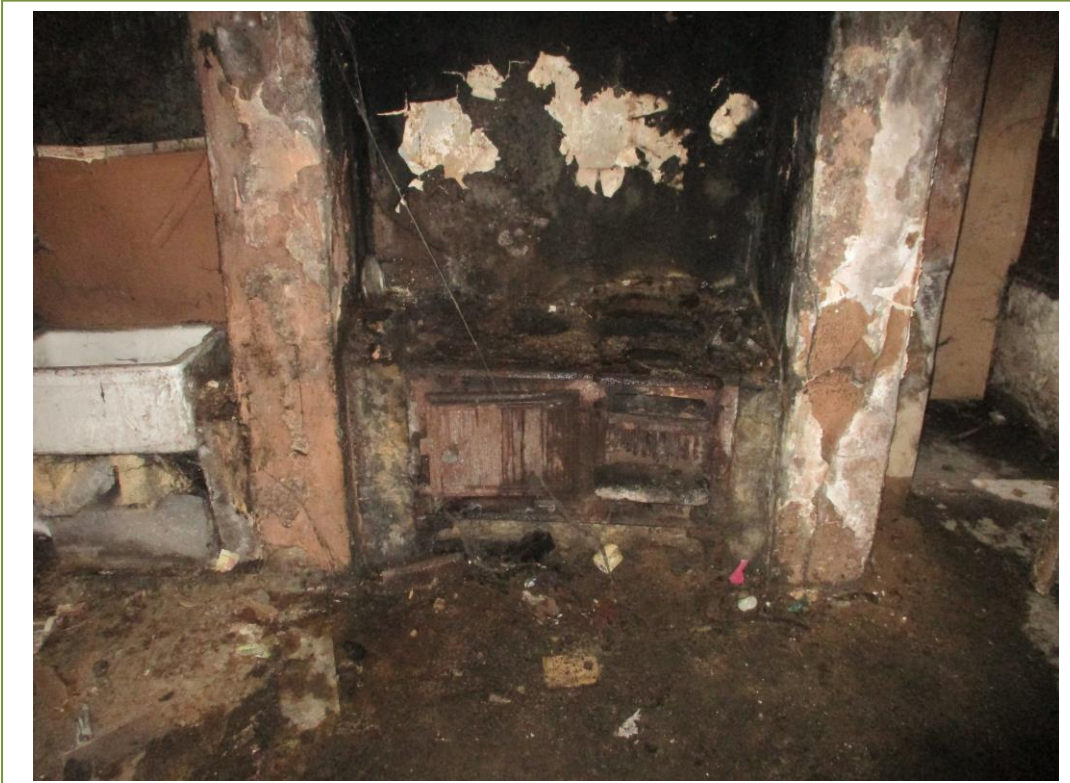
Cooking in the kitchen

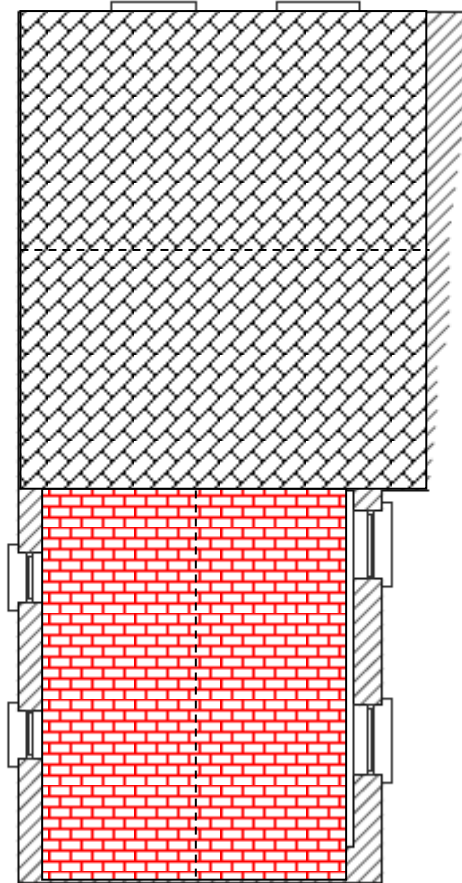
ROOF PLAN

- Asbestos cement slates were presumed on the rear roof of 8 Old Church Street (30 m² approx. floor area)

Area where asbestos cement slates were identified
