## PRELIMINARY CONSERVATION REVIEW OF EXISTING STRUCTURES AT THE FORMER ARDAGH AND BARNAGH RAILWAY STATIONS

A visual inspection and photographic record of the structures was carried out on 12<sup>th</sup>. March 2020.

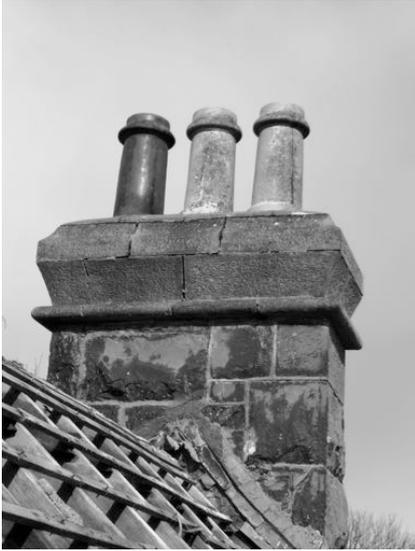
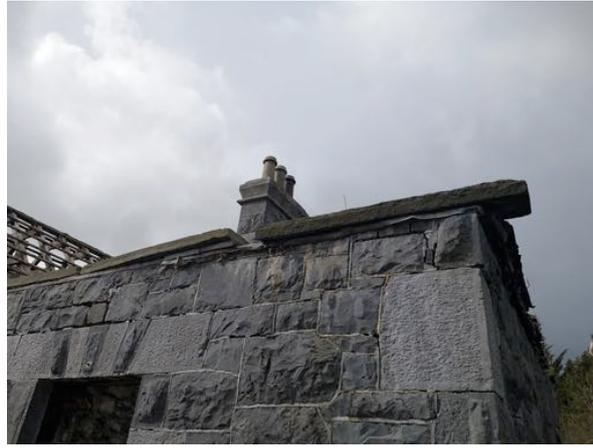
Chimney masonry and wall copings in poor condition

Externally: Basic stone masonry sound. Embedded foliage needs to be carefully removed. Chimney, coping and platform stonework needs to be dismantled and re bedded. Roofs need to be reinstated to existing details.

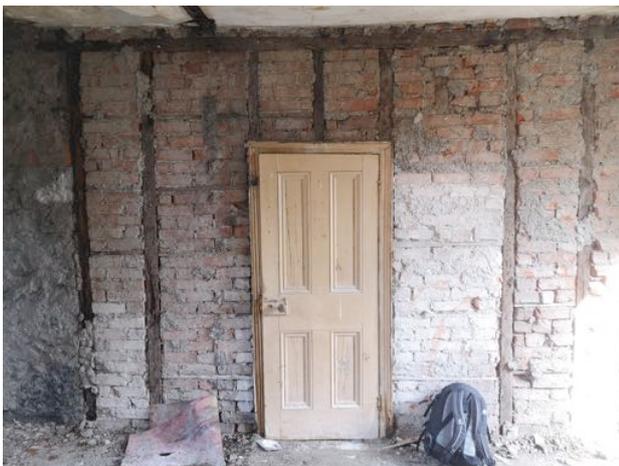
Internally: Defective ground and first timber floor structures need to be removed. Ground floor to be cleaned out and all debris and decayed timbers removed from sub floor level. Sleeper walls to be retained. Brick noggin / stud partition walls to be pinned at level of first noggin to allow repairs to defective lower section of wall. Stairs to be propped following removal of any defective timbers in contact with floor or partition wall base.

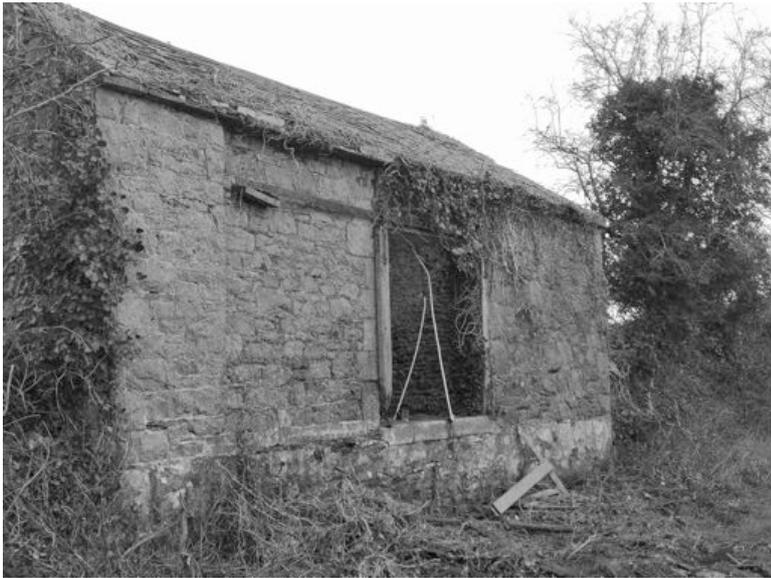
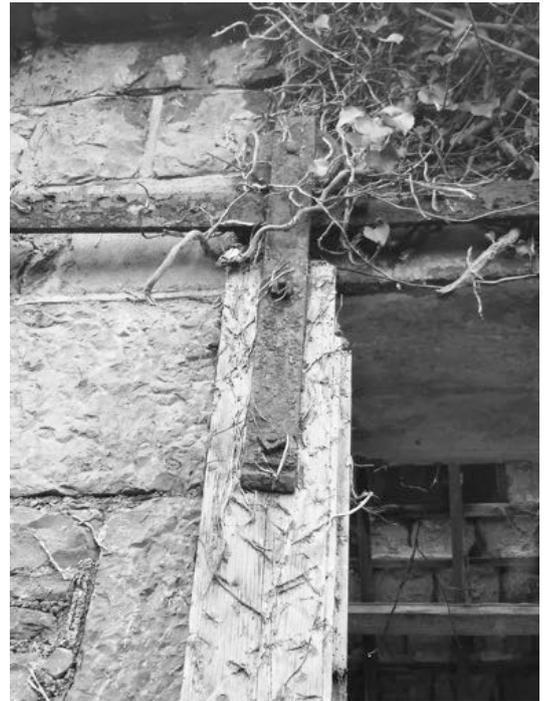
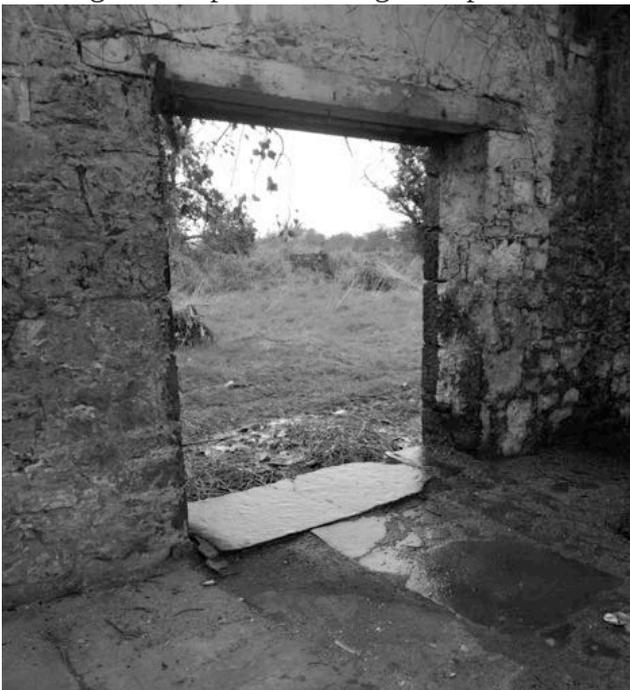
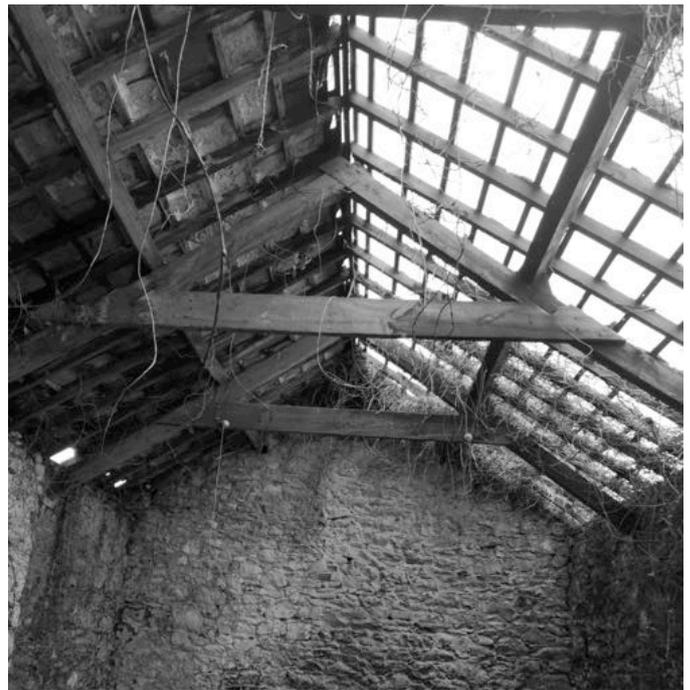
Clockwise:  
Sliding doorway, landside. Sliding mechanism detail. Extant roof structure. Trackside entrance with sound lintel and relieving arch in place and flagstone paved floor.

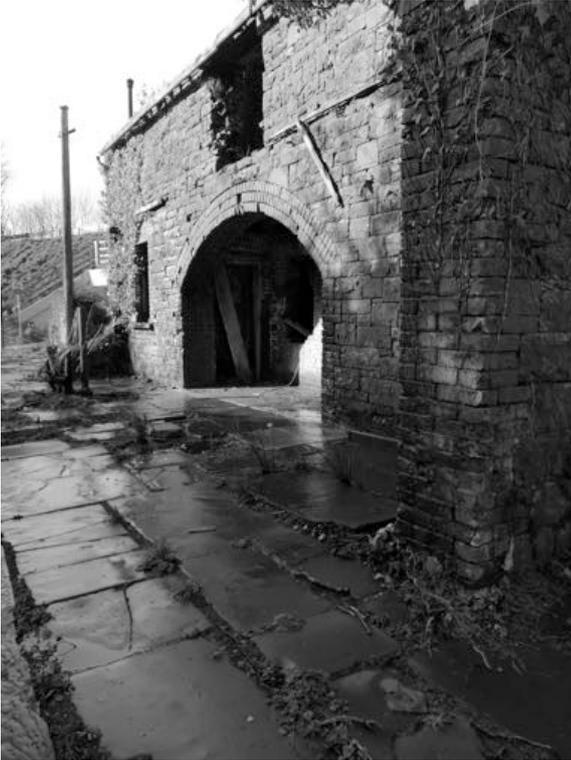
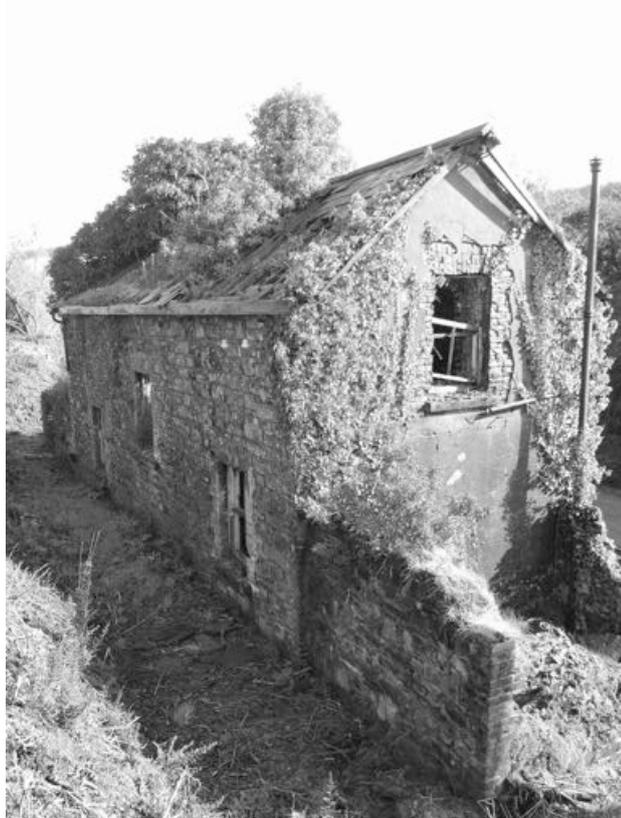
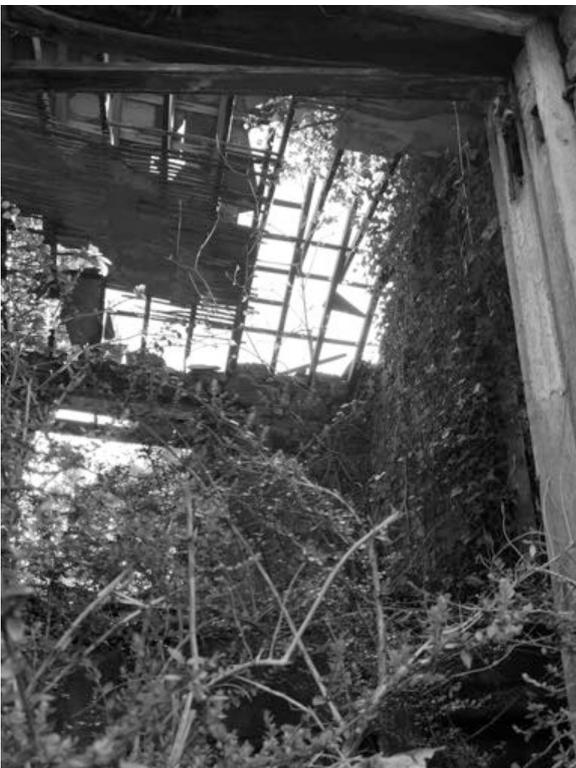
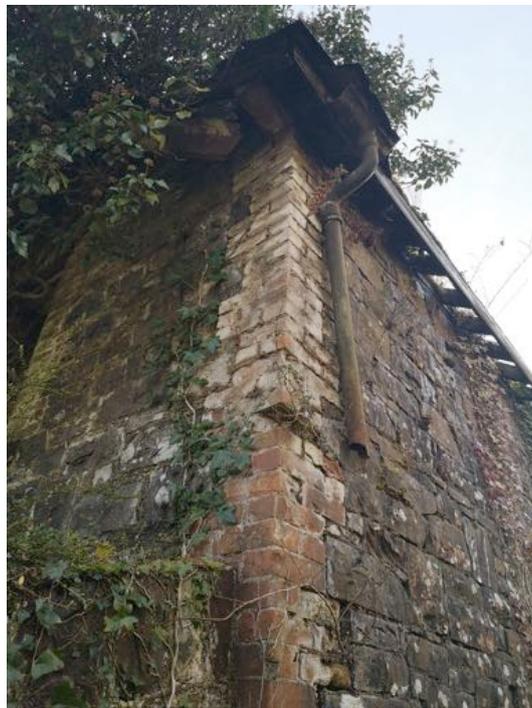
Paved platform and brick entrance archway. View of rear. Defective roof / guttering and damp brick / stone masonry. View of roof condition through rear sliding sash window. First floor missing. Roof structure needs complete reinstatement and masonry opens repaired. As at Ardagh there remain sufficient examples of window, door, staircase etc. joinery to allow for

accurate replacements.

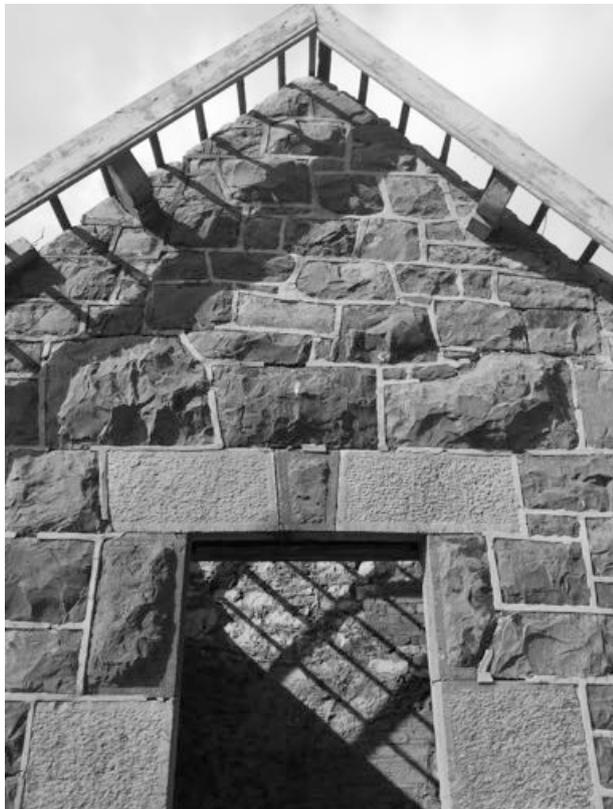
Cementitious pointing to be removed

and re pointed with lime mortar  
New ornate barge board required

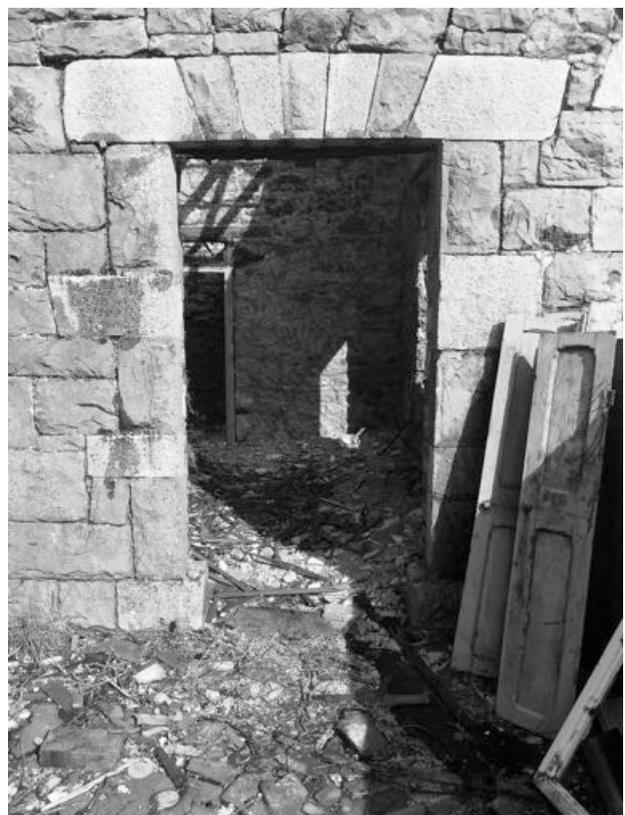
Limestone ashlar masonry in good condition but

requiring lime mortar pointing.

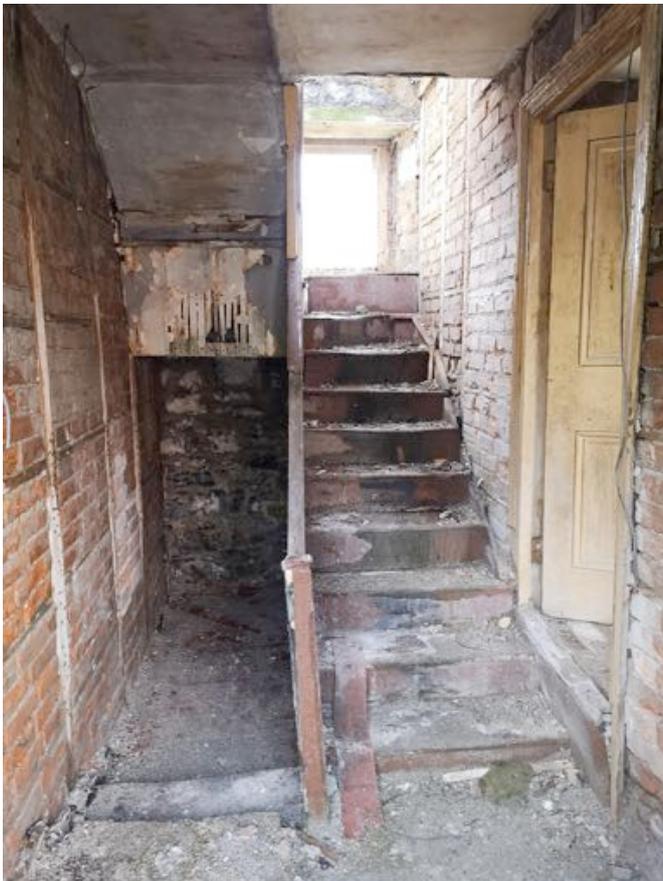
Hallway. Modern concrete floor slab running from front doorway to base of stairs to be removed. Decayed stair timbers to be cut back to firm wood and temporarily propped in situ. Brick paved floor under stairs to be retained.

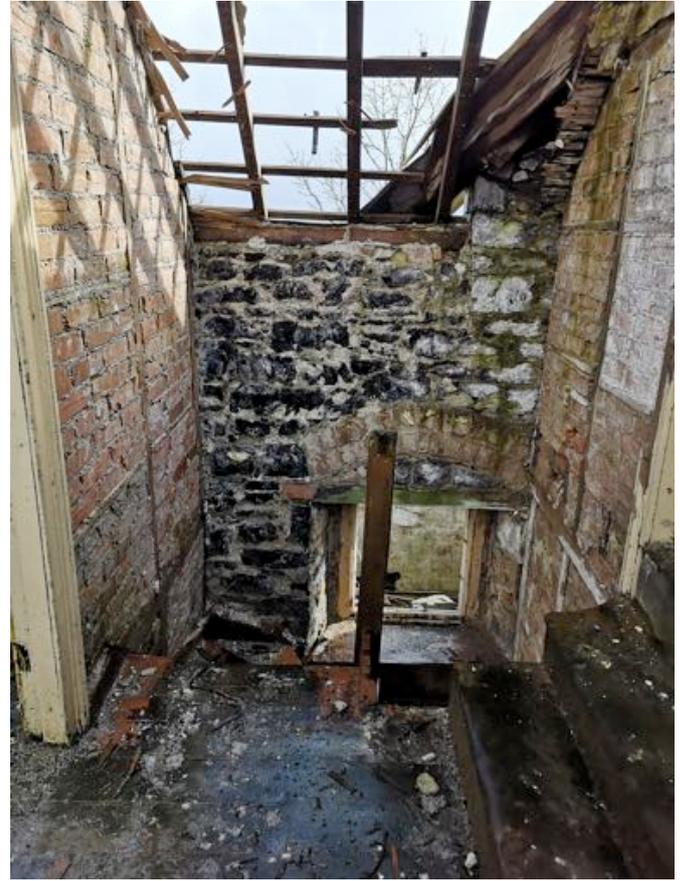
As noted earlier the load bearing internal stud/noggin brick infill partition walls have been adversely affected by water ingress at the base and flanking the external walls. These should be secured and repaired as outlined in Eddie O'Donovan's report. The repaired work should rest on a firm base such as a concrete lintel and incorporate a DPC. Retained and repaired timber framing should be treated with wood preservative.

View of stud/noggin brick walls from landing  
Timber lintel at landing window to be replaced

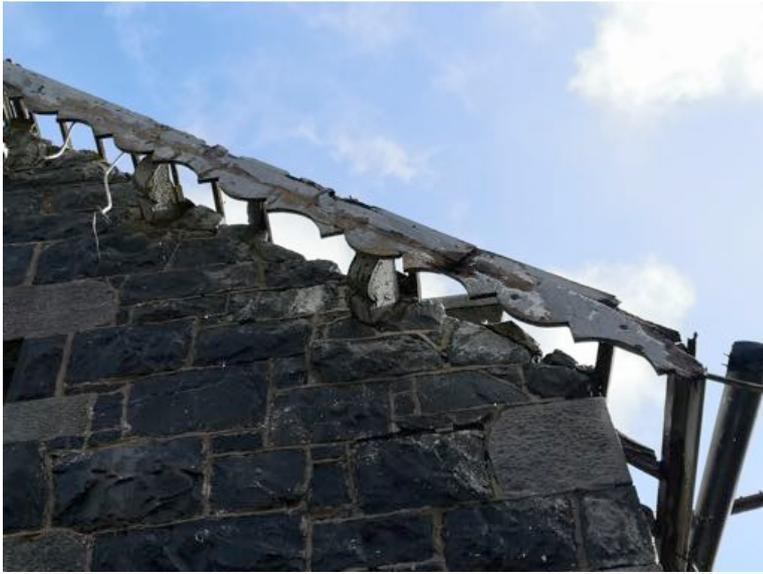
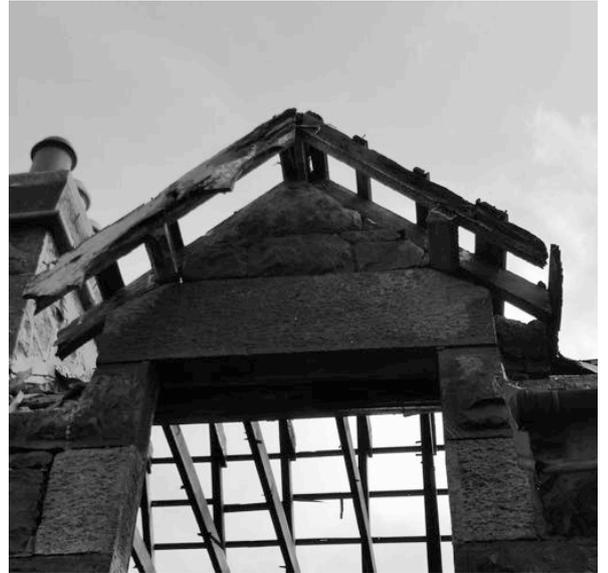
Ornate barge board details to gables and dormers. Note cementitious mortar on gable stonework.

Retain ornate barge boards to gables and dormer windows for reinstatement patterns.

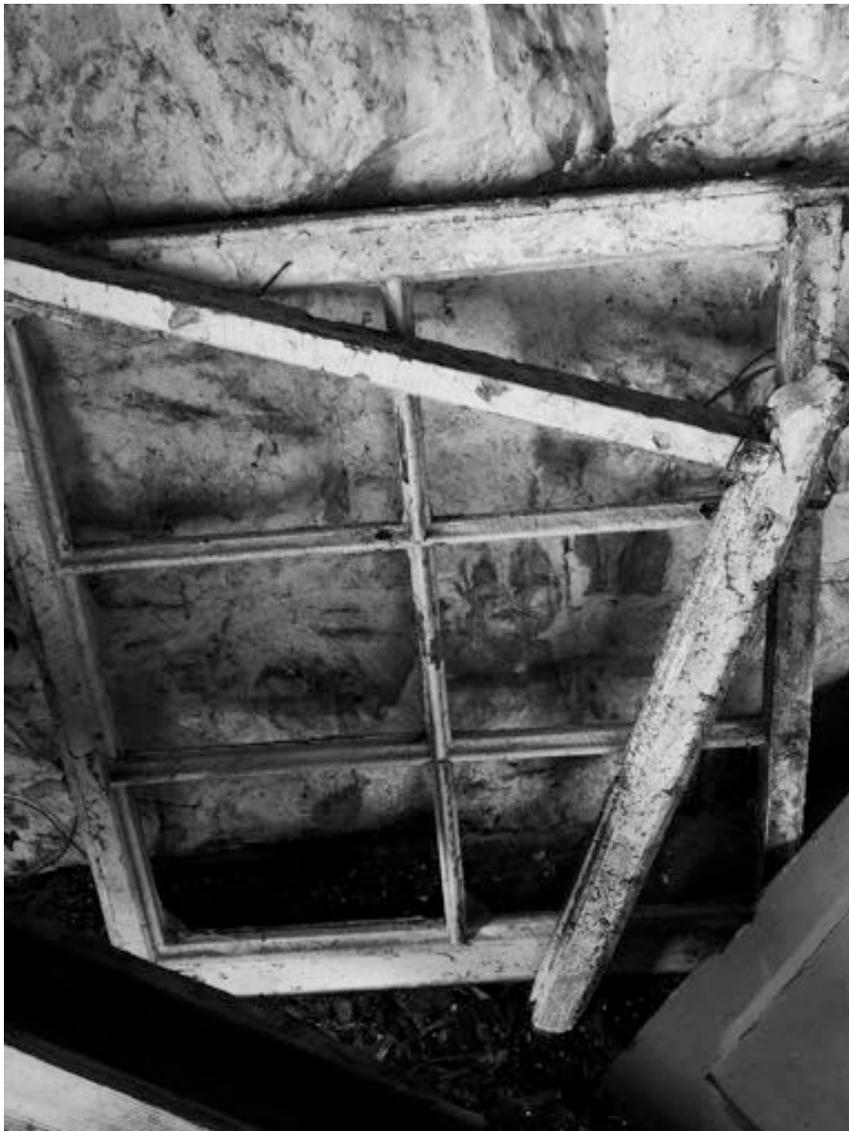
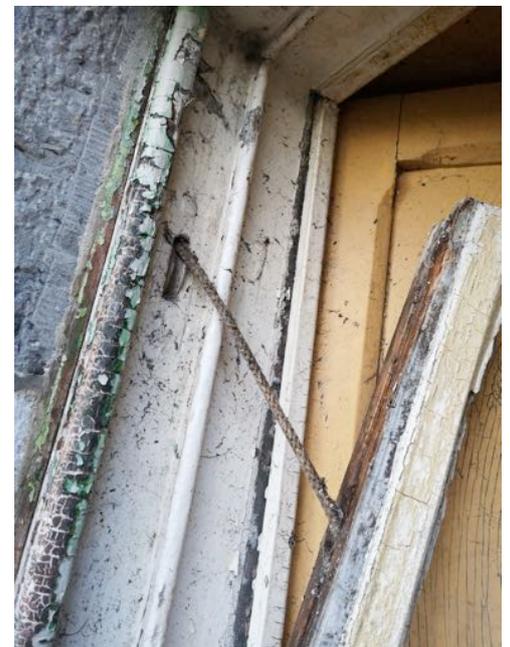
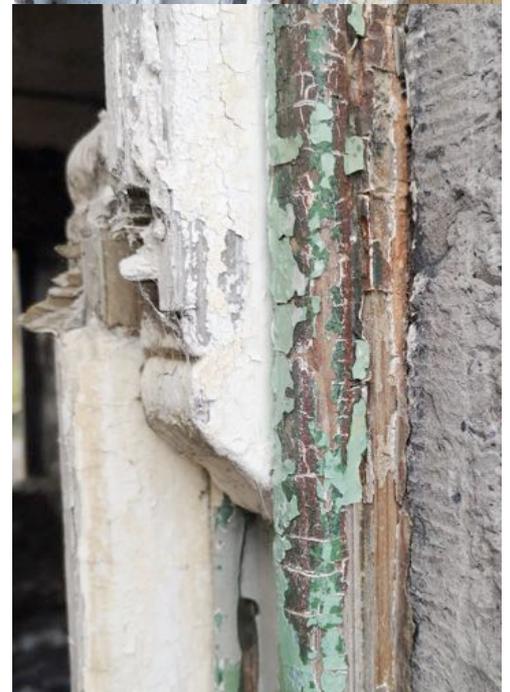
Original 6 over 6 sliding sash window frames and sections to be retained for reproduction.

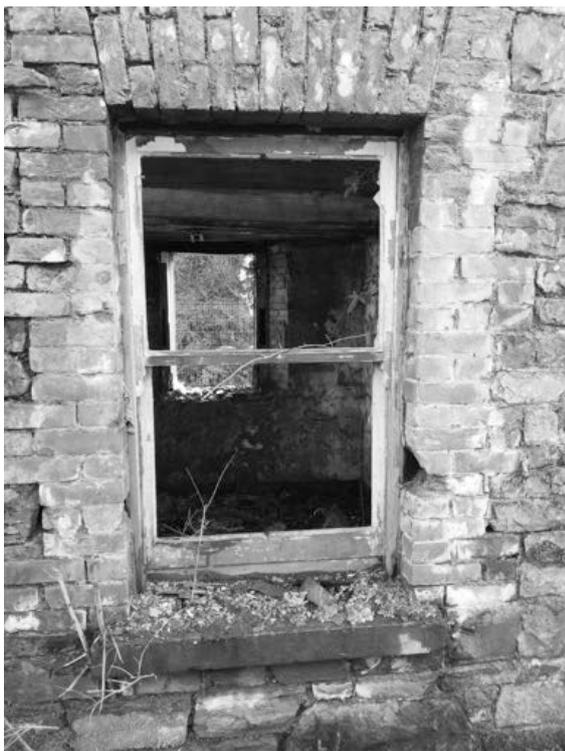
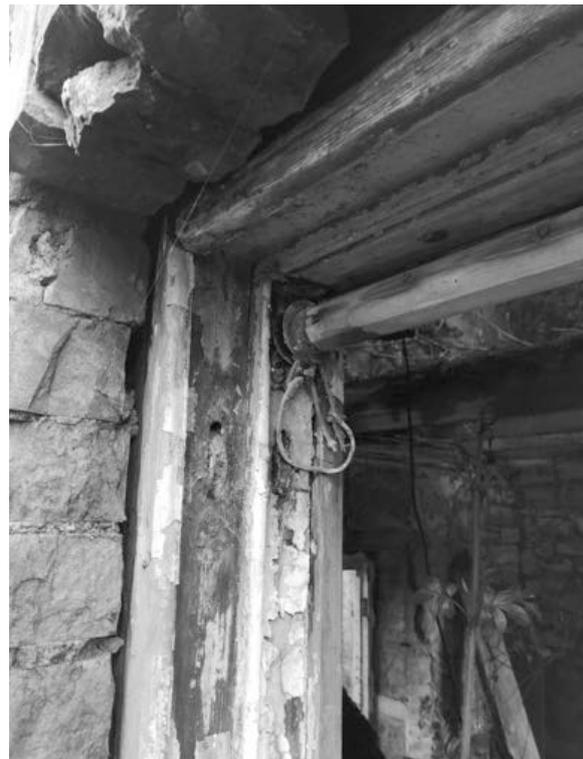
Rear ground floor sliding sash window and frame detail showing sash cord pulleys and early roller blind mechanism.

Masonry pointing in poor repair.

Rake out and re-point defective lime mortar and remove all cementitious pointing followed by raking out and lime mortar repointing.
