Site Inspection Report

H1137 - Tourism and Limerick Greenway Projects

Structural Condition Survey - Fullers Folly

15.02.2023

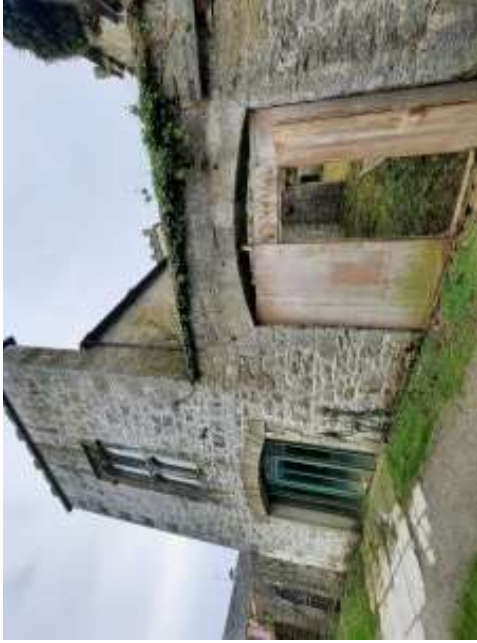
001 / 001

East Elevation of Fullers Folly showing south section of the building..

Southern section of building - Vacant office accommodation over 3 no. floors.

This section of the building is generally in good structural condition.

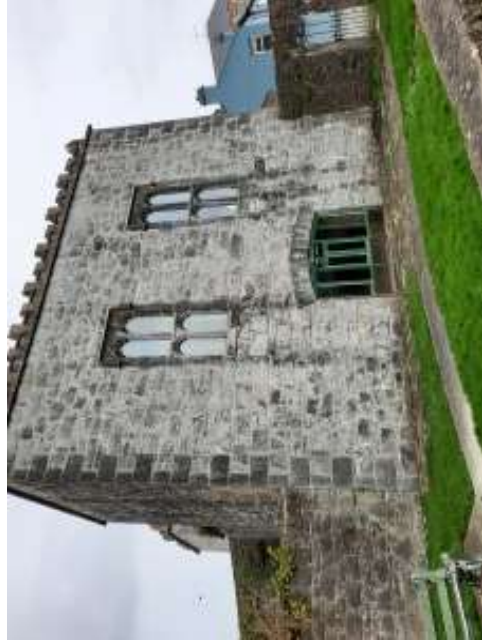
001 / 002

South Elevation of Fullers Folly showing south section of the building.

Southern section of building - Vacant office accommodation over 3 no. floors.

This section of the building is generally in good structural condition.

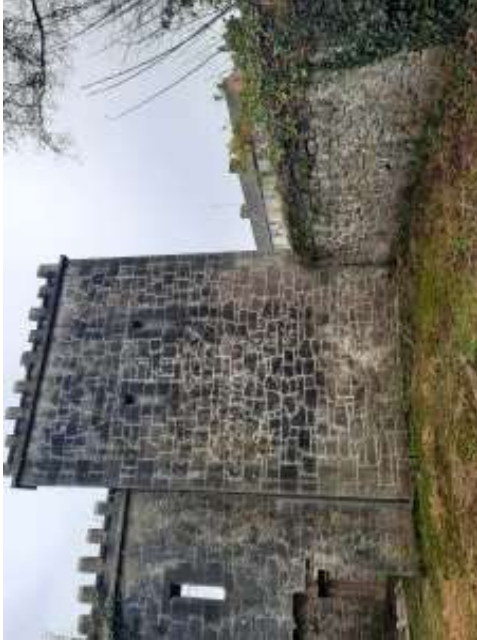
001 / 003

West Elevation of Fullers Folly showing south section of the building.

Southern section of building - Vacant office accommodation over 3 no. floors.

This section of the building is generally in good structural condition.

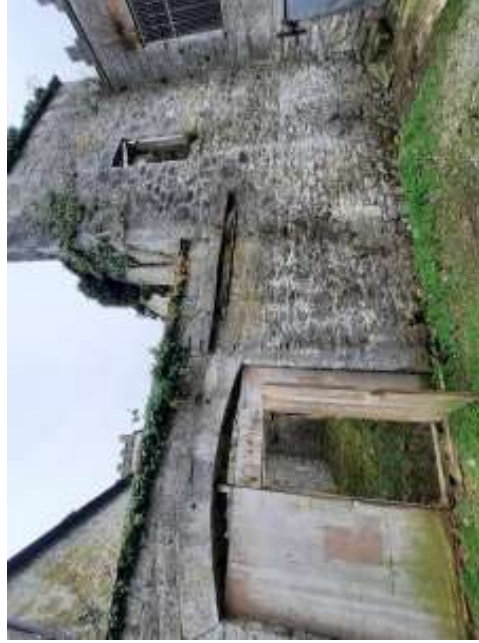
001 / 004

East Elevation of Fullers Folly showing north section of building.

Northern section of building - derelict.
This section of the building is in poor structural condition. The roof and first floor structure have partially collapsed.

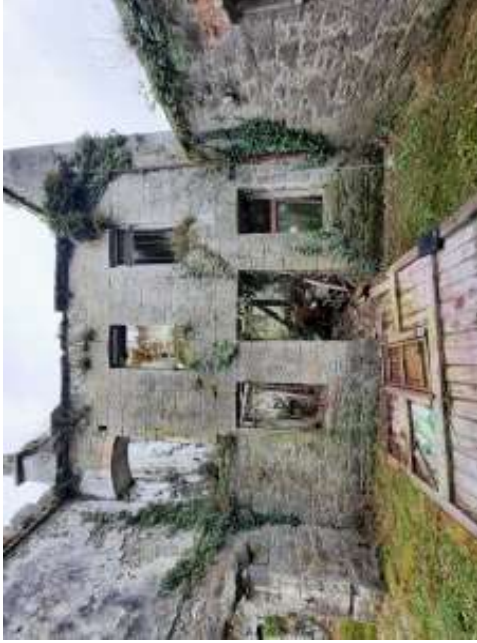
001 / 005

Comment
South Elevation of north section of the building.

This section of the building is in poor structural condition. The roof and first floor structure have partially collapsed.

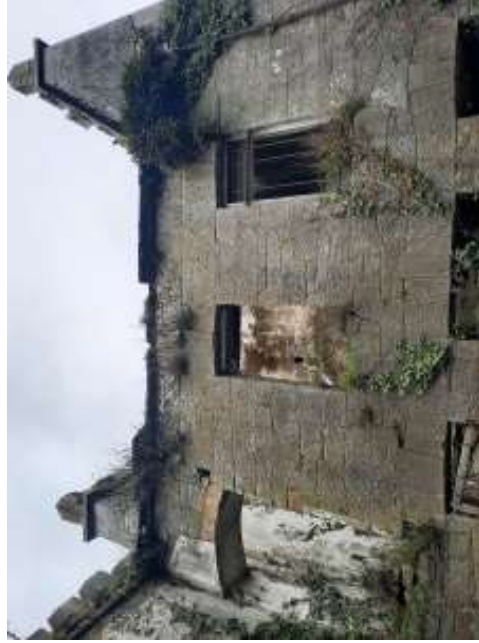
001 / 006

Comment
Upper South Elevation of north section of the building.

This section of the building is in poor structural condition. The roof and first floor structure have partially collapsed.

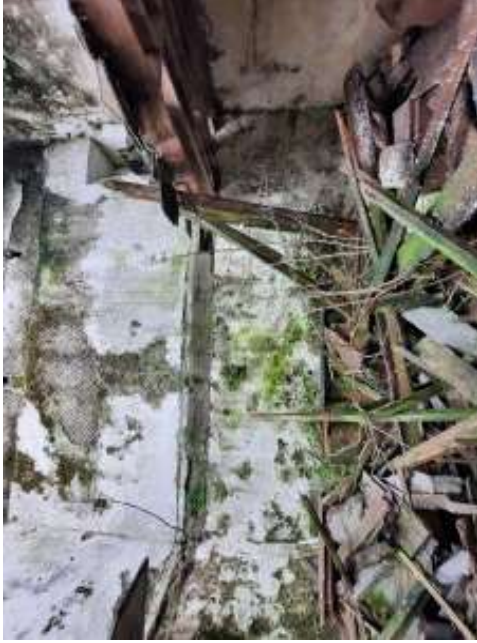
001 / 007

Comment
North section of the building.

The roof and first floor have partially collapsed. There is a lot of debris and rubble at ground floor level.

We recommend that the debris and rubble is cleared from the building.

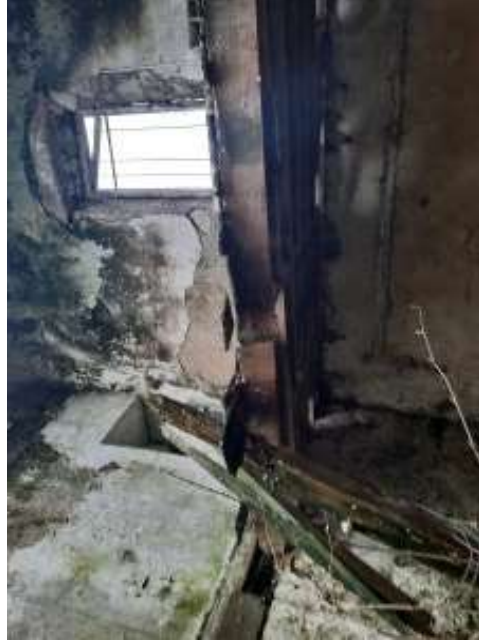
001 / 008

Comment
North section of the building.

A part of the first floor remains intact but is in poor condition. The floor joists are open to the elements and degraded.

We recommend that the remaining first floor structure is demolished and removed off-site.

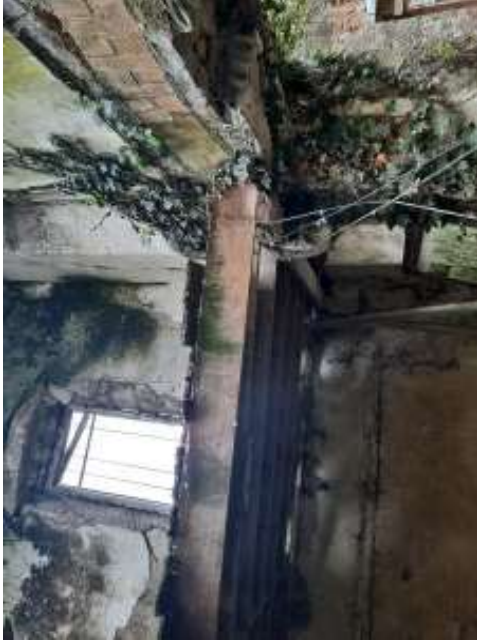
001 / 009

Comment
North section of the building.

A part of the first floor remains intact but is in poor condition. The floor joists are open to the elements and degraded.

We recommend that the remaining first floor structure is demolished and removed off-site.

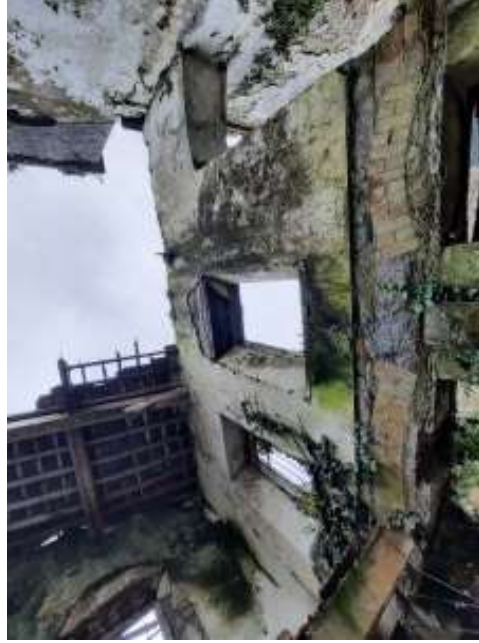
001 / 010

Photo of the internal face of the south wall to the north section of the building.

The roof has partially collapsed. There are no windows or doors.

The south stone rubble wall is stable and generally in good condition.

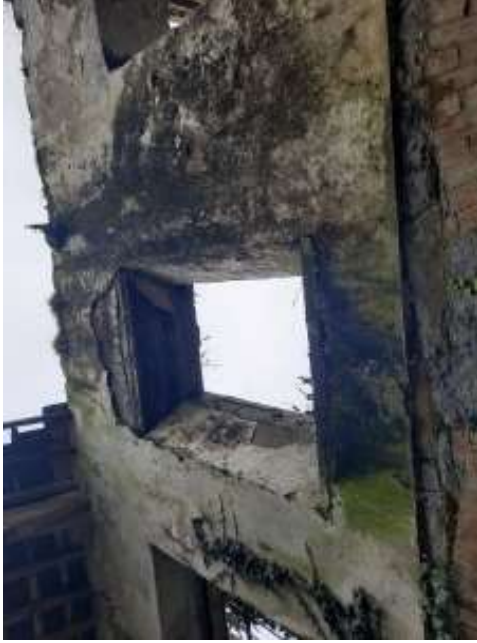
001 / 011

The existing timber lintels are exposed and have degraded. There is a brick arch visible above the timber lintels. The window opening is stable. The timber lintels will need to be removed and replaced during the proposed refurbishment of the building.

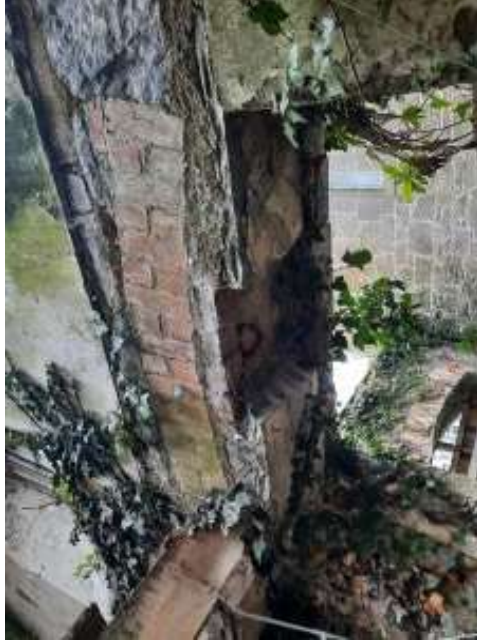
001 / 012

There are brick arches visible over the door and window openings at ground floor level. The arches generally appear to be in good condition.

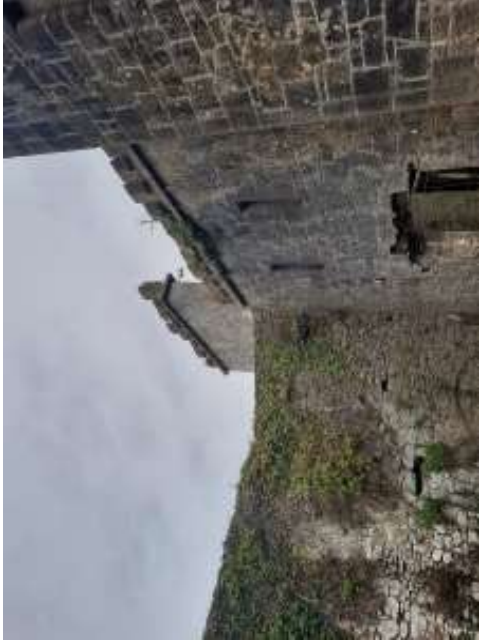
001 / 013

West Elevation of Fullers Folly showing north section of building.

Northern section of building - derelict.

This section of the building is in poor structural condition. The roof and first floor structure have partially collapsed.

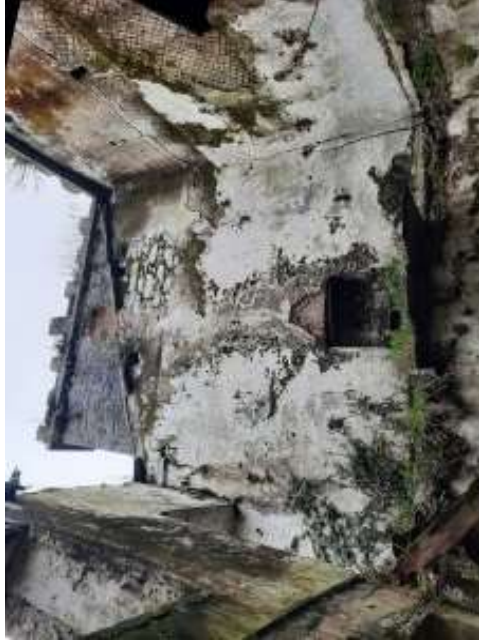
001 / 014

Photo of the internal face of the west wall to the north section of the building.

The roof has collapsed over this wall.

The west stone rubble wall is stable and generally in good condition.

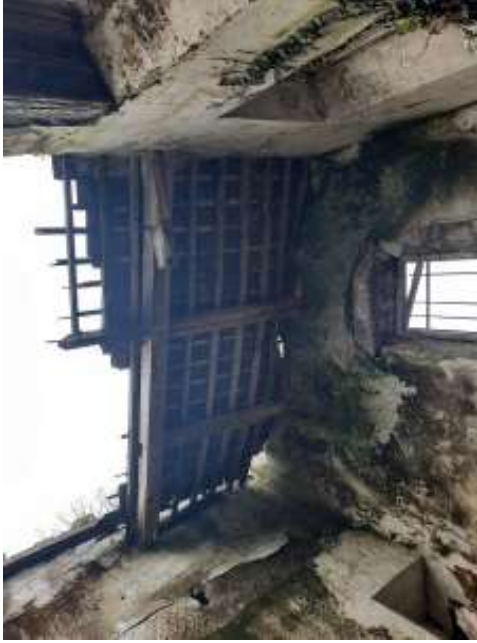
001 / 015

A part of the roof structure remains in place but is in very poor condition. The main timber roof beam has degraded at the ends and fallen from its bearing.

We recommend that the remaining roof structure is demolished and removed off-site.

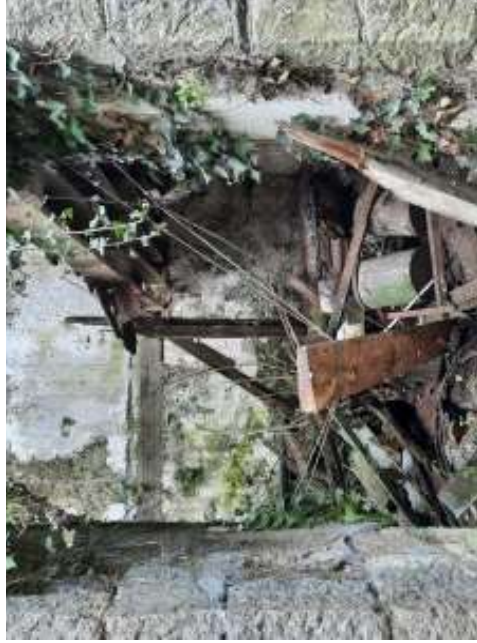
001 / 016

Photo showing the debris and fallen timbers at ground floor level. Some of the fallen timber members are pulling on electrical cables. It could not be determined if the cables are live. The cables should be inspected by a suitably qualified electrician , disconnected and removed prior to any demolition works.

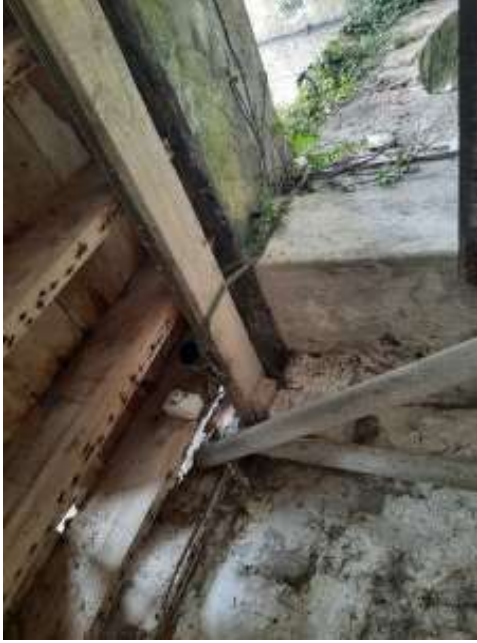
001 / 017

Photo showing electrical cables below the first floor joists. It could not be determined if the cables are live. The cables should be inspected by a suitably qualified electrician , disconnected and removed prior to any demolition works.

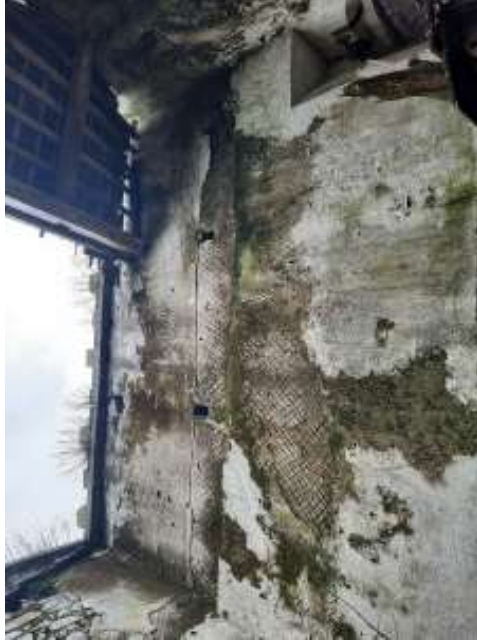
001 / 018

Photo of the internal face of the north wall to the north section of the building.

The roof has partially collapsed over this wall.
The north stone rubble wall is stable and generally in good condition.

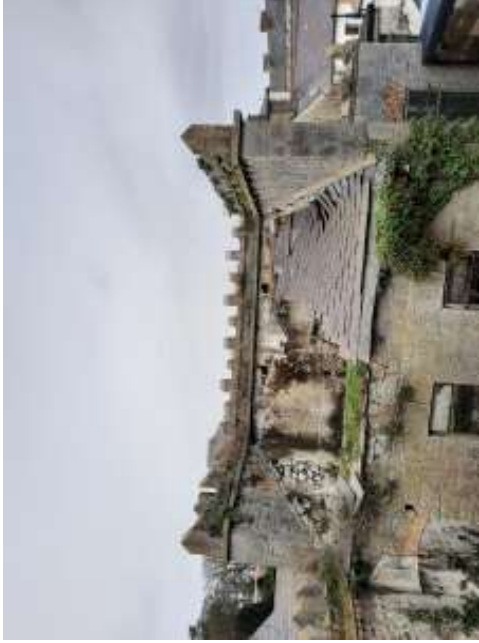
001 / 019

Photo of the roof of the north section of the building from above.

The roof has partially collapsed. The remaining section of the roof structure is in very poor condition and in a state of collapse.

We recommend that the remaining roof structure is demolished and removed off-site.

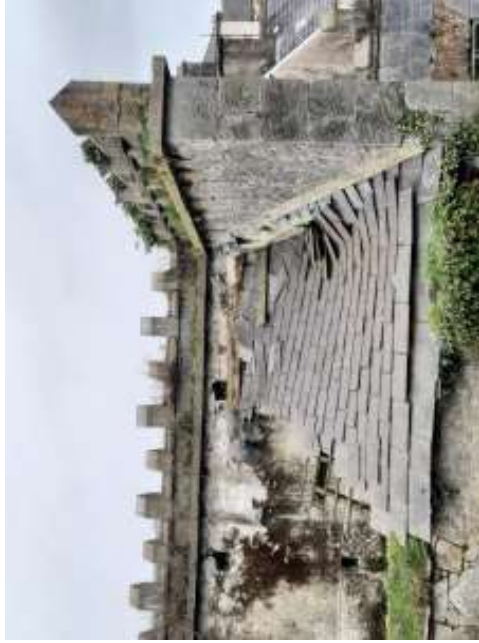
001 / 020

The castellated parapet walls above the roof appears to be structurally stable in the relatively good condition.

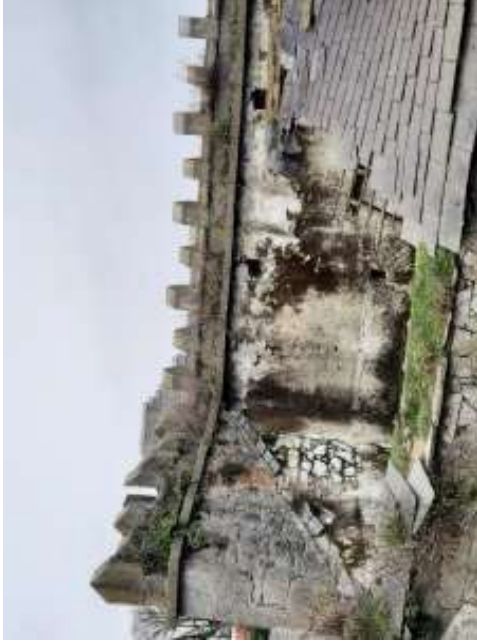
001 / 021

The castellated parapet walls above the roof appears to be structurally stable in the relatively good condition.

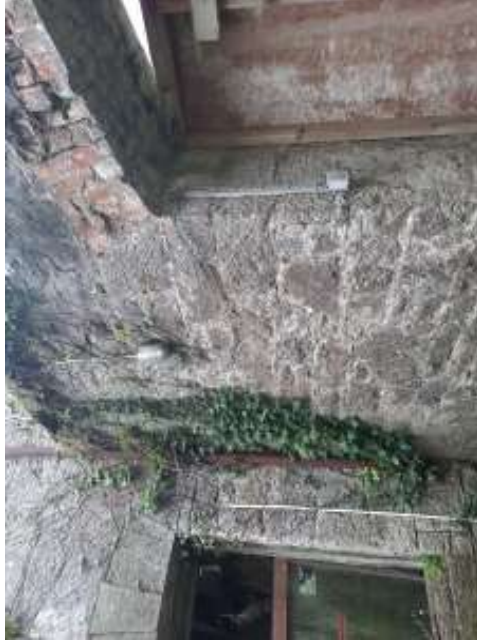
001 / 022

The electrical cables from the north section of the derelict building run to light fittings in the yard.

The cables should be inspected by a suitably qualified electrician , disconnected and removed prior to any demolition works.

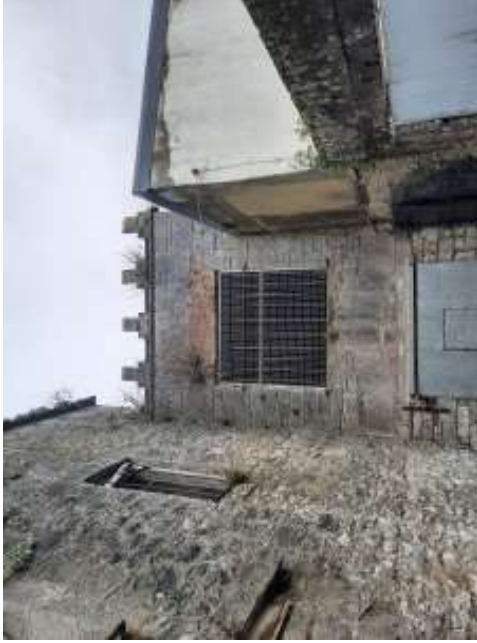
001 / 023

Photo showing an electrical cable running from the north derelict building across the alleyway to a neighbouring property to the east. The cable should be inspected by a suitably qualified electrician , disconnected and removed prior to any demolition works.

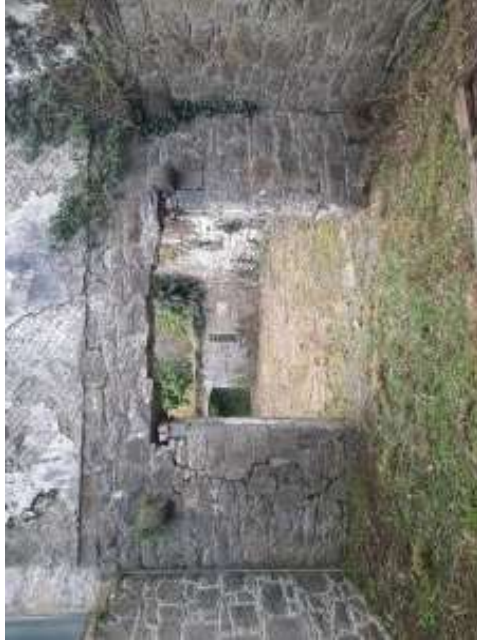
001 / 024

Comment
Photo of stone rubble wall to yard area.

Original beam lintel to ope has been removed. The stonework above the opening is unsupported but appears to be stable.

The remaining stone rubble wall appears to be in good condition.

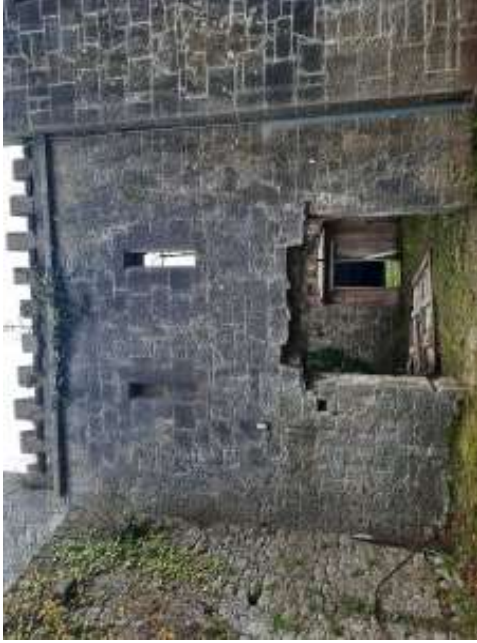
001 / 025

Photo of stone rubble wall to yard area.

Original beam lintel to ope has been removed. The stonework above the opening is unsupported but appears to be stable.

The remaining stone rubble wall appears to be in good condition.

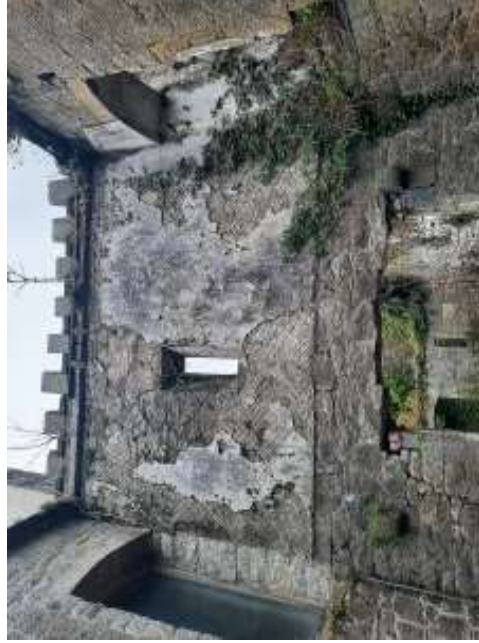
001 / 026

Photo of stone rubble wall to yard area.

Original beam lintel to ope has been removed. The stonework above the opening is unsupported but appears to be stable.

The remaining stone rubble wall appears to be in good condition.

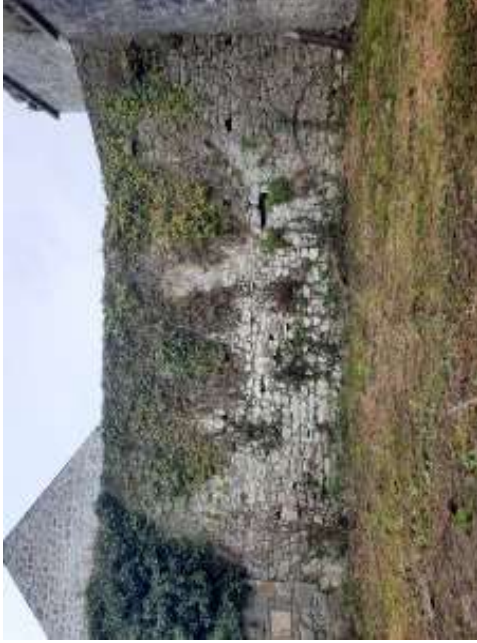
001 / 027

Comment
Stone rubble wall to rear yard.

The wall appears in be stable and in good condition.

We would recommend that the ivy is cut back at the base and removed when it has died back to prevent the ivy damaging the wall.

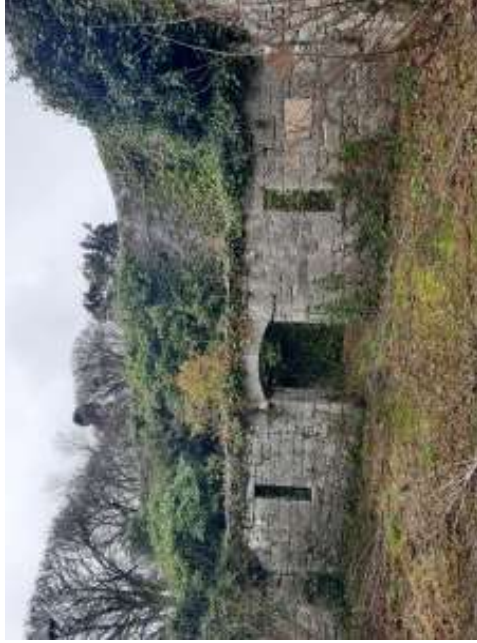
001 / 028

Comment
Stone rubble wall to rear yard.

The wall appears in be stable and in good condition.

We would recommend that the ivy is cut back at the base and removed when it has died back to prevent the ivy damaging the wall.

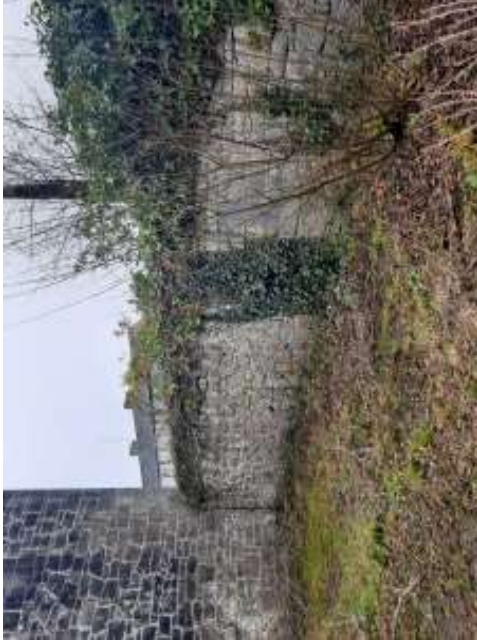
001 / 029

Comment
Stone rubble wall to rear yard.

The wall appears to be stable and in good condition.

We would recommend that the ivy is cut back at the base and removed when it has died back to prevent the ivy damaging the wall.

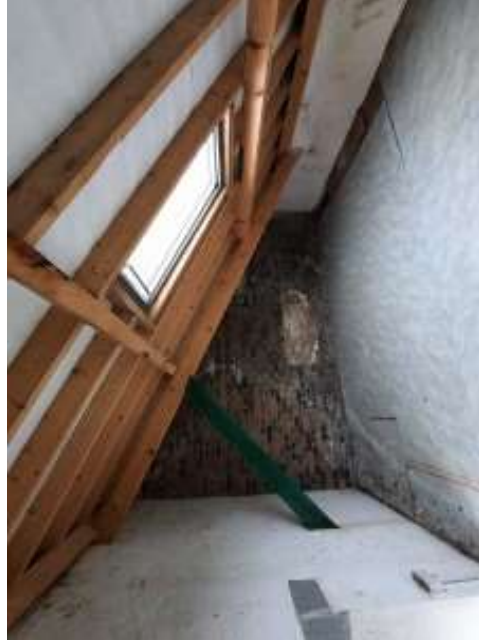
001 / 030

South section of building. - top floor.

The roof appears to have been refurbished and recovered. The timber rafters, purlins and trusses appear to be in good condition.

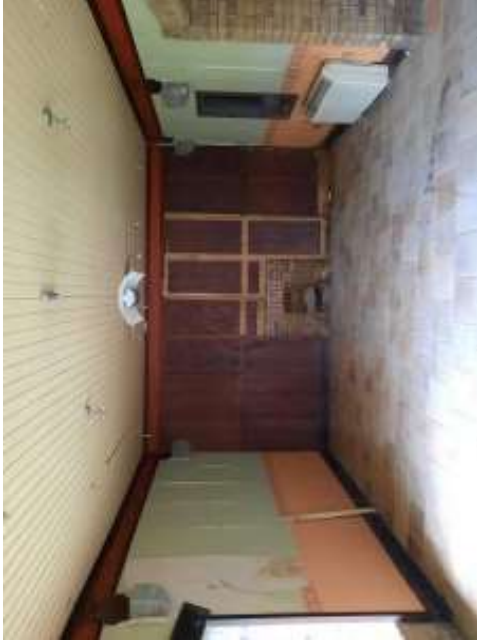
001 / 031

South section of building - first floor.

Walls are drylined. The structure generally appears to be good condition.

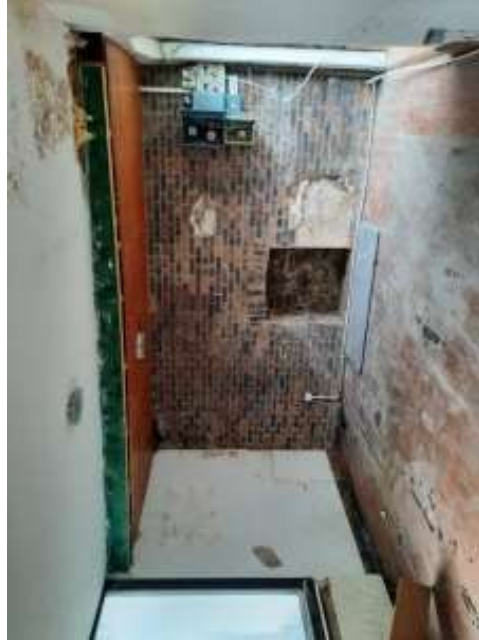
001 / 032

South section of building - first floor.

Walls are drylined. The structure generally appears to be good condition.
