Arboricultural Impact Assessment Report

Assessment of trees in relation to the Proposed development

January 2021

Project: Tree survey for the proposed development at Mungret

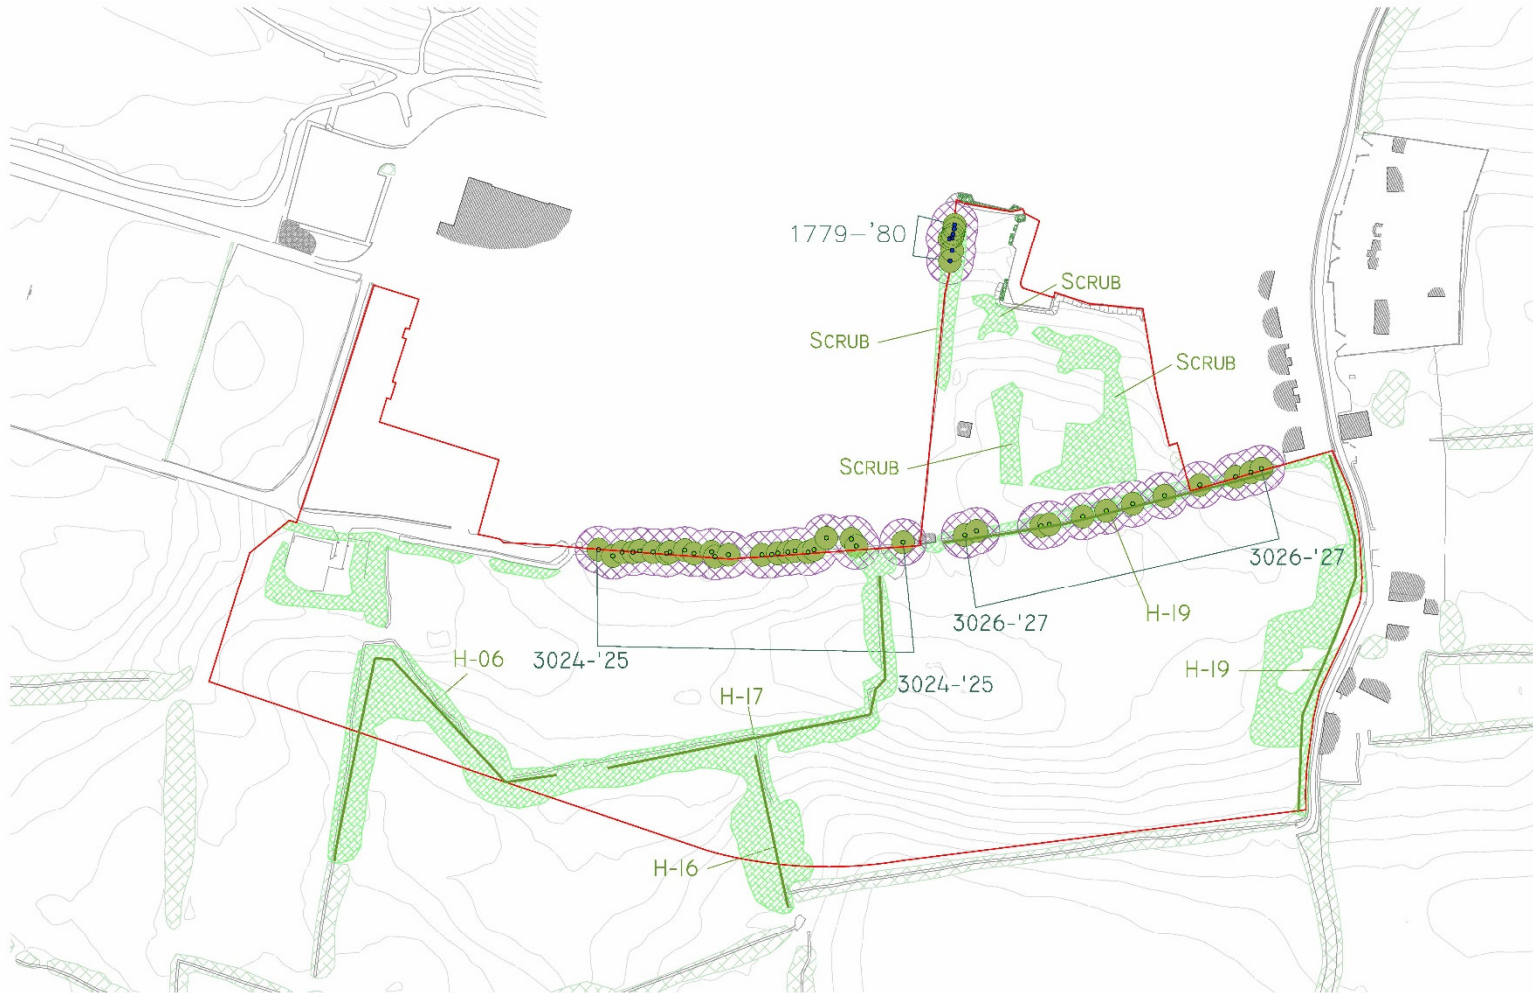
Figure 5. Tree Constraints Plan

The arboricultural impact of the development is low, only 3 trees out of 43 trees will require removal. It will also require the complete removal of hedgerow 17 and the complete removal of two un-surveyed areas and some areas of scrub, and partial removal of hedgerows 6, 16 and 19 and one further un-surveyed area (Please refer to Appendix 1 (Page 17), Appendix 2 (page 18) and the Vegetation Removal Plan (Dwg. MP-L-006 Vegetation Removal Plan - Figure 6 on page 20) for further information). There is an extensive landscape plan that will plant site appropriate trees which will enhance the arboreal footprint of the site.

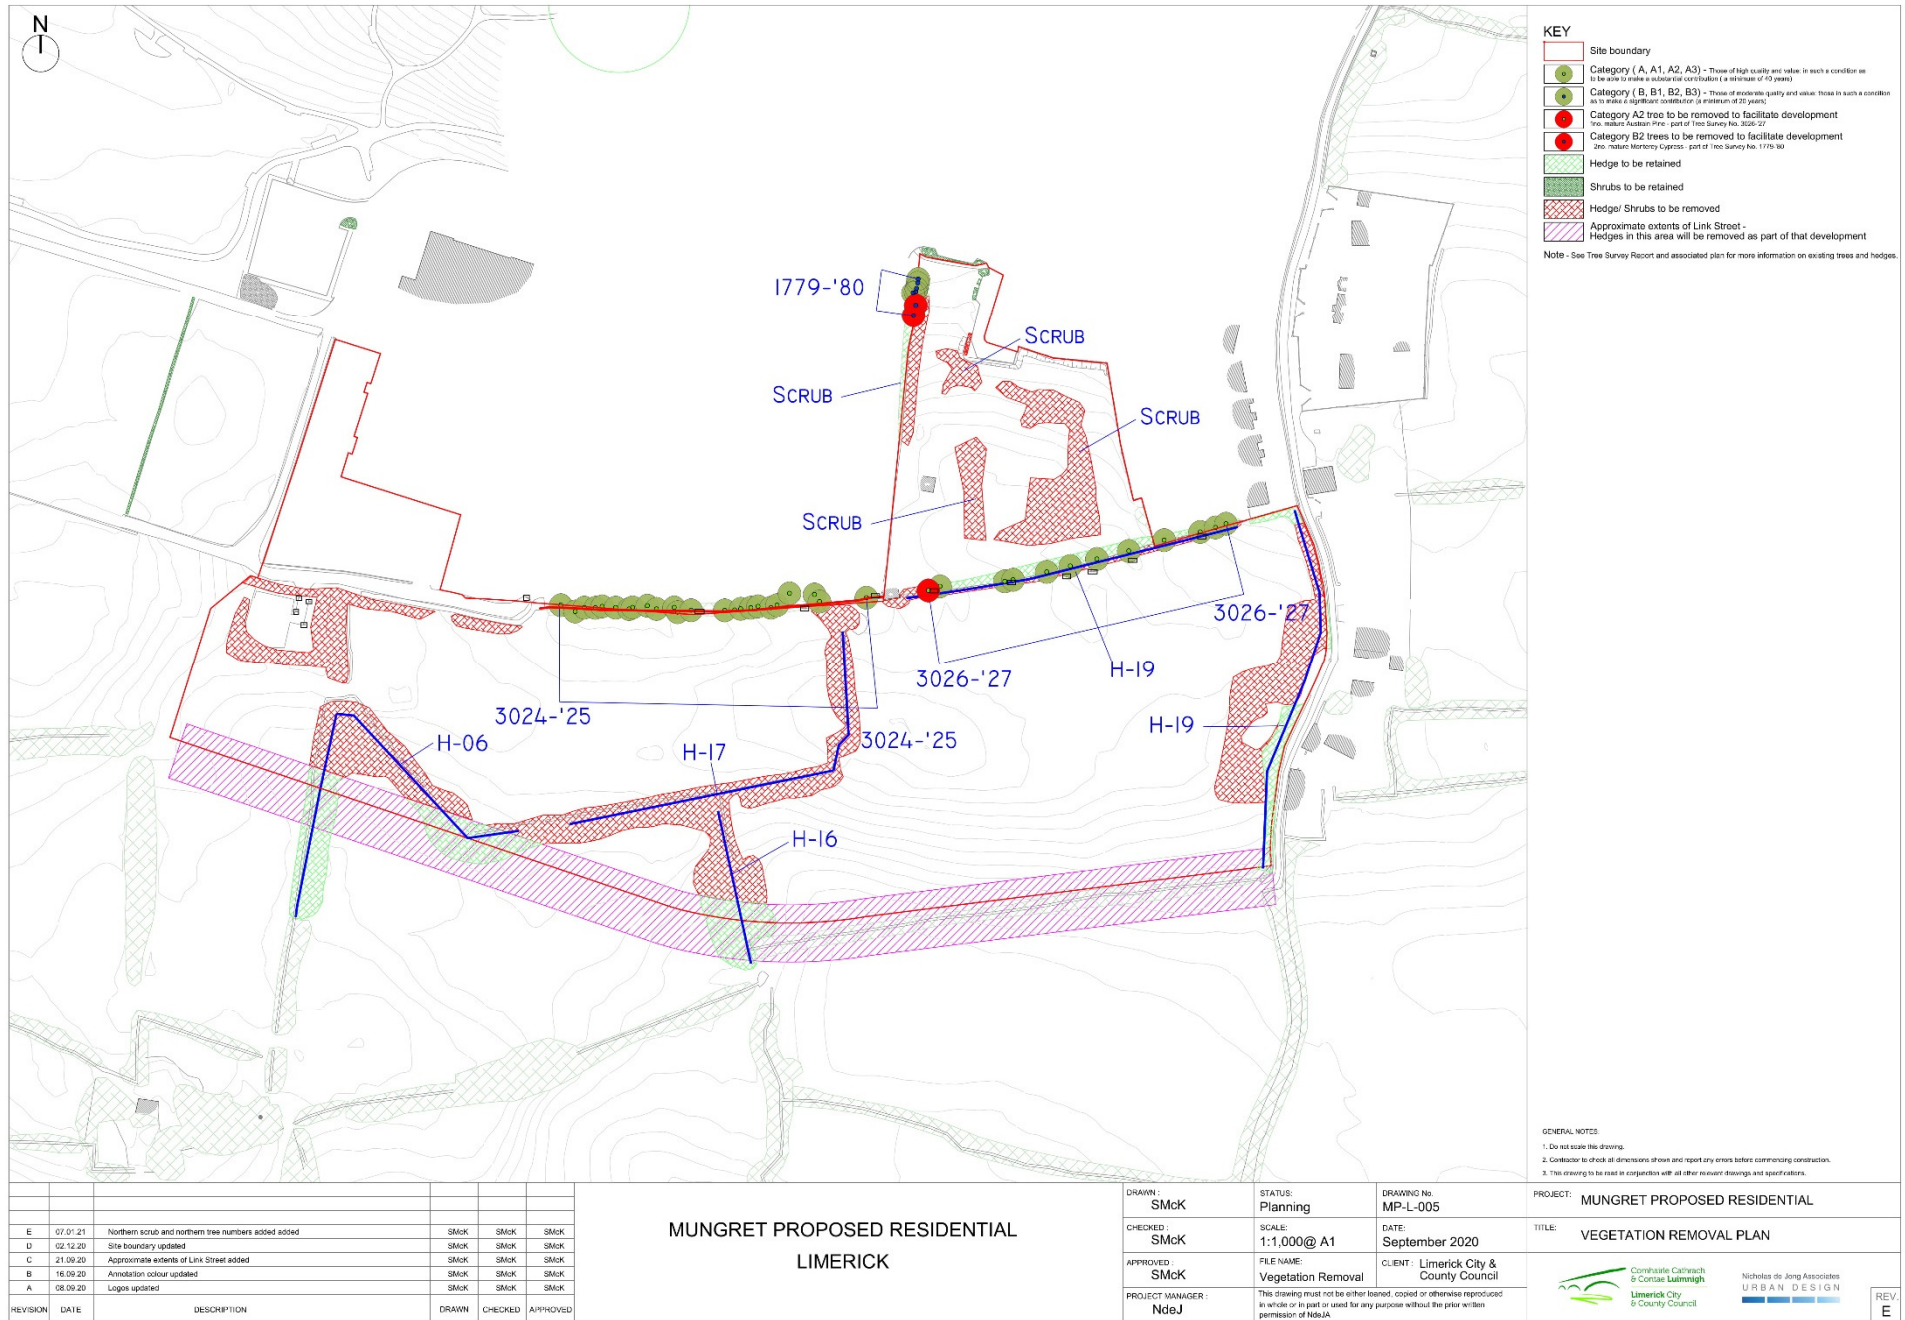
Figure 6. Vegetation Removal Plan

Tag number	Species Botanical Name	Age class	DBH	Height	Crown Sp.	Crown clearance	Condition	Structural/Physiological Observations	Category	Impact of the development	RPA
3024-3025	Austrian Pine	M	800	24	N=5 S=5 E=5 W=5	1	Good	A row of 24 mature Pines displaying a good overall condition. As a group they have a high amenity value due to their prominent location	A2	Retain	9m
3026-3027	Austrian Pine	M	800	24	N=5 S=5 E=5 W=5	1	Good	A row of 12 mature Pines displaying a good overall condition. As a group they have a high amenity value due to their prominent location	A2	One tree within the row will have to be removed, please refer to the vegetation removal drawing	9m
1779-1780	Monterey Cypress	M	800	24	N=4 S=4 E=4 W=4	1.5	Good	A row of 7 large mature Monterey Cypress displaying a good overall condition. As a group they have a high amenity value due to their prominent location.	B2	Two trees within the row will have to be removed, please refer to the vegetation removal drawing	9m

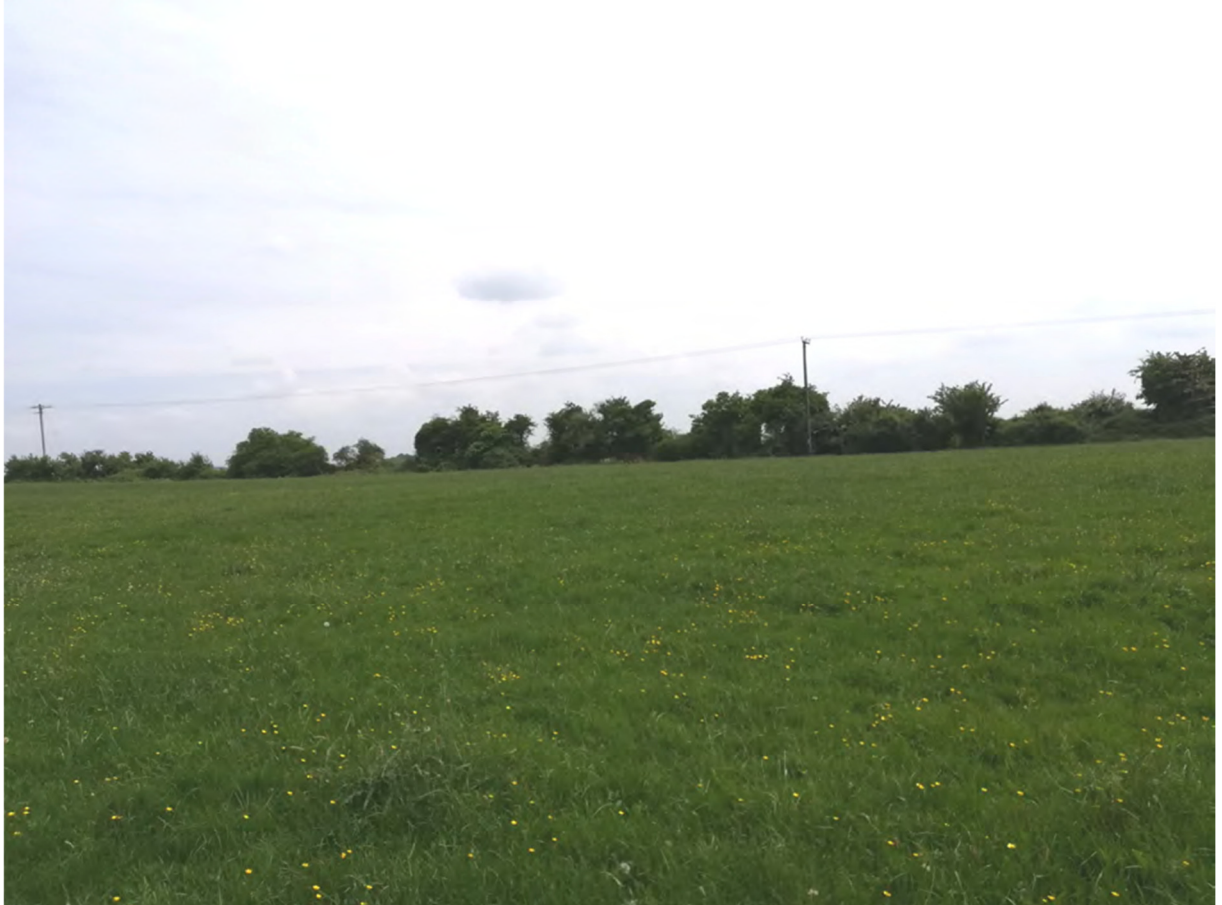
Tree	Species Botanical Name	Age class	Height (M)	Crown Cl.(M)	Condition	Structural/Physiological Observations	Category	Impact of the development
H6	Hawthorn Blackthorn elder	M	6-8	1	Good	A mature hedgerow displaying a good overall condition. Typical native hedgerow	B2	Partial removal to facilitate the development
H16	Hawthorn Blackthorn elder	M	3-6	1	Good	A mature hedgerow displaying a good overall condition. Typical native hedgerow	B2	Partial removal to facilitate the development
H17	Hawthorn Blackthorn elder	M	3-6	1	Good	A mature hedgerow displaying a good overall condition. Typical native hedgerow	B2	Remove entire hedge to facilitate the development
H19	Hawthorn Blackthorn elder	M	3-6	1	Good	A mature hedgerow displaying a good overall condition. Typical native hedgerow	B2	Partial removal to facilitate the development

Figure 7. Displays typical image of the hedgerow on site. Containing good quality hawthorn and blackthorn. This image is H6

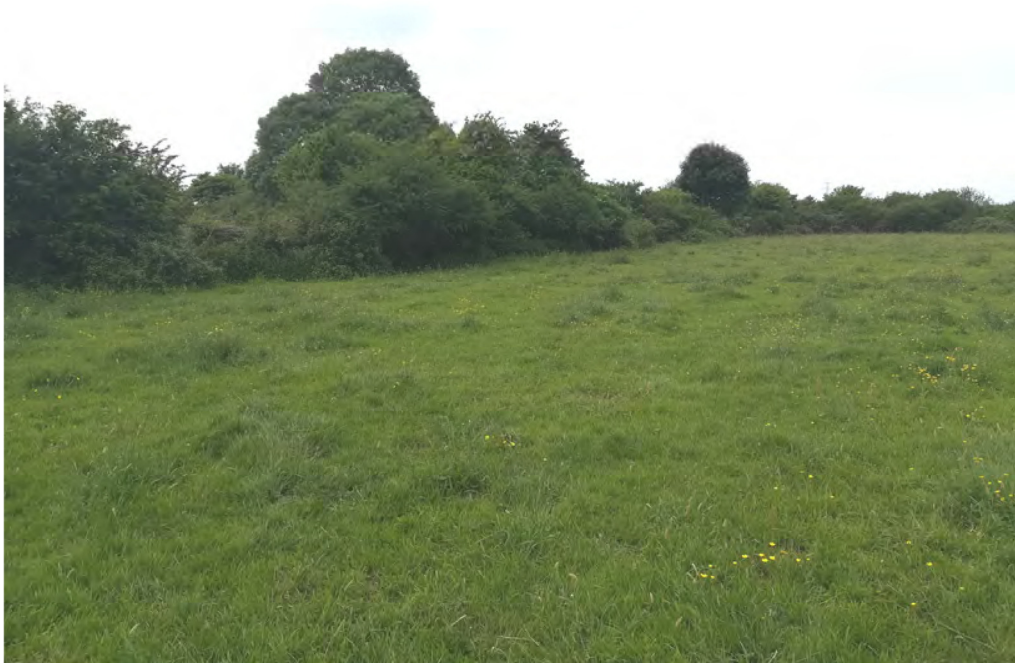
Figure 8. Displays a typical hedgerow.
