A Tree survey and Arboricultural Impact Assessment.

**For,
Patrickswell,
Co. Limerick.**

**Prepared for,
Limerick City & County Council,
Merchants Quay,
Limerick.**

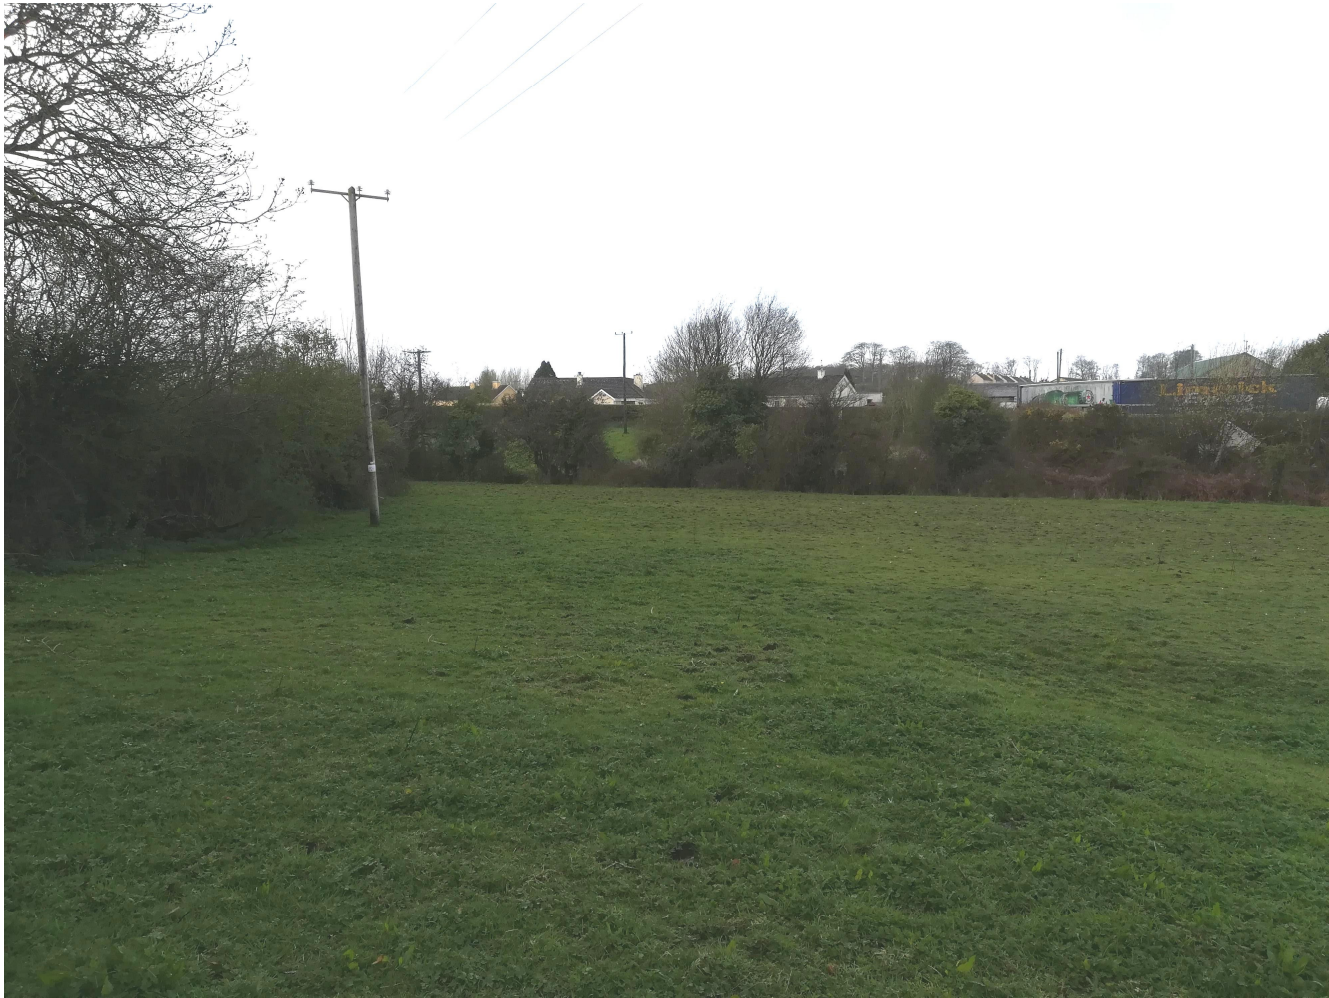
Figure 2. Displays the southern boundary.

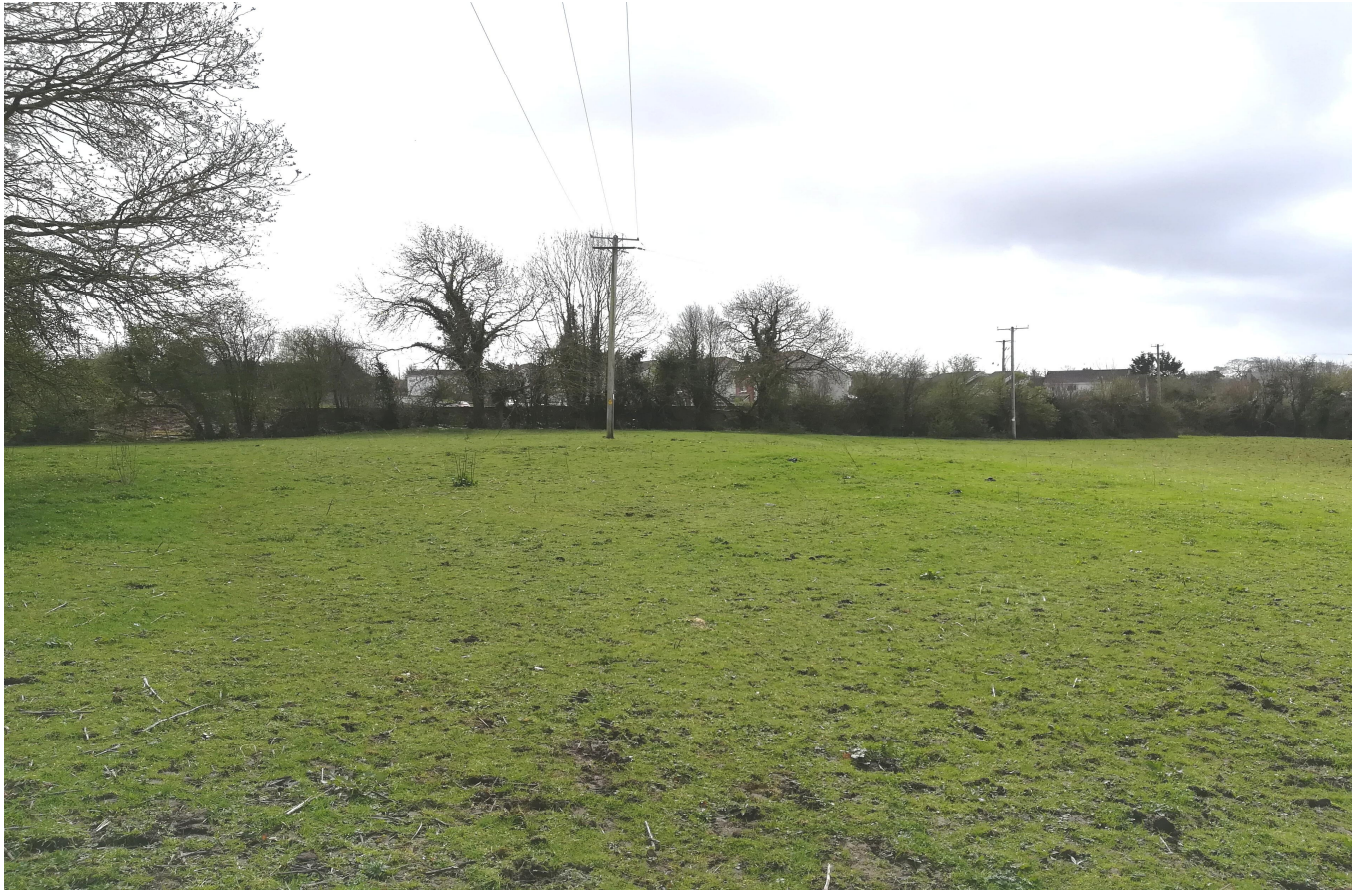
Figure 3.
Eastern boundary, there are examples of quality trees along this boundary that screen the proposed development from the existing housing estate.
