BS:5837 TREE SURVEY  
BLOODMILL ROAD,  
BALLYSIMON,  
CO. LIMERICK,

Document Stage	Document Version	Prepared by
Draft Report	1	Gary Doherty L6 Arb, PTI

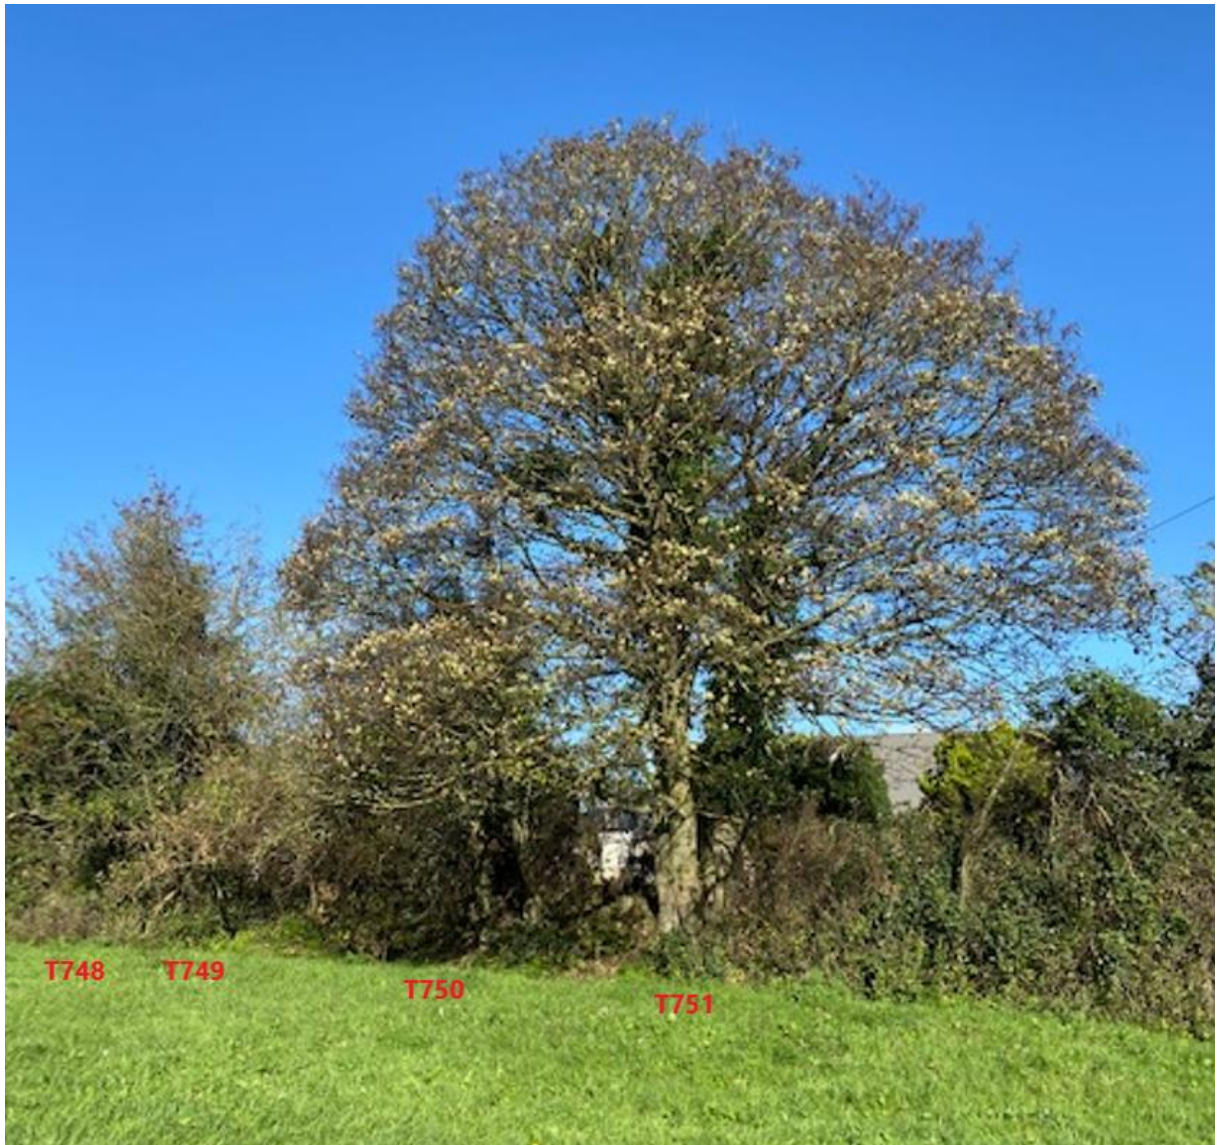
**FIG 3 – Trees T748 – T751**

Trees T748, T749 and T750 are all smaller trees overgrown by T751. The trees have been continuously cut back to the main stem and are dominated by re-growths. T750 is a smaller Hawthorn with extensive decay at the base from older stem failure.

Tree T751 is a dominant category B Sycamore tree along the hedgerow. There are three co-dominant stems growing from base with a large spreading canopy. The canopy extends over the road by approx. 3m.

All four trees are in direct conflict with the proposed extension upgrade of Bloodmill Rd. and recommended for removal.

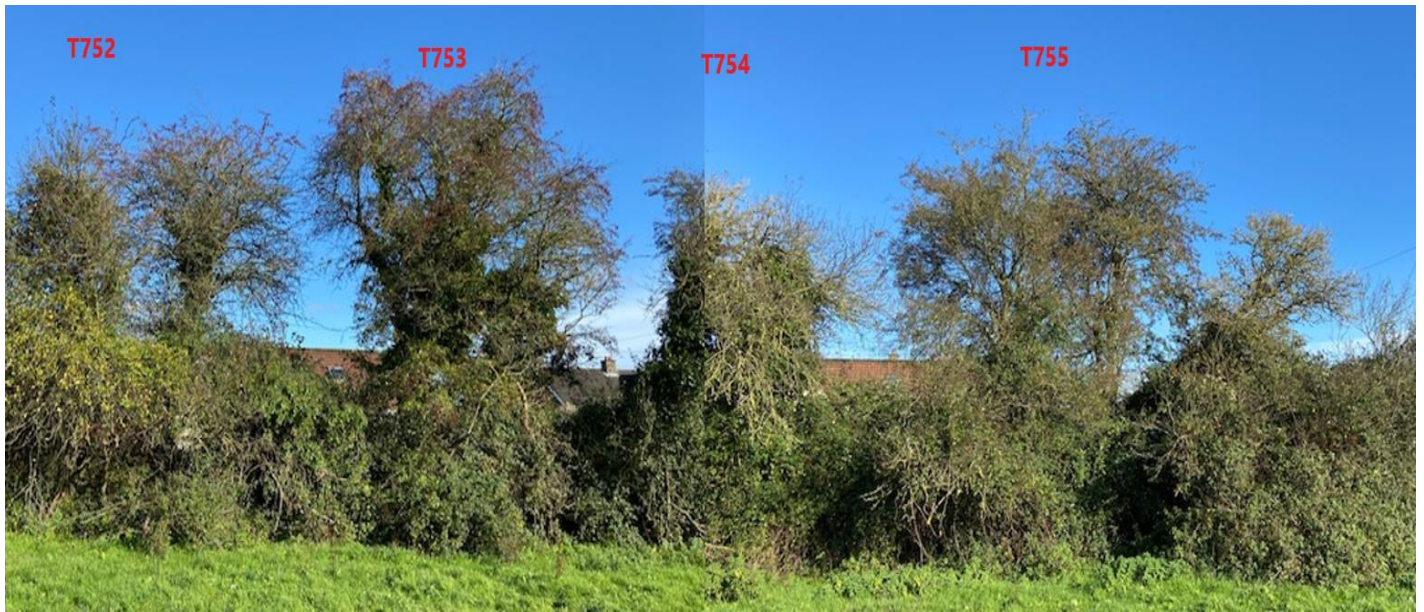
**FIG 4 – Trees T752 – T755**

Trees T752 through to T755 are all older Apple and Hawthorn trees that possibly formed the older ditch-line and orchard dating back between eighty and hundred years. The trees are all densely overgrown with ivy and bramble and there are a number of Apple trees, that had been growing from the old stone ditch, collapsed from the root base and forming a dense thicket.

All four trees are in direct conflict with the proposed extension upgrade of Bloodmill Rd. and recommended for removal.

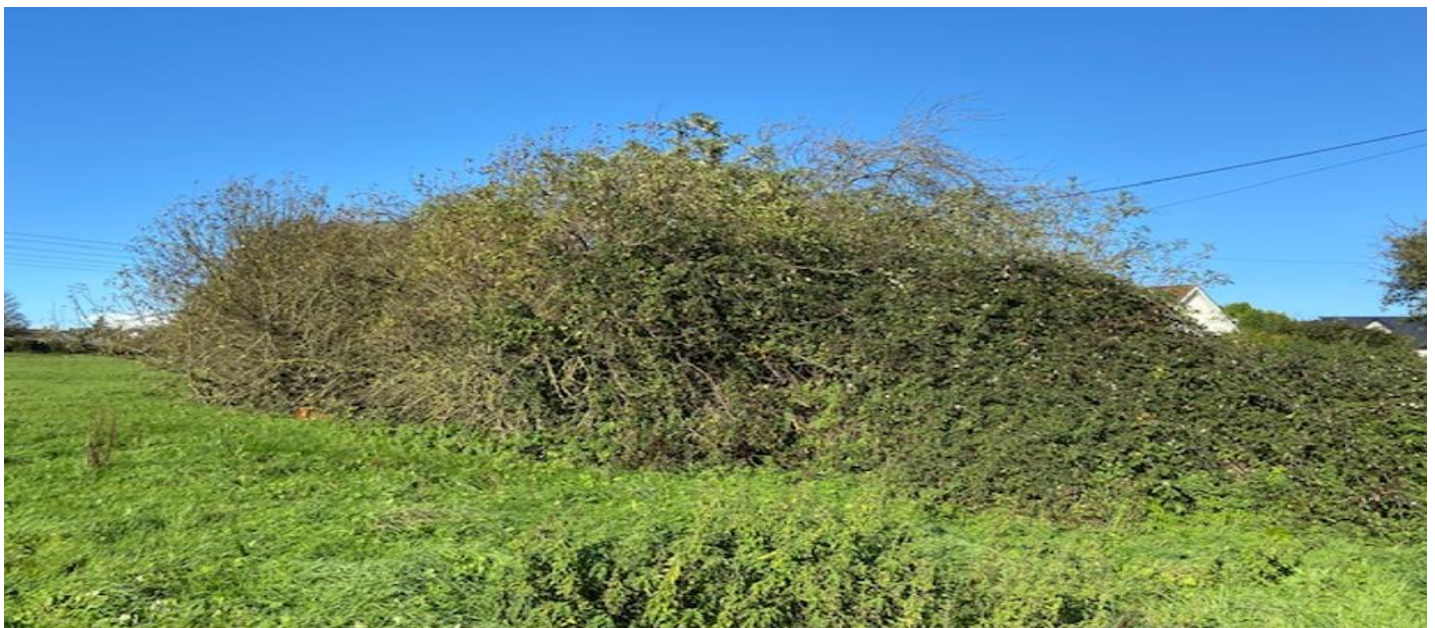
**FIG 5 – Tree T756 – Dense thicket of collapsed Apple trees dominated by Bramble & Blackthorn**

Tree T756 is an older Apple tree heavily weighted and leaning over the road. A number of older trees have collapsed either side T756 from the roots and are forming a dense thicket shown in Fig 5.

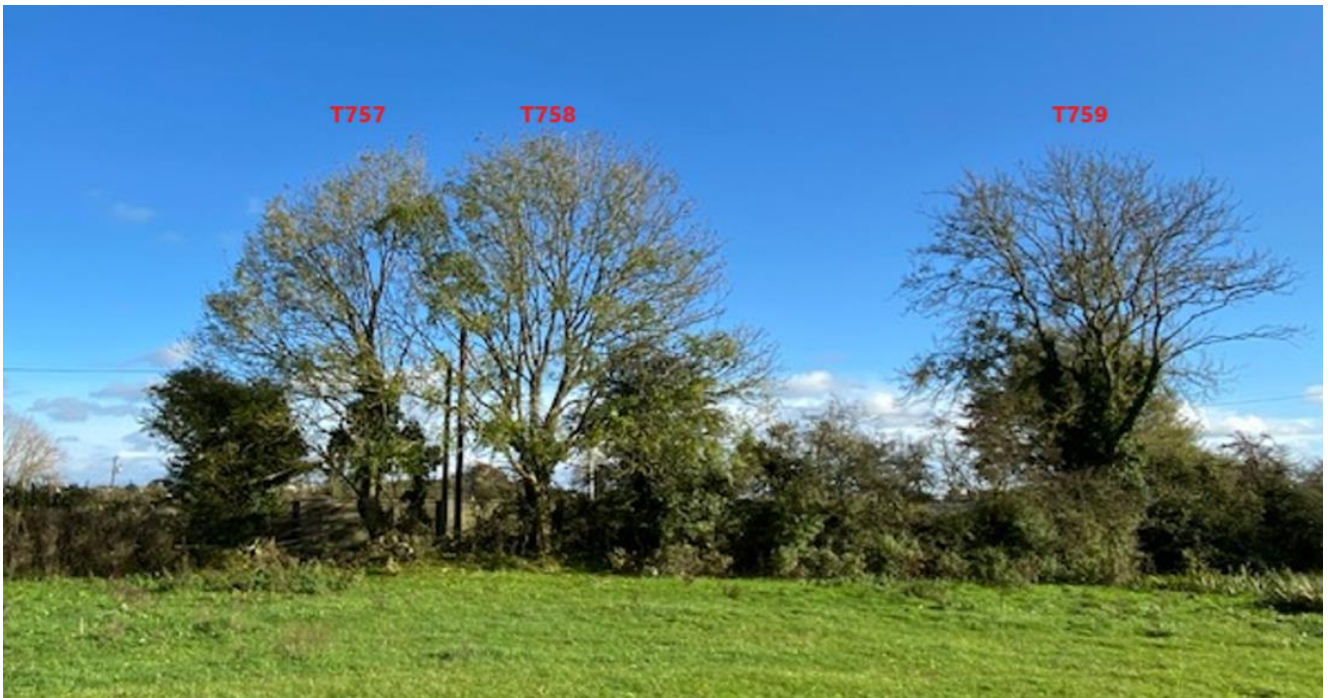
**FIG 6 – Trees T757 – T759**

The three Ash trees T757, T758 and T759 dominate the hedgerow close to the Towlerton stream. All of the trees have extending canopies over the road and there is evidence of dense epicormic growth from their branches and main stems. The profusion of such epicormic growth is usually in response to stresses been placed on the trees. Such stressors would include Ash Dieback which is affecting Ash trees throughout the country. There are very early indicators that Ash Dieback is present within the canopies of the trees.

All three trees are in direct conflict with the proposed extension upgrade of Bloodmill Rd. and recommended for removal.

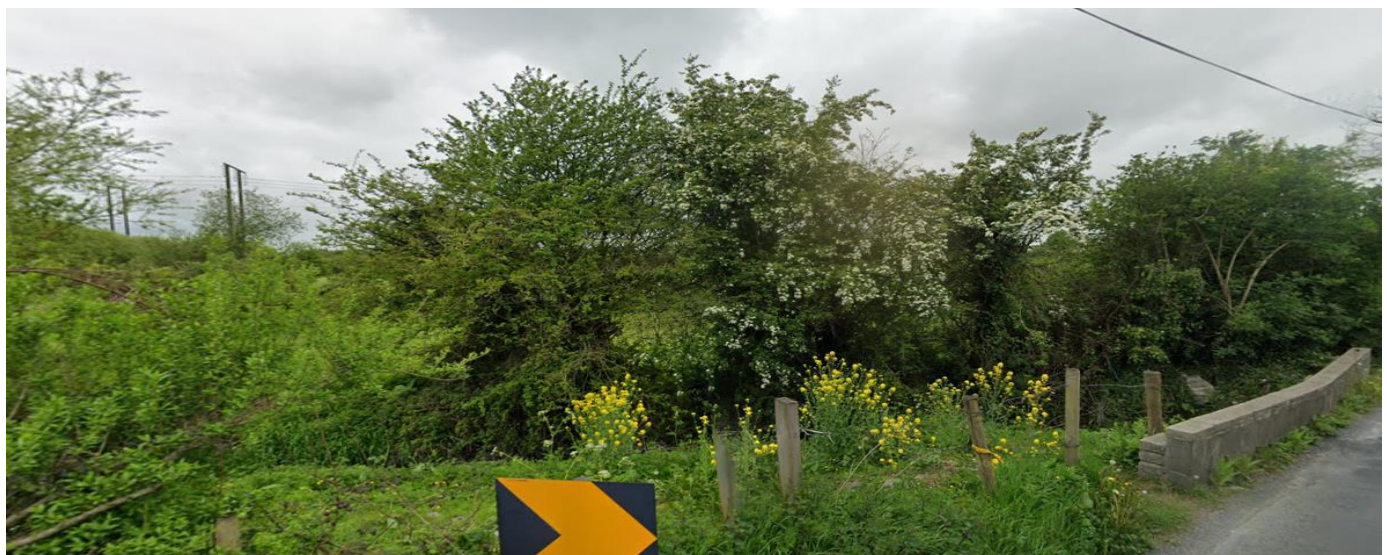
**FIG 7 – Tree T760**

The tree T760 represents a dense Hawthorn hedgerow growing on the western bank of the Towlerton stream to the south of Bloodmill Rd. At present it is not clear whether this section of the existing road is to be impacted by the proposed extension upgrade and it is recommended to retain these trees.

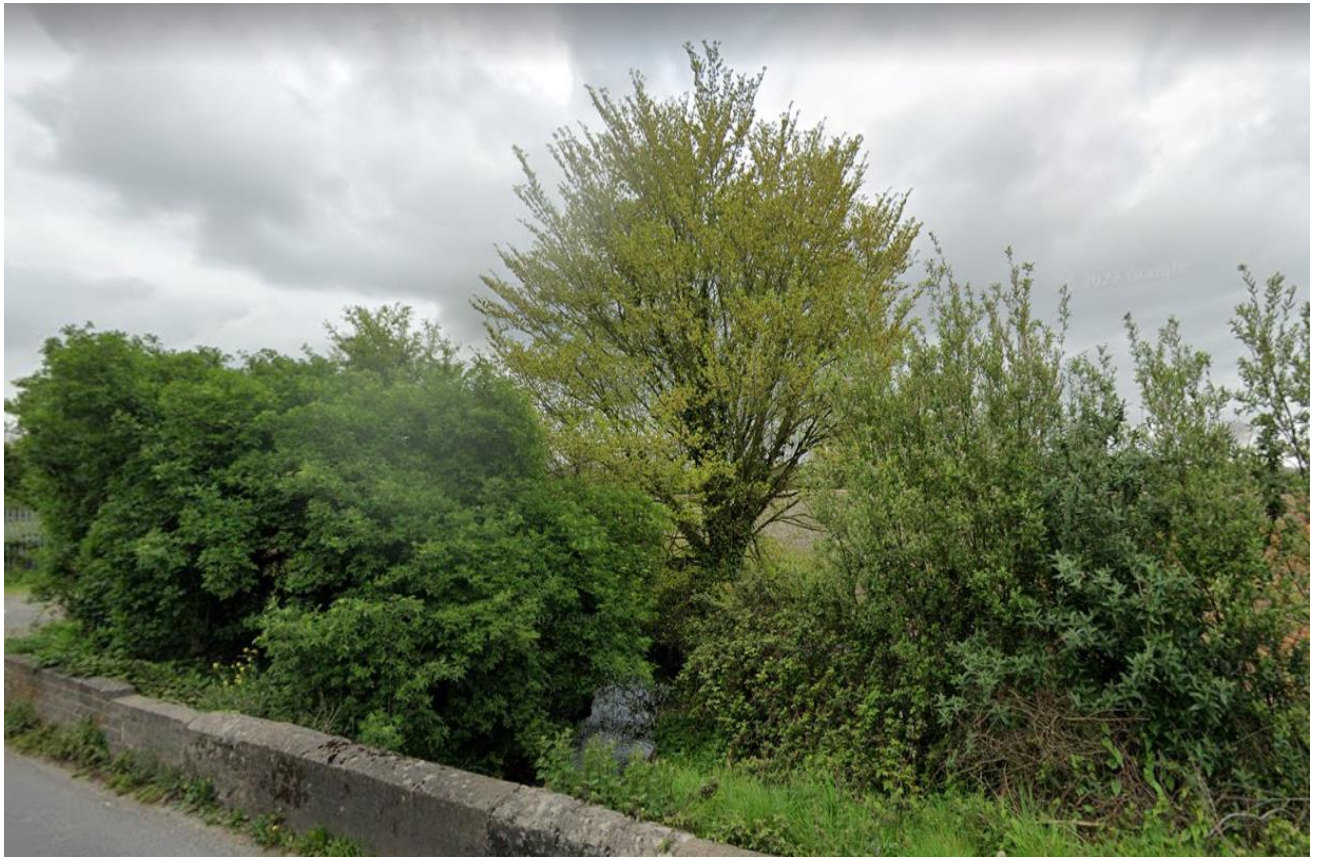
**FIG 8 – Tree T761**

The trees T761 and T762 highlighted in Figs 8 & 9 are both mature Hornbeams. T761 is an early mature Hornbeam growing on the eastern bank of the Towlerton stream to the north of the existing Bloodmill Rd. There is a dense understory of Blackthorn and Willow on either side of the stream. T762 is a mature Hornbeam growing further to the east adjacent to the north side of the road. The trees root system has been severely damaged in the past. The ground beneath the tree has also been compacted putting further pressure on the trees rooting system.

Both trees are in direct conflict with the proposed extension upgrade of Bloodmill Rd. and recommended for removal.
