Gravel removal works, Galey River, Athea, Co. Limerick

Underwater Archaeological Impact Assessment

21D0079 (Dive) & 21R0222 (Metal detection)

January 2022

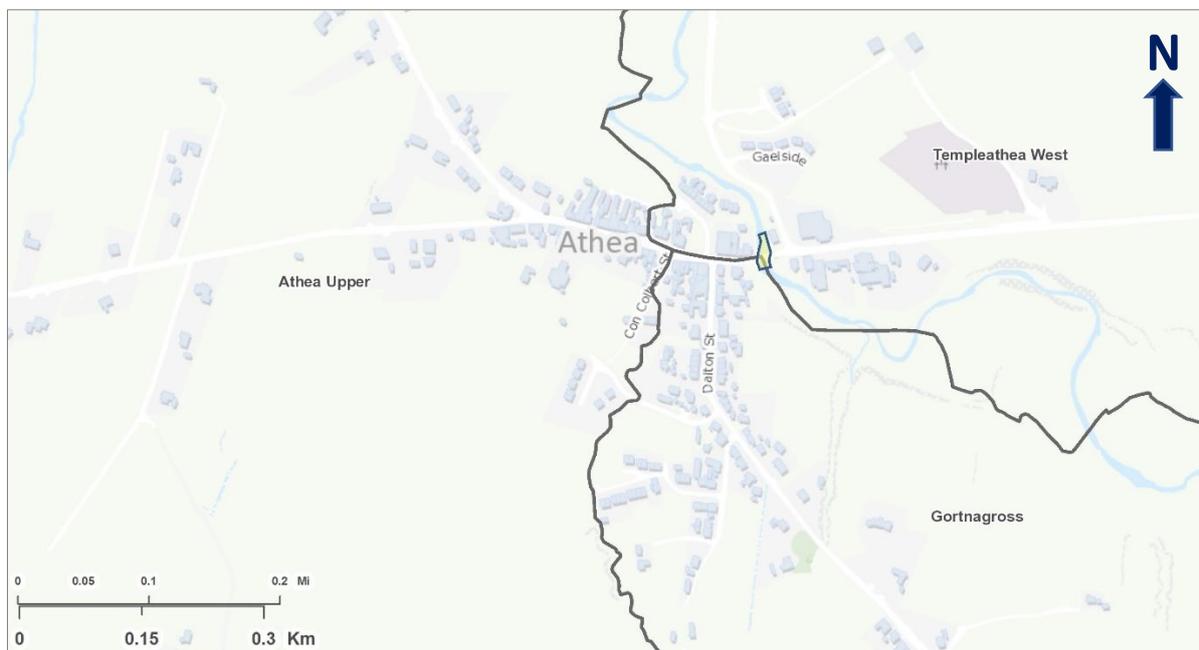
Figure 3: Proposed gravel removal works location (blue) with townlands (grey).

The proposed works will be undertaken by the OPW over a two-week period between July and September, dependent on suitable flow and weather conditions. A 6t excavator will be utilized to excavate gravel from the river channel to just above low flow levels and to load a waiting 6t dumper. Excavation will commence on the downstream extremity, leaving approximately 500mm of gravels between deposition and flowing channel to act as a buffer and to filter any run-off prior. This 500mm strip of gravels will be removed once all other gravel works have been completed.

The excavator and site dumper will enter the works area from the right bank upstream of Athea bridge. To facilitate access, it is proposed to form a temporary access ramp from the existing gravel material, which will be removed once works are complete. All plant movement will take place along deposited material, where feasible and safe to do so, to minimise contact with flowing waters and prevent suspended solids entering the channel.

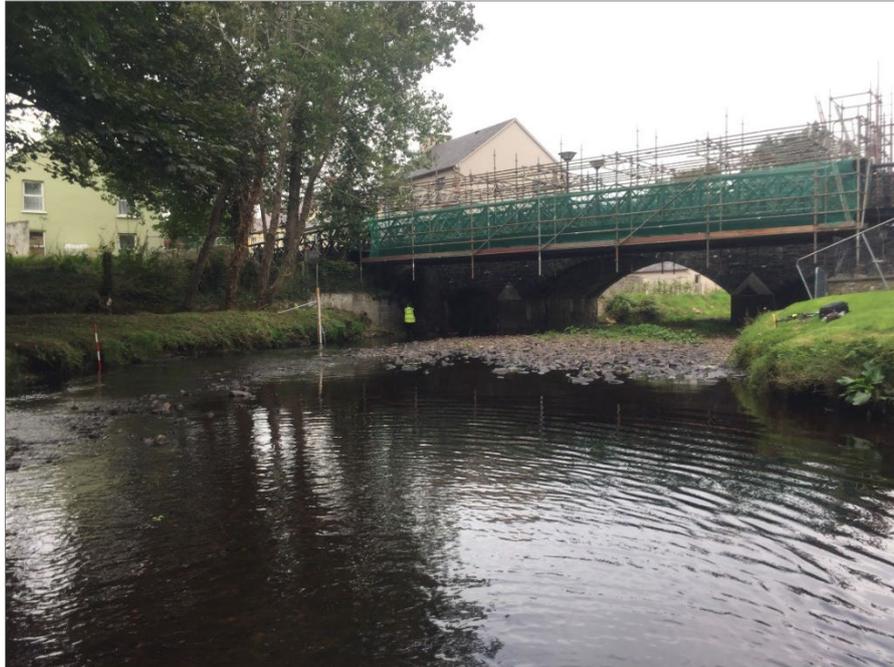
The survey included a visual investigation of the riverbed, banks and attendant ground in an effort to identify upstanding or slightly submerged archaeological and architectural material (Plate 1). Any such material present was recorded and photographed.

Plate 1: Visual survey and bridge recording in progress, taken from southeast.

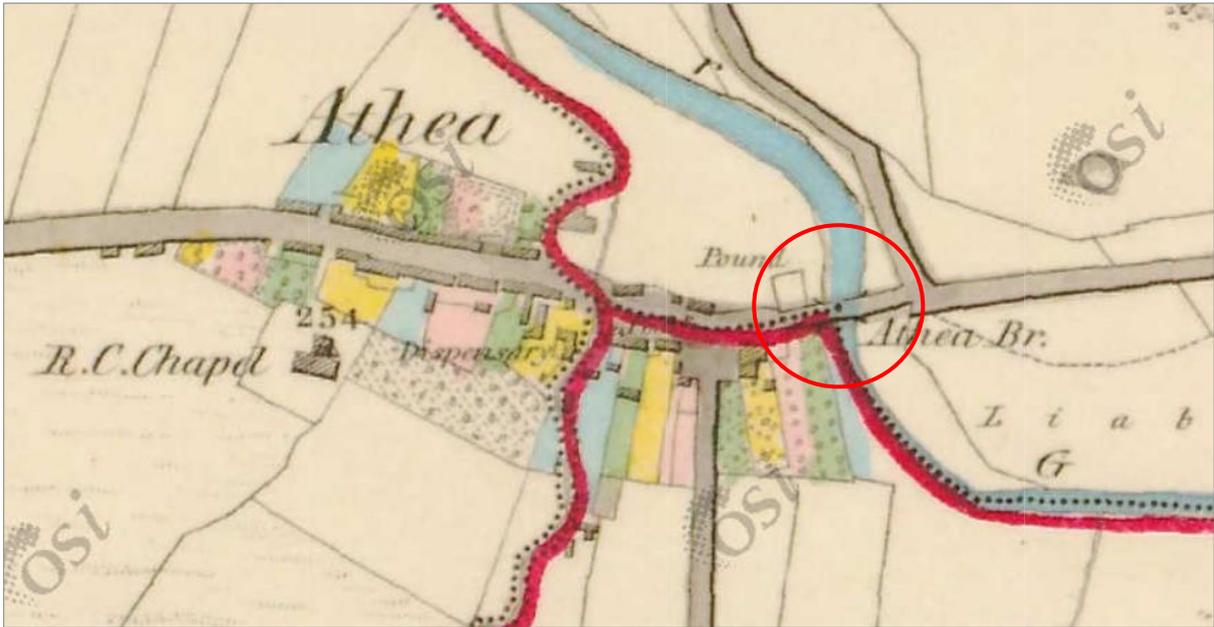
The village and bridge are visible on both the 1<sup>st</sup> edition 6-inch Ordnance Survey (OS) map (1841; Figure 7) and the 2<sup>nd</sup> edition 25-inch map (1919; Figure 8). The 1<sup>st</sup> edition 6-inch OS map shows a 'Pound' set back from the western riverbank, north of the bridge, by the 2<sup>nd</sup> edition OS map, the pound is no longer marked.

Figure 7: First edition 6-inch OS map, 1836. Survey location encircled in red.

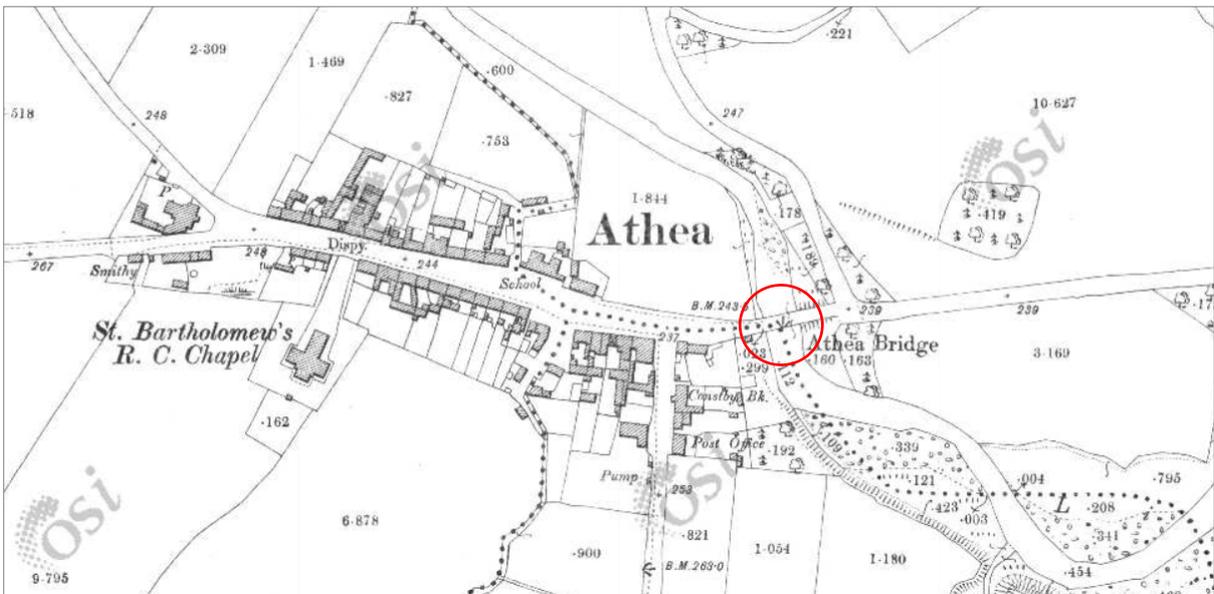
Figure 8: Second edition 25-inch OS map, 1905. Survey location encircled in red.

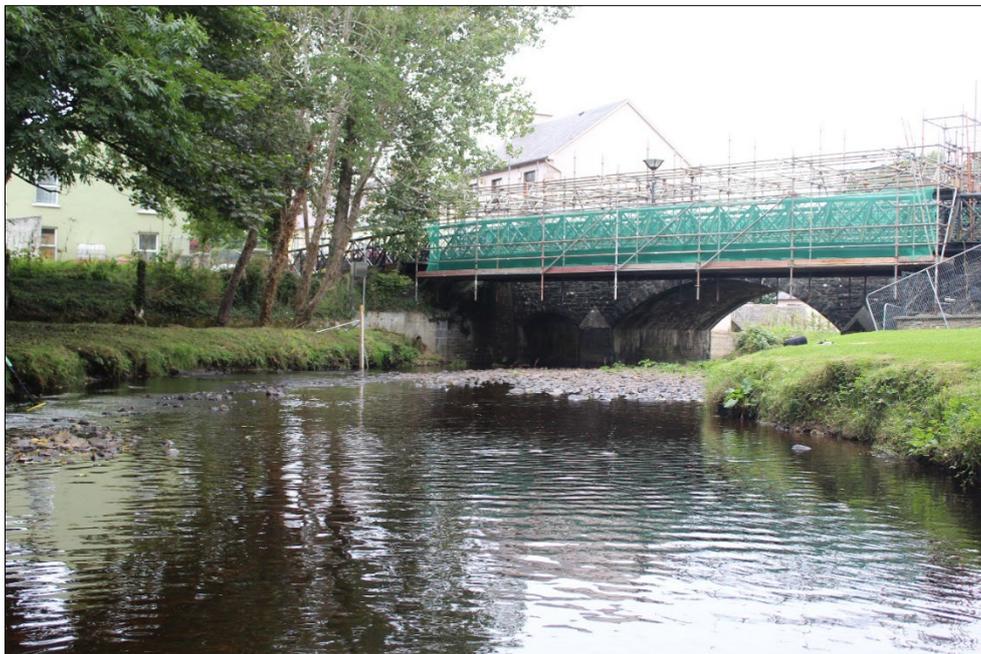
*Plate 2: View of the survey area south of Athea Bridge, taken from the southeast. The scaffolding was present to facilitate cleaning works.*

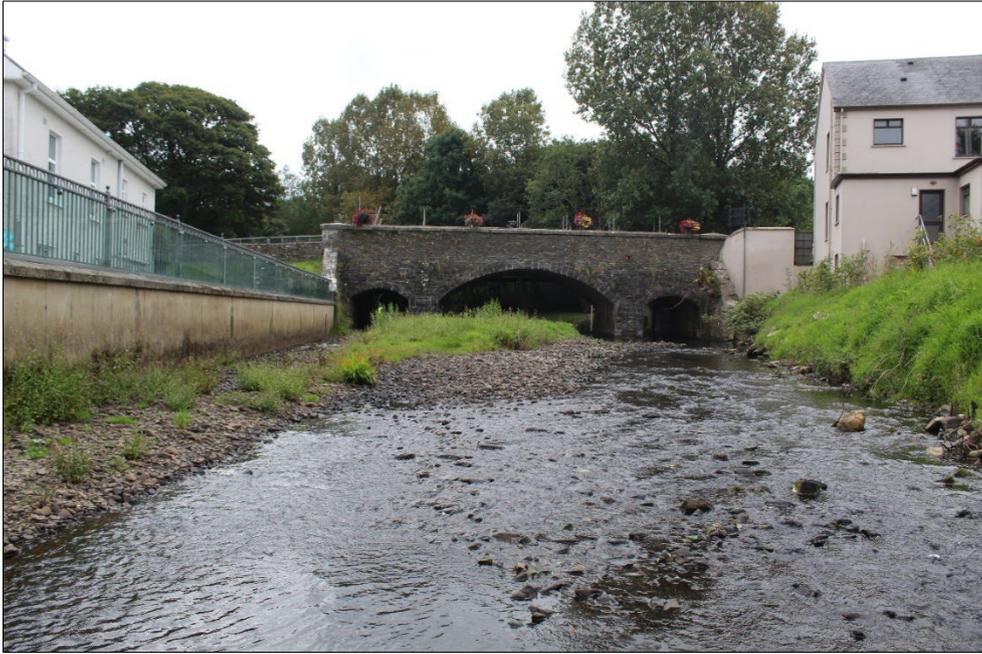
*Plate 3: View of the survey area north of Athea Bridge, taken from the north. Note the gravel bank to the left.*

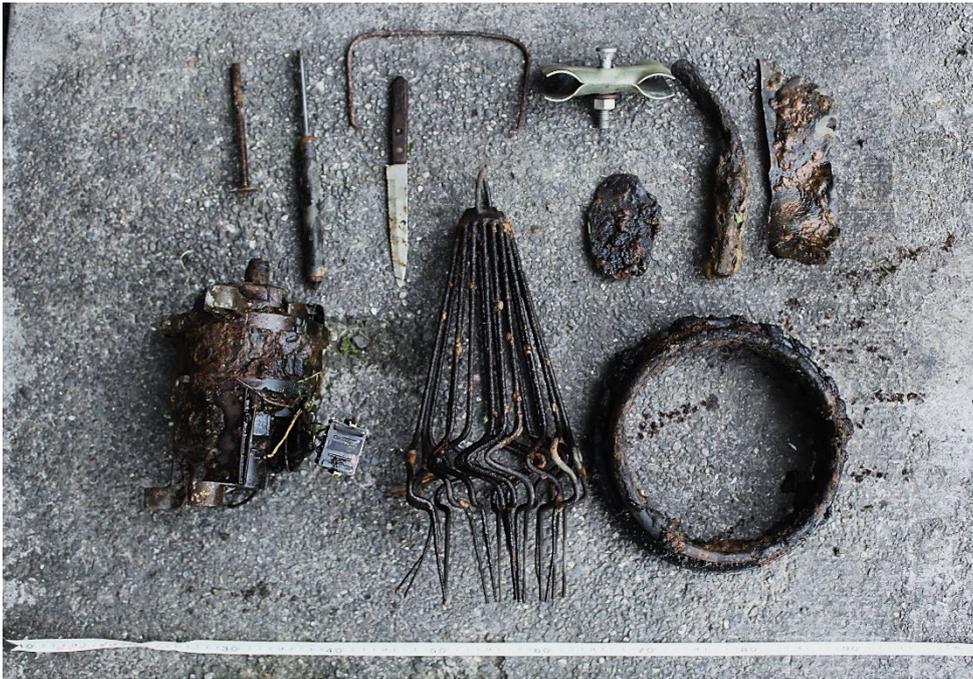
*Plate 4: Selection of metal debris found in the Galey River.*

The metal detector survey identified frequent targets of modern metal debris and the visual survey similarly identified modern material including beer bottles, glasses, brick, and occasional post-medieval pottery (Plates 4 & 5). No archaeological material was identified. Non-archaeological material was disposed of.

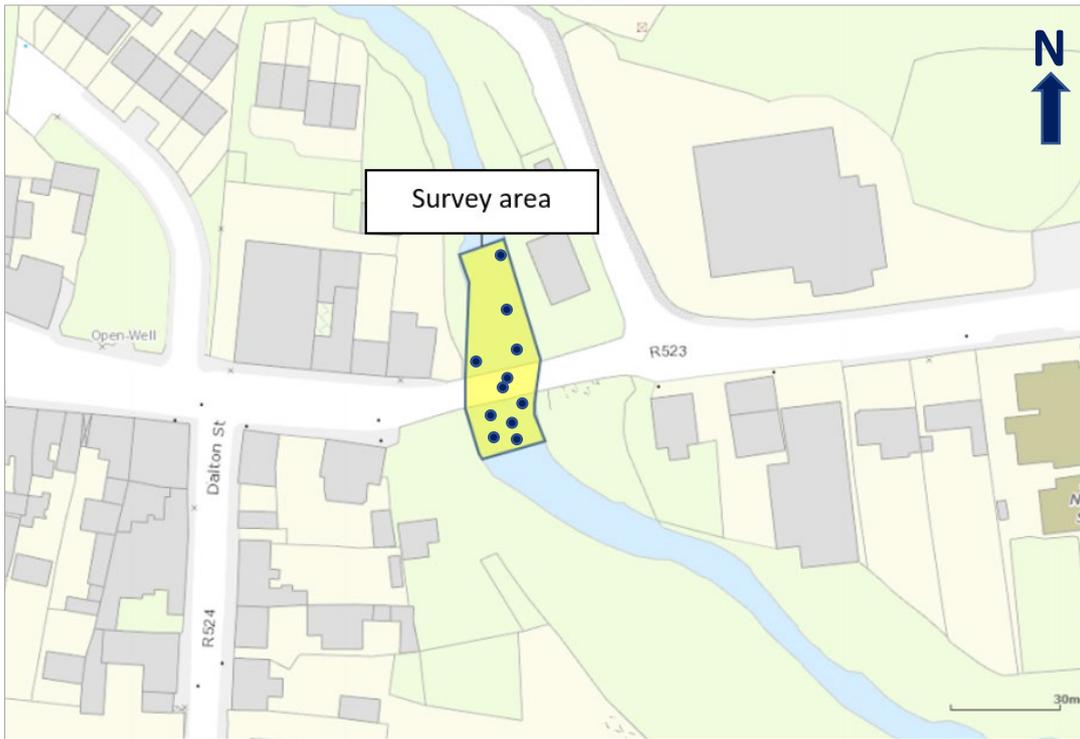
Figure 9 Approximate find locations for metal debris identified in the survey area.

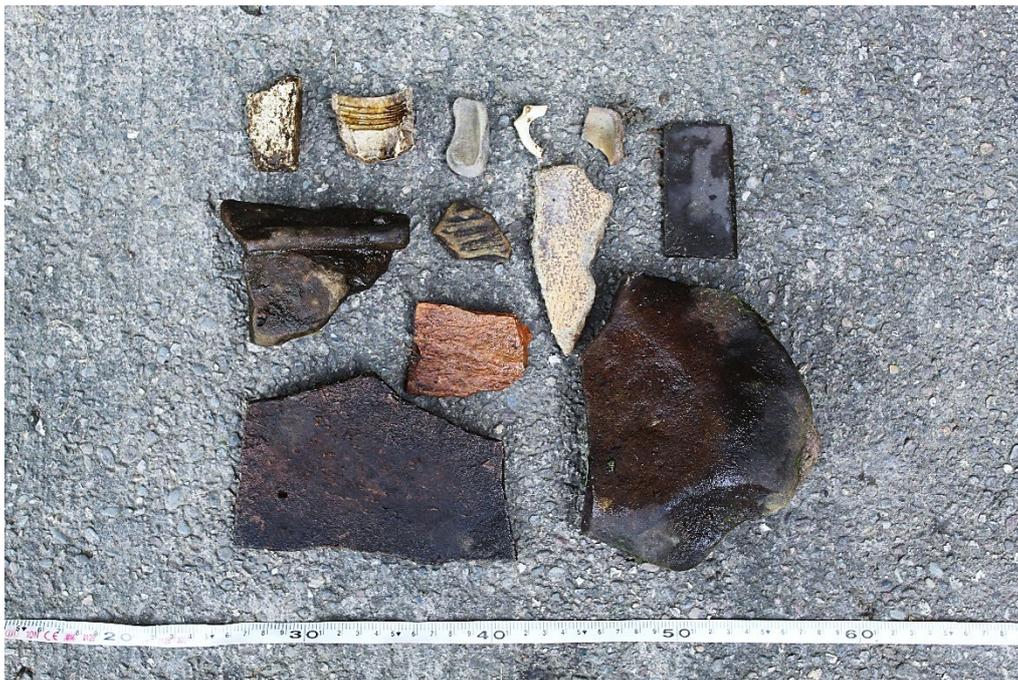
Plate 5: Selection of post-medieval pottery found in the Galey River.

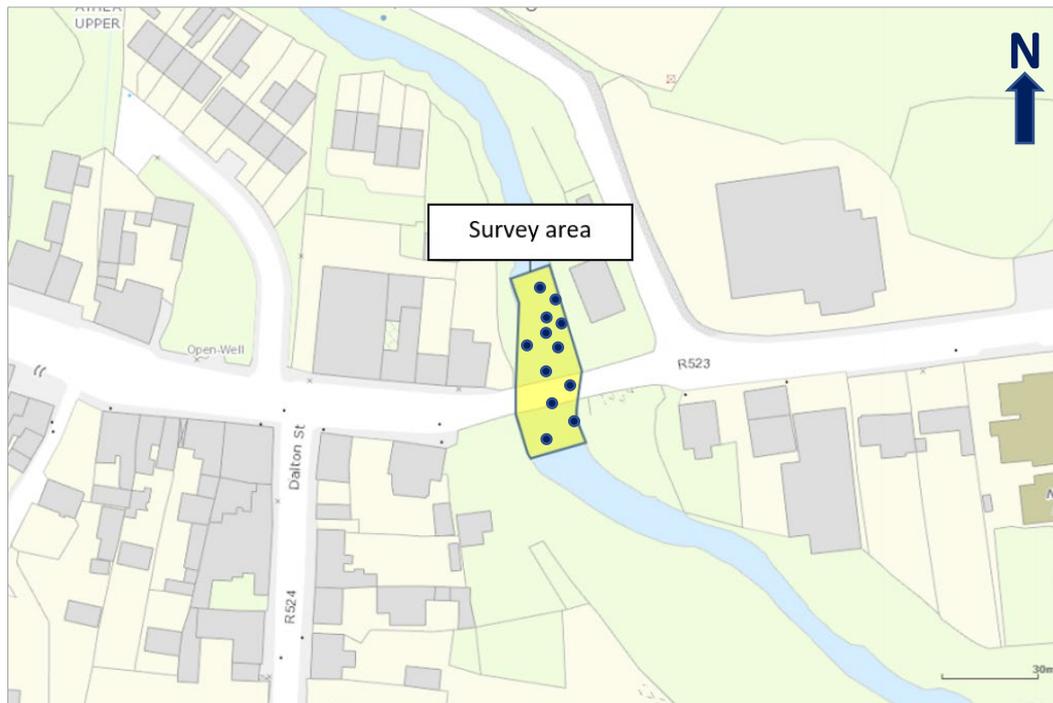
Figure 10 Approximate find locations of post-medieval pottery identified in survey area.

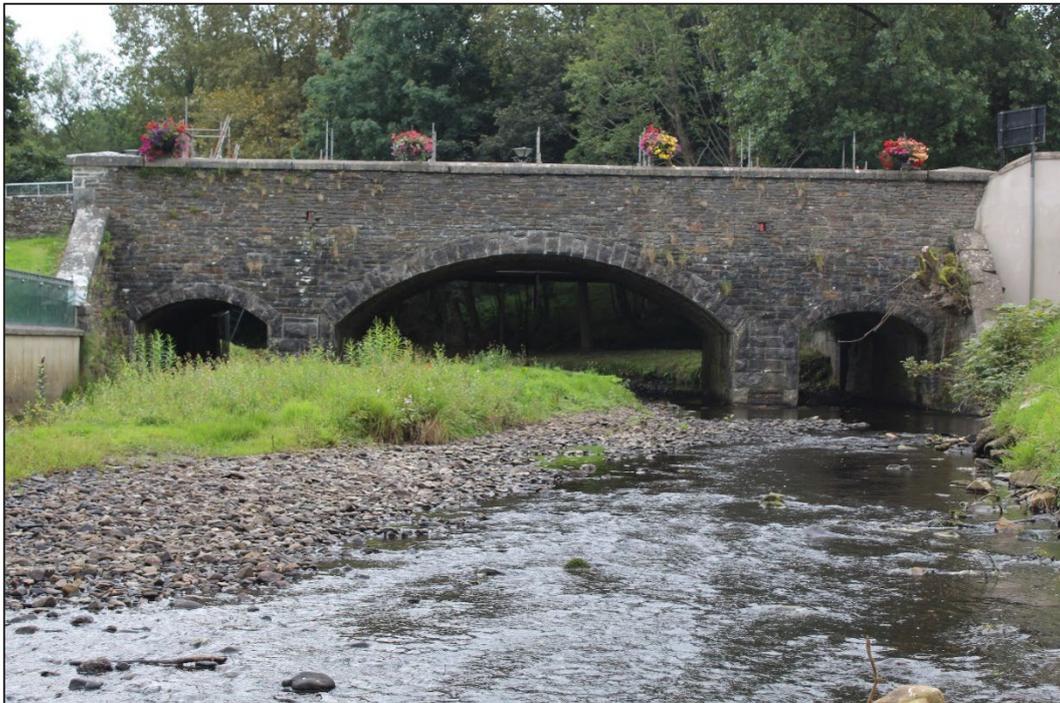
Athea Bridge carries the R523 roadway east to west over the River Galey. It is a triple span bridge with the central arch measuring 9.6m in width, and the side arches measuring 3.1m in width (Plate 6). The central arch-ring comprises 33 voussoirs of rusticated limestone, alternating in size between small (0.39m x 0.25m) and large (0.56m x 0.31m). The 13 voussoirs in the side arches are also of rusticated limestone, but alternate between a single large stone (0.39m x 0.25m) and two smaller stones (0.25m x 0.25m and 0.15m x 0.25m). The side arches have a rise of just 0.5m, springing from a level of 1.55m from the riverbed. The central arch has a rise of 1.5m.

Both elevations measure c.6m in height and 21.34m in width. The spandrels, piers, and parapet walls are all constructed of squared, rusticated sandstone not set to courses.

*Plate 6: View of Athea Bridge northern elevation, taken from the north.*

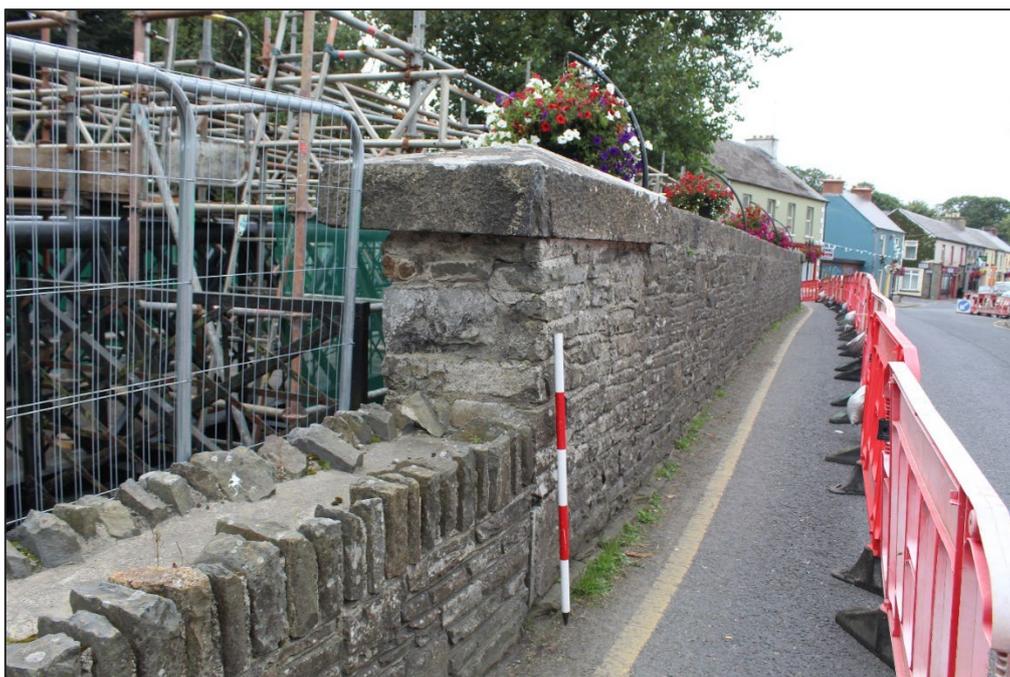
The parapet walls are 1.50m high, composed of sandstone with a flat, roughly dressed limestone coping and lime mortar bonding (Plate 7). The coping stones are 0.21m high x 1.02m long x 0.62m deep, while the stones of the parapet wall are between 0.03m x 0.09m and 0.20m x 0.28m. There are squat pyramidal terminus stones at the ends of the parapet coping, which measure 0.36m high x 1.76m long x 0.80m wide. The distance between the parapet walls is 6.75m. There are two stone drains, measuring 0.20m high x 0.15m wide in the base of the north parapet wall.

*Plate 7: Parapet wall of Athea Bridge, taken from east.*

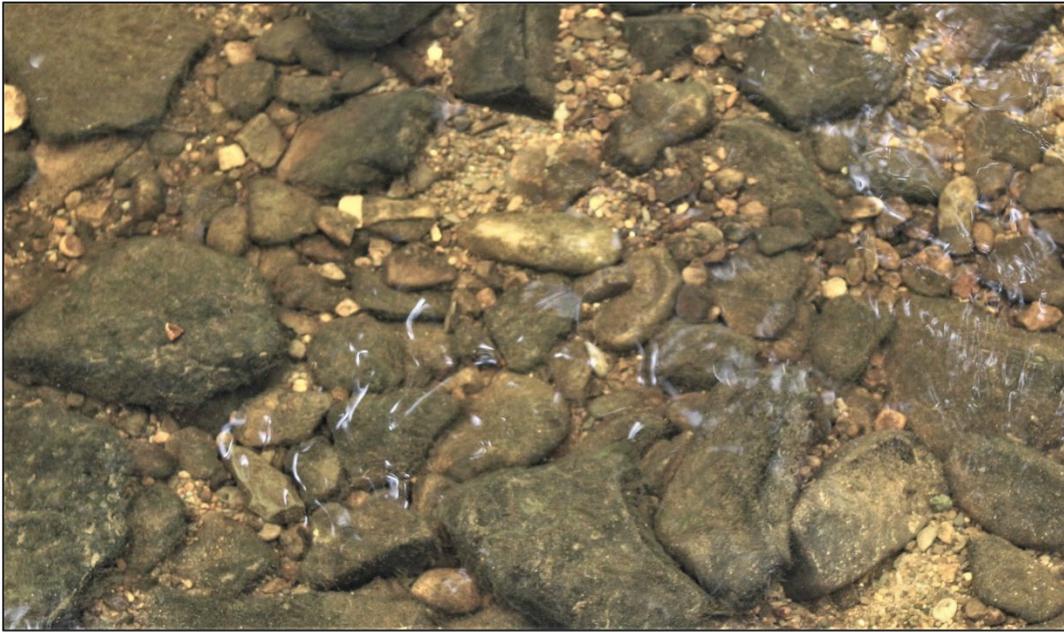
The riverbed throughout the survey area comprises silt mixed with cobbles (measuring from 0.08 x 0.05 x 0.03m to 0.48 x 0.22 x 0.10m) and gravels (Plate 8). At the time of the survey, a gravel bank barred the flow of water under the eastern arch and the eastern half of the central arch. The gravel bank upstream of the bridge is 16.15m long and 11.35m wide at a maximum. Downstream of the bridge, it extends for 32.20m and is a maximum of 11.37m wide. The downstream portion is also moderately vegetated.

*Plate 8: Riverbed composition of the Galey River at Athea Bridge.*
