20125-01-001 - Rev A

Quins Cross to Raheen Roundabout Cycle Scheme, Limerick

ROAD SAFETY AUDIT STAGE 1

November 2021

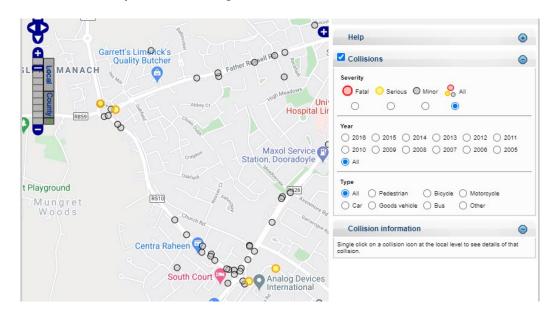
The collisions consisted of 15 minor injury collisions of which 3 involved pedestrians, 2 cyclists, 1 motor cycle and 9 cars. No serious or fatal injury collisions were recorded in that time period.

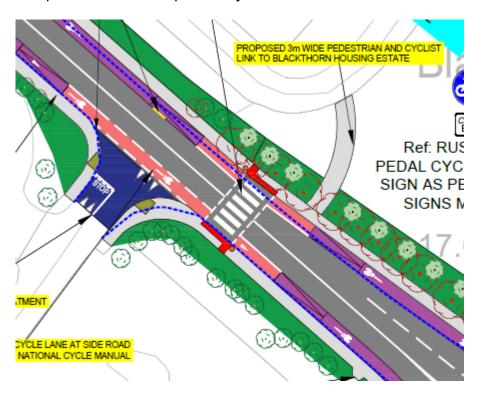
2.2 Problem

It is unclear how it is intended that cyclists on the proposed cycle link from Blackthorn Housing Estate can directly access the on-road cycle lanes where the pedestrian and cycle link meet the R519 Raheen Road. A lack of an adequate safe access point may result in conflicts at this location.

Layout should be revised to ensure cyclists have safe access to the proposed cycle facility.

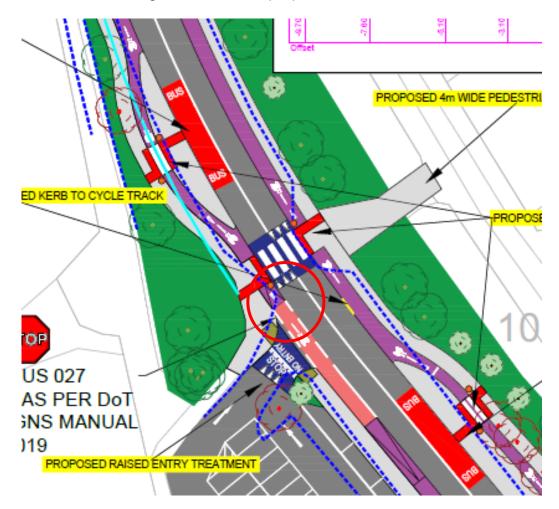
2.3 **Problem**

Visibility at the proposed exit from the existing parking area at the front of St. Nessan's National school may be restricted by vegetation and parked vehicles in the school car park to the southeast and buses stopped at the on-road bus stop to the northwest. A lack of adequate visibility may contribute to turning conflicts at the proposed exit.

Ensure that adequate visibility splays are provided at the proposed exit from the existing parking area at the front of St. Nessan's National school.

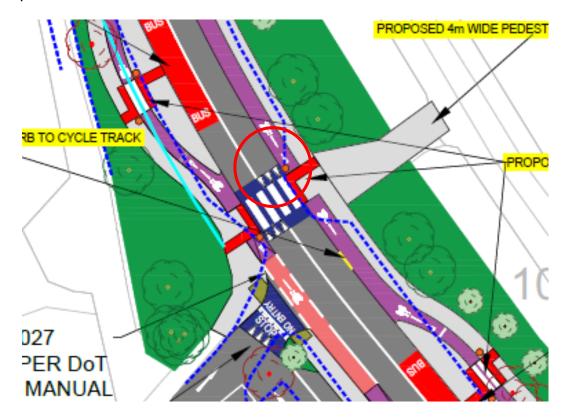
2.4 **Problem**

Inter-visibility between pedestrians crossing at the proposed pedestrian crossing and drivers of vehicles approaching the crossing may be restricted by buses stopped on the on-road bus stops on either side of the pedestrian crossing. A lack of adequate visibility splays may contribute to a pedestrian collision at this location.

Ensure that adequate inter-visibility splays are provided between pedestrians crossing at the proposed pedestrian crossing and drivers of vehicles approaching the crossing.

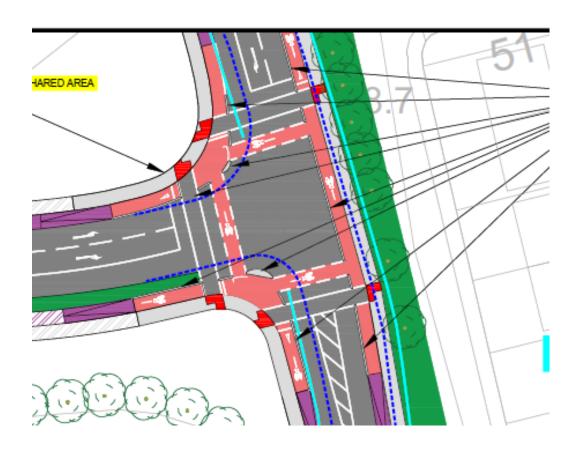
2.6 **Problem**

Details of the proposed signals and phasing has not been provided for the Mungret Gate junction. The layout of the cycle facilities coupled with inadequate signal and phasing design could lead to collisions between cyclists, pedestrians and vehicles.

Adequate signals and signal phasing design should be provided to ensure all users can navigate the junction safely.

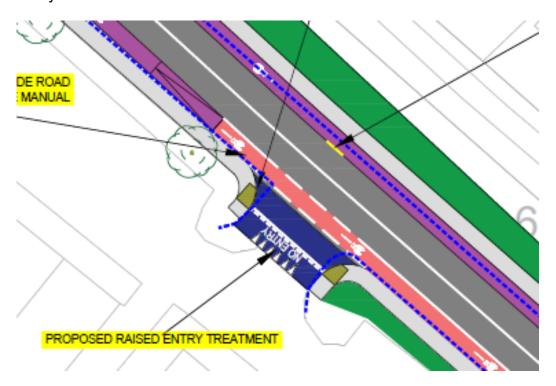
2.7 Problem

Drop kerb has been show opposite the Courtfield shopping centre exit. However, the extent of the dropped kerb is short and in line with vehicles wishing to exit to the left. Right turning cyclists would take up a position on the right of the exit to turn to the right. Cyclists would need to double back to enter the tight access point for the cycle facility. This may contribute to cyclist injury if struck by a vehicle when attempting to access the cycle facility.

Provide adequate cycle facilities at all priority T-junctions to allow cyclists to turn right.

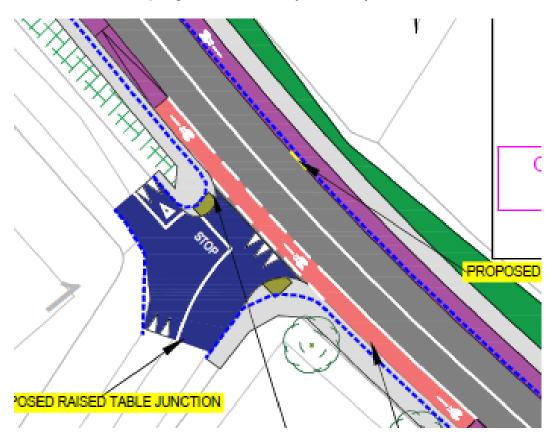
2.8 **Problem**

Drop kerbs have been shown opposite priority junctions throughout the scheme. However, the dropped kerbs appear short. This results in a tight angle that cyclists have to navigate to exit the carriageway quickly. This may contribute to cyclist injury due to loss of control or if struck by a vehicle when attempting to access the cycle facility.

Provide adequate cycle facilities at all priority T-junctions to allow cyclists to turn right.

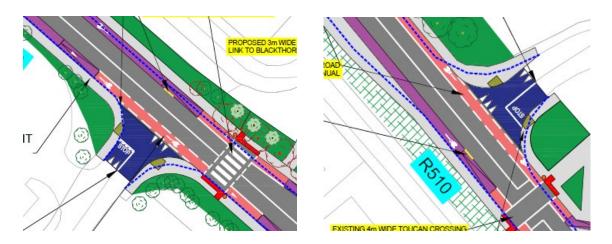
2.9 **Problem**

Drop kerbs have been shown opposite the priority junctions for Courtfield shopping centre and Chruch Road. However, the dropped kerbs appear short and are located on the cycle facility ramp. This results in a tight angle that cyclists have to navigate combined with an undesirable gradients in the surface at the cycle facility. Cyclists using the facility or wishing to access the facility at these locations could lose control increasing the risk of cyclist injury.

Provide adequate cycle facilities at all priority T-junctions to allow cyclists to turn right.

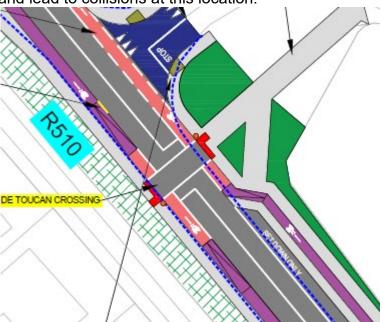
2.10 **Problem**

Belisha beacons as shown to be provided at the proposed toucan crossing adjacent to the junction with Church Road. The proposed belisha beacons are inconsistant with the proposed toucan crossing which could cause confusion and lead to collisions at this location.

Replace the belisha beacons with pedestrian signals at this location.

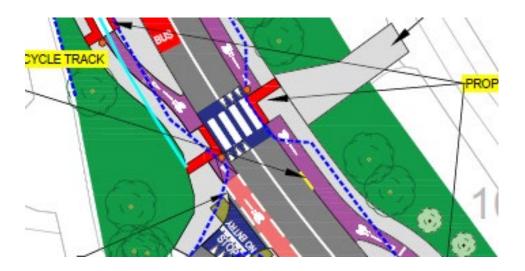
2.11 **Problem**

The cycle facility is shown to ramp up to footpath level at its intersection with the pedestrian crossing imediately north of St Nessans school on both sides of the road however corduroy hazard warning tactile has not been provided to warn users of the crossover between cyclists and pedestrians at these locations. This could increase the risk of cyclist / pedestrian collisions.

Adequate tactile paving should be provided to ensure all users are aware of the crossover between pedestrians and cyclists.

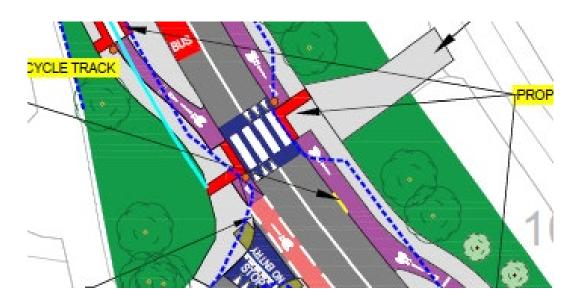
2.12 **Problem**

Proposed Belisha Beacons are located within the proposed cycle facility at its intersection with the pedestrian crossing imediately north of St Nessans school on both sides of the road. This may reduce the available width for cyclists which could increase the risk of cyclist collisions.

Belisha Beacons should be positioned to avoid any conflict with pedestrians or cyclists on the proposed cyclepaths and footpaths.
