**TUS Moylish to City Active Travel
Scheme**

Stage 1 Road Safety Audit

Document Ref: P21-103-RSA-PD-RP-001

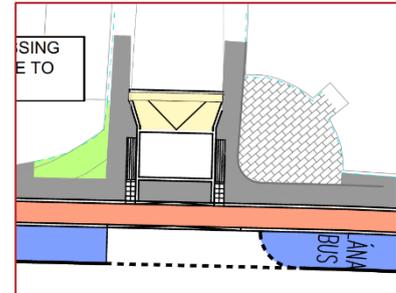
Location: General – Raised Table at Side Roads

Summary: Hazard tactile paving has been indicated at the edge of the footpath at raised table junctions which may lead to confusion for visually impaired pedestrians.

A raised table has been indicated at the majority of side road junctions within the proposed Scheme with the footpath indicated continuing across the top of the table and a ramp rising from the side road carriageway to tie into the raised table.

Corduroy hazard tactile paving has been indicated at the edge of the footpath on both sides of the side road adjacent the ramp. The Audit Team are concerned that the use of this type of paving in this location could mislead visually impaired pedestrians, into mistaking the raised table for a series of steps, resulting in unsafe entry to the side road carriageway and an increased risk of being struck by a vehicle.

The corduroy hazard tactile paving should be omitted.

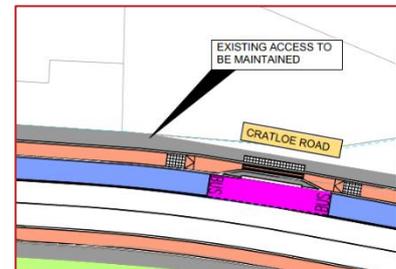
Location: General – Vehicular Accesses

Summary: The layout at vehicular accesses within the Scheme, where drivers are required to cross the footpath and cycle track, has not been indicated.

There are a number of existing vehicular accesses on both sides of Cratloe Road, for example at residential properties and at the Thomond Park Stadium, with some residential properties located in close proximity to each other, which would require drivers to cross the footpath and cycle track when entering/exiting these accesses. The proposed layout of these accesses has not been indicated and it is unclear how drivers will cross the raised cycle track, and subsequently the footpath, at these locations which may lead to material damage as vehicles travel over the raised kerbs.

Also, if it is required to lower and raise the footpath/cycle track, at residential properties there is a risk of discomfort for cyclists.

This is a particular concern for drivers of powered two-wheelers who may experience greater difficulty in traversing raised kerbs increasing the risk of loss of control collisions.

As the design progresses, a layout, which is safe for all road users, should be provided at vehicular accesses which require drivers to cross the footpath and cycle track.

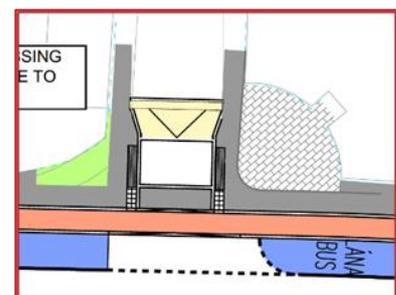
Location: General – Uncontrolled crossings at side roads

Summary: The tactile paving at uncontrolled pedestrian crossings at side road junctions is not of the required depth for this type of crossing.

Uncontrolled pedestrian crossings have been indicated across side roads at the majority of priority-controlled side road junctions within the Scheme. The depth of the tactile paving indicated at these crossings is not sufficient for an in-line crossing. This could lead to a visually impaired pedestrian inadvertently stepping over the tactile paving and entering the area shared with motorised vehicles where there is an increased risk of being struck by a vehicle.

Tactile paving at in-line pedestrian crossings should be a minimum of 1.2m (three rows of tactile paving) deep.

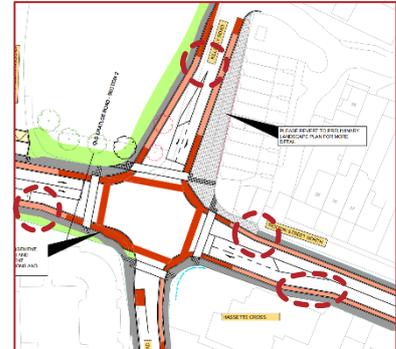
Location: General – Throughout the Scheme

Summary: The amended alignment of roads within the proposed Scheme result in a number of sudden changes in the kerb line which may lead to an increased risk of kerb strikes.

The provision of segregated cycle tracks on Cratloe Road and adjoining side roads within the Scheme results in amendments to the existing, and the provision of new, kerb lines.

The amended alignment of the roads within the Scheme, due to the new kerb lines, results in a number of locations where there are sudden, sharp, changes in direction of the kerb, which may lead to an increased risk of kerb strikes and material damage or loss of control type incidents and secondary collisions with other road users or items of roadside furniture.

The new, and revised, kerb line alignment should include smooth transitions at changes of direction in the horizontal alignment such that drivers are gradually guided through any change in direction, thus mitigating the potential for kerb strikes.

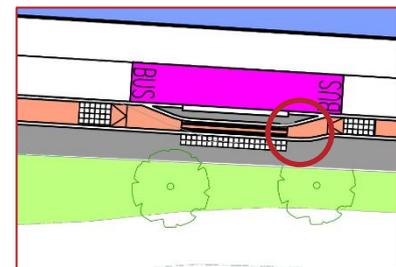
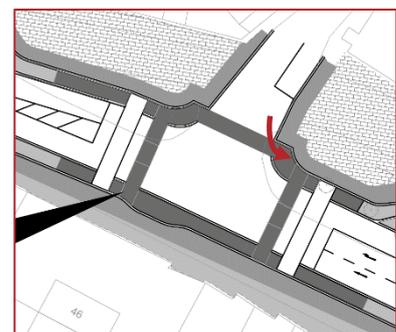
Location: General – Cycle track throughout the Scheme

Summary: Sharp changes in the cycle track alignment, combined with tight radius curves, may lead to an increased risk of loss of control type incidents.

There are some locations within the proposed cycle tracks throughout the Scheme that include sudden changes in the horizontal alignment, combined with short radius curves, including locations where cyclists turn left onto the cycle track at signalised junctions from side roads which do not provide segregated facilities, as this manoeuvre is likely to require cyclists to turn through 90°.

The combination of short radius curves and changes in direction could lead to cyclists, who are likely to approach these locations at higher speeds from relatively straight sections upstream, losing control of, and falling from their bicycle, resulting in personal injuries.

A more forgiving horizontal alignment should be provided within the cycle track with no sharp changes in direction or tight horizontal radii, ensuring cyclists can safely travel through horizontal curves within the cycle track alignment and can safely access/transition to the cycle track/lanes from adjacent side roads.

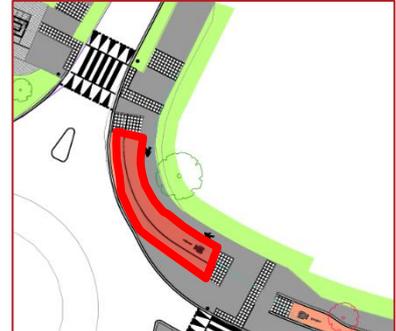
Location: Drawing 19-003-LCCC-CR-S2-0001 (Rev. P0.15)

Summary: Short section of segregated pedestrian and cycle facilities in the north-eastern quadrant of the Moylish Roundabout may increase the risk of a visually impaired pedestrian being struck by a cyclist when transitioning between the different surfaces.

Zebra crossings have been indicated on the northern and eastern arms of the Moylish Roundabout at the western extents of the Scheme. A shared surface is indicated at both crossings with the segregated pedestrian and cycle facilities terminating upstream of, and then recommencing downstream of, the crossing. This however results in a relatively short section of segregated footpath and cycle track in the north-eastern quadrant of the roundabout between the two crossings.

This will require visually impaired pedestrians to transition between shared and segregated facilities four times over a relatively short distance which may lead to confusion for visually impaired pedestrians and an increased risk of collisions with cyclists as they transition between the different surfaces.

A shared surface should be provided, in lieu of the segregated facilities indicated, between the Zebra crossings on the northern and eastern arms of the Moylish Roundabout commencing upstream of the crossing on the northern arm at the transition with the existing footpath and terminating downstream of the crossing on Cratloe Road at the transition with the proposed segregated footpath and cycle track.

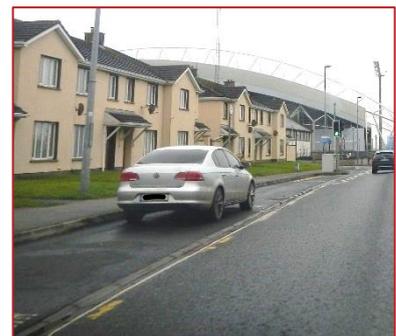
Location: Drawing 19-003-LCCC-CR-S2-0001 (Rev. P0.15)

During the Site Visit, the Audit Team noted on-street parking on Cratloe Road in front of the residential properties at Mayorstone Court. This parking is proposed to be removed as part of the Scheme to facilitate the proposed eastbound cycle track. It is unclear if the existing parking is public parking or exclusively for residents of the adjacent properties and, if residential, if alternative parking facilities will be provided for residents. A failure to provide alternative parking facilities for residents, close to their properties, could lead to residents parking within the cycle track or footpath resulting in obstacles for non-motorised road users, particularly the visually impaired and wheelchair users, resulting in the risk of pedestrians/cyclists entering the adjacent cycle track/carrageaway where there is an increased risk of pedestrian-cyclist, or vehicle-cyclist, collisions.

If parking is required for residents at this location, ensure alternative parking facilities are provided nearby.

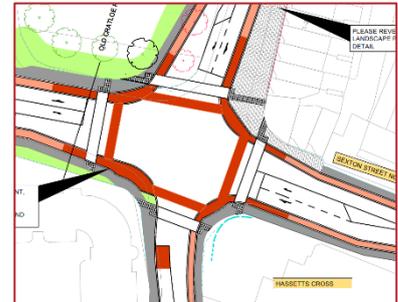
3.10 Problem

Location: Drawings 19-003-LCCC-CR-S2-0002 (Rev. P0.07) & 19-003-LCCC-CR-S2-0004 (Rev. P0.13)

The width of the pedestrian crossings at signalised junctions within the Scheme should be increased in accordance with the DMURS which recommends a minimum width of 4m for pedestrian crossings in busy urban areas.

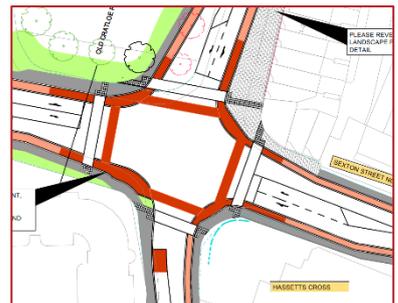
3.11 Problem

Location: Drawings 19-003-LCCC-CR-S2-0002 (Rev. P0.07) & 19-003-LCCC-CR-S2-0004 (Rev. P0.13)

Similarly, should cyclists be permitted to proceed, but their dedicated signal head not given a green signal, they may be insufficiently aware that the vehicular signal head is also intended for them resulting in them failing to proceed and being at an increased risk of being struck by a vehicle.

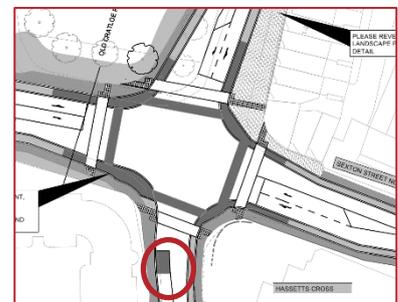
Segregated cycle facilities have been indicated on the majority of arms at signalised junctions within the Scheme with the exception of Shelbourne Road and Cross Road where an advance stop line and no facilities have been indicated respectively. Protected cycle lanes, via the provision of kerbs within the corner radii, are proposed at the signalised junctions.

At this early stage in the design, information regarding the proposed signal phasing at the junctions has not been provided and it is therefore unclear if cyclists will receive separate cyclist phases within the signal cycle. If separate phases are to be provided for cyclists, it is unclear if cyclists on Shelbourne Road and Cross Road will be permitted to proceed with vehicular traffic should their corresponding cycle signal head be red during vehicular phases on these arms. If not, stationary cyclists in the advance stop line, or within the carriageway on Cross Road, will be at risk of being struck by a vehicle.

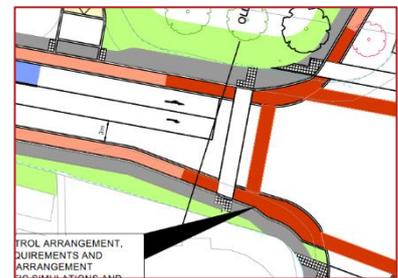
The eastbound traffic lane on Cratloe Road develops into the right-turn lane at its junction with Shelbourne Road & Kileely Road with the bus lane terminating upstream of the junction to allow straight-ahead and left-turn movements from the nearside lane. Drivers in the eastbound lane, wishing to continue straight through the junction, may be insufficiently aware of the need to change lane on approach to the junction leading to sudden lane changing manoeuvres upstream of the junction resulting in side swipe collisions.

The Audit Team acknowledge that further design is required regarding turning lanes at signalised junctions following traffic modelling however, should the lane configuration indicated be retained, drivers should be clearly advised of the correct lane to enter for their intended destination in good advance of the junction such that they have time to take in the information and undertake safe lane changing manoeuvres upstream of the stop line.

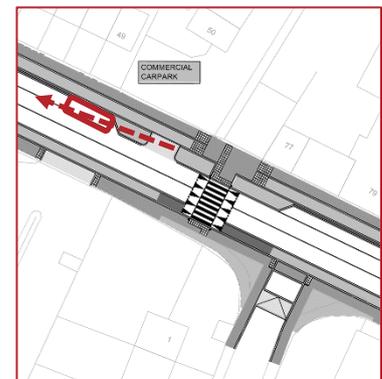
Should the on-street parking spaces at this location be occupied there is a risk that a parked vehicle may be located within the visibility splay of a driver exiting the Commercial Carpark. This could lead to an exiting driver's visibility to the west being restricted leading to them exiting onto Cratloe Road when it is unsafe to do so resulting in side-on collisions.

Ensure parked vehicles at this location do not restrict a driver's visibility to the west when exiting the Commercial Carpark. If the parking is determined to be within an exiting driver's visibility splay the section of parking within the visibility splay should be omitted.

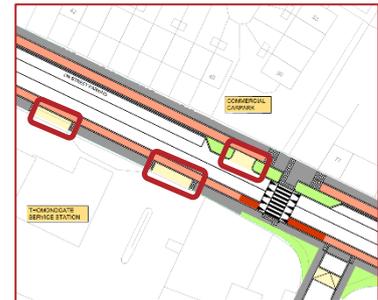
Raised tables have been indicated at the accesses to the Commercial Carpark and the Thomondgate Service Station on the northern and southern sides of Cratloe Road respectively to the west of the side road junction with Stenson Park. Ramps have not been indicated at any of these accesses and it is therefore unclear how the carriageway on Cratloe Road, and the internal carriageway within the carpark and service station will tie-into the proposed ramps. If the transition between the ramps and carriageway on either side of the ramps is too sudden there is a risk of drivers having to traverse a steep gradient/level difference which may lead to difficulties particularly for drivers of powered two wheelers.

Additionally, the footpath across all accesses is indicated as discontinuous with priority afforded to vehicles entering/exiting the accesses which is inconsistent with the layout at other side road junctions within the Scheme.

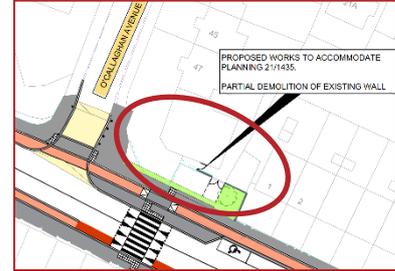
The existing loading bay on the northern side of Sexton Street North, which is associated with an existing shop premises on the corner of the junction with O'Callaghan Avenue, has been indicated as being removed as part of the proposed Scheme. The Audit Team have been advised that alternative arrangements have been agreed with the shop owner regarding deliveries to the shop, which is proposed to be extended as part of a current planning application. The arrangement will involve delivery vehicles now entering the shop site from the existing vehicular access on O'Callaghan Avenue and unloading items within the extended section of the site, proposed as part of the planning application.

Information regarding the swept path of vehicles using the access (delivery vehicles, refuse vehicles etc.), turning within the site and exiting the access has not been provided, and it is unclear if these vehicles will have sufficient space within the site to turn around, possibly leading to lengthy reversing manoeuvres which can present a hazard to other road users.

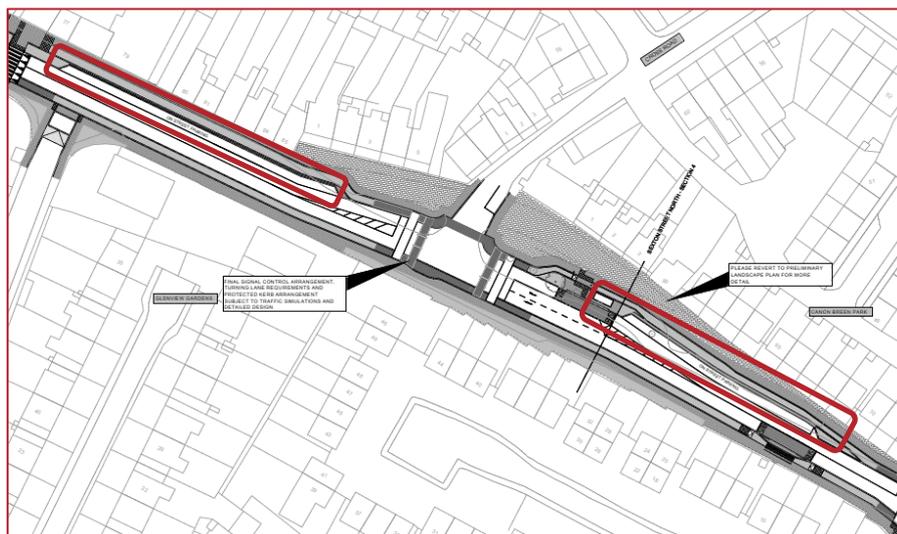
Summary: It is unclear if there will be a sufficient buffer between the on-street parking on the northern side of Cratloe Road and the adjacent eastbound cycle track.

On-street parking has been indicated at some locations on both sides of Cratloe Road within the proposed Scheme. While a kerbed buffer zone has been indicated at some locations between the on-street parking and the adjacent cycle track it is unclear from the drawing provided if a buffer zone is proposed between the parking and cycle track on the northern side of Cratloe Road to the east and west of its junction with Cross Road. If a sufficient buffer zone is not provided between the parking and adjacent cycle track there is a risk of a vehicle door being opened into the path of a cyclist resulting in collisions.

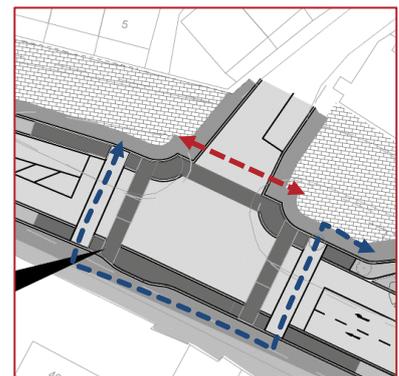
A pedestrian crossing has not been indicated across Cross Road at the signalised junction with Cratloe Road. It is unlikely that pedestrians on the northern side of Cratloe Road will take the lengthy route via the crossings indicated to continue east on Cratloe Road and instead take the shortest route across Cross Road. This could lead to pedestrians crossing the carriageway during red pedestrian phases at the junction when drivers may be less attentive to them resulting in an increased risk of vehicle-pedestrian collisions.

A pedestrian crossing should be provided across Cross Road and incorporated into the signal cycle at the junction.

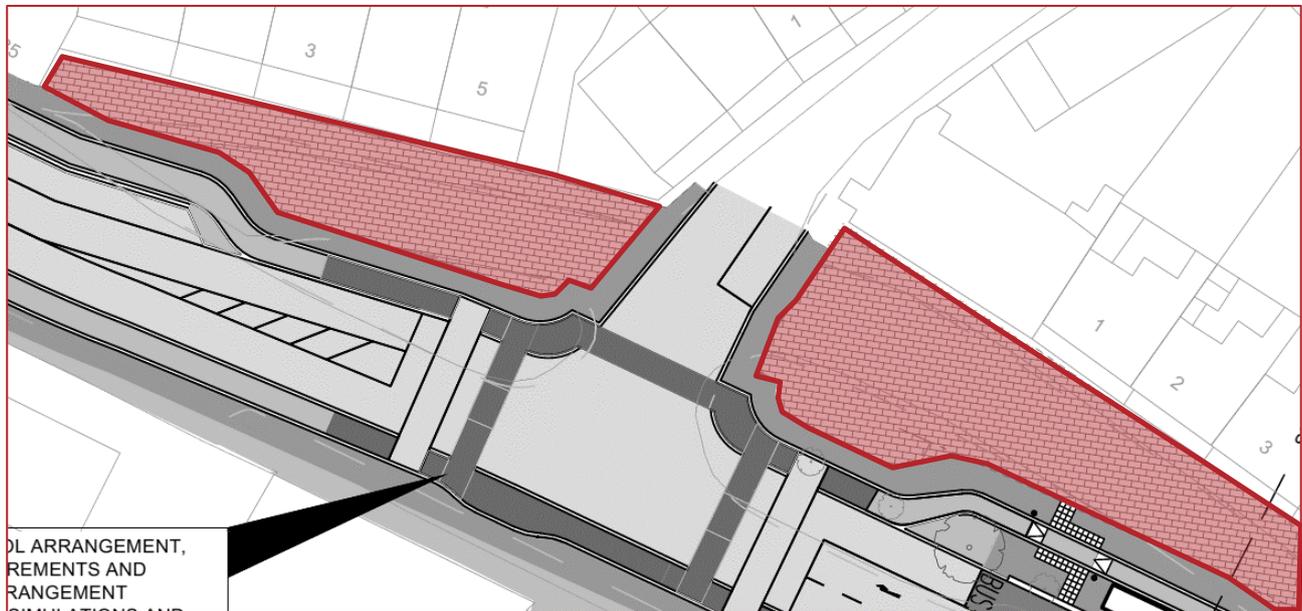
Summary: There is a risk of collisions between vehicles and visually impaired pedestrians within the paved areas in front of the residential properties on both sides of Cross Road at its signalised junction with Cratloe Road.

The existing side roads at Hibernian Villas and An Bóthar Ard, on either side of Cross Road adjacent its junction with Cratloe Road, are proposed to be closed up and paved with a material different to that of the adjacent footpath. These existing roads currently permit access for vehicles to park at the residential properties at these locations. It is unclear if vehicular access will be maintained from Cross Road to these locations to continue to permit residents to park their vehicles here. It is also unclear if these areas will be at the same level as the adjacent footpaths or if a means of segregation/delineation is proposed. If vehicular access is to be maintained to these areas, and sufficient delineation not provided between the footpath and adjacent shared surfaces, there is a risk of visually impaired pedestrians inadvertently entering the shared surfaces where there is an increased risk of being struck by a vehicle.

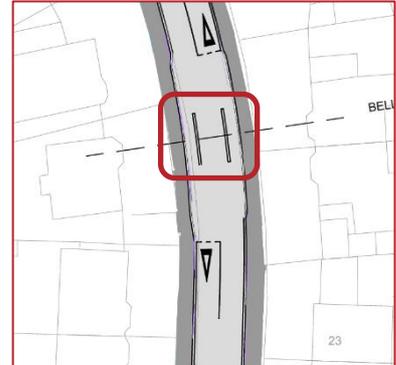
These kerbs are indicated as having an upstand of 125mm. Drivers approaching the chicane may be insufficiently aware of the kerbs, particularly during the hours of darkness, leading to an increased risk of wheels striking kerbs, or to vehicles with low bodies colliding with the kerbs, resulting in material damage.

Measures should be provided to increase a driver's awareness of the kerbs at the proposed chicane on Bellefield Gardens.

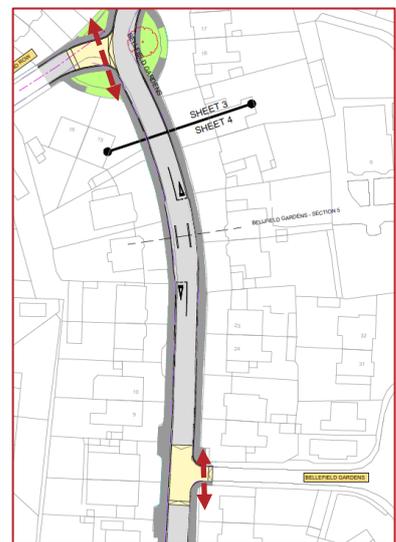
Additionally, a failure to provide crossing points with dropped kerbs may lead to difficulties for mobility impaired pedestrians, particularly wheelchair users, when crossing the carriageway resulting in a risk of trips and falls should they have to descend/ascend full height kerbs.

Pedestrian crossings, including dropped kerbs and associated tactile paving, should be provided at the side roads on Bellefield Road and Bellefield Gardens.

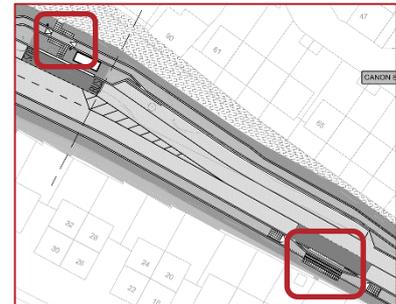
- 4.2 Zebra crossing road markings have not been indicated at crossings of the cycle track where the tactile paving for a controlled crossing has been indicated yet have been indicated at crossings where tactile paving for an uncontrolled crossing is indicated.

This could lead to confusion for visually impaired pedestrians regarding what type of crossing is provided resulting in them being unable to safely and independently navigate the road layout.

Tactile paving at controlled crossings (i.e. Zebra, Pelican, Puffin, Toucan etc.) should be 'L-shaped' and red in colour with the stem located on the right-hand side while tactile paving at uncontrolled pedestrian crossings should be buff in colour and of a sufficient depth for the type of crossing provided (i.e. in-line or inset).

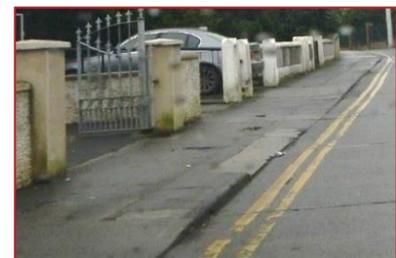
- 4.4 During the Site Visit, the Audit Team noted that the existing footpaths on Bellefield Road and Bellefield Gardens at some locations were in poor condition.

It is assumed that the Scheme will include renewal of the existing footpaths at these locations. A failure to upgrade the footpath at these locations may increase the risk of trips and falls.

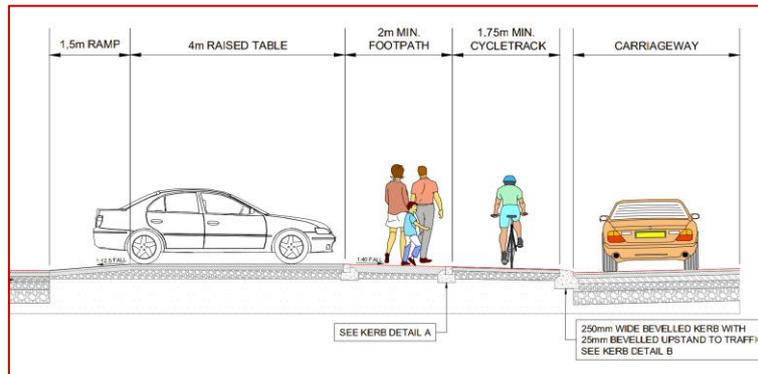
4.5 The cross-section of the proposed raised-table arrangement at side roads within the Scheme shows the footpath and cycle track on the same level as the proposed raised-tables.

However, the plan drawings do not indicate any change in level within the cycle tracks on the approach to the raised-table.

While the proposed arrangement is unlikely to give rise to a safety issue, it may be preferable to maintain a level difference between the pedestrian and cyclist areas of the raised-table in order to deter inadvertent straying into the adjacent area by pedestrians and/or cyclists, and to improve a side-road driver's awareness of the crossing.

To this end, a level difference of 25mm minimum could be provided between the footpath and the cycle track and between the footpath and side road carriageway to improve the definition and conspicuity of the footpath across the side road.
