APPROPRIATE ASSESMENT

This document relates to the Appropriate Assessment process undertaken for proposed bridge repairs on Galbally Bridge, Mandeville Park, Moorabbey, Co. Tipperary

Project: Proposed bridge repairs on Galbally Bridge, Mandeville Park, Moorabbey, Co. Tipperary

Document: Appropriate Assessment

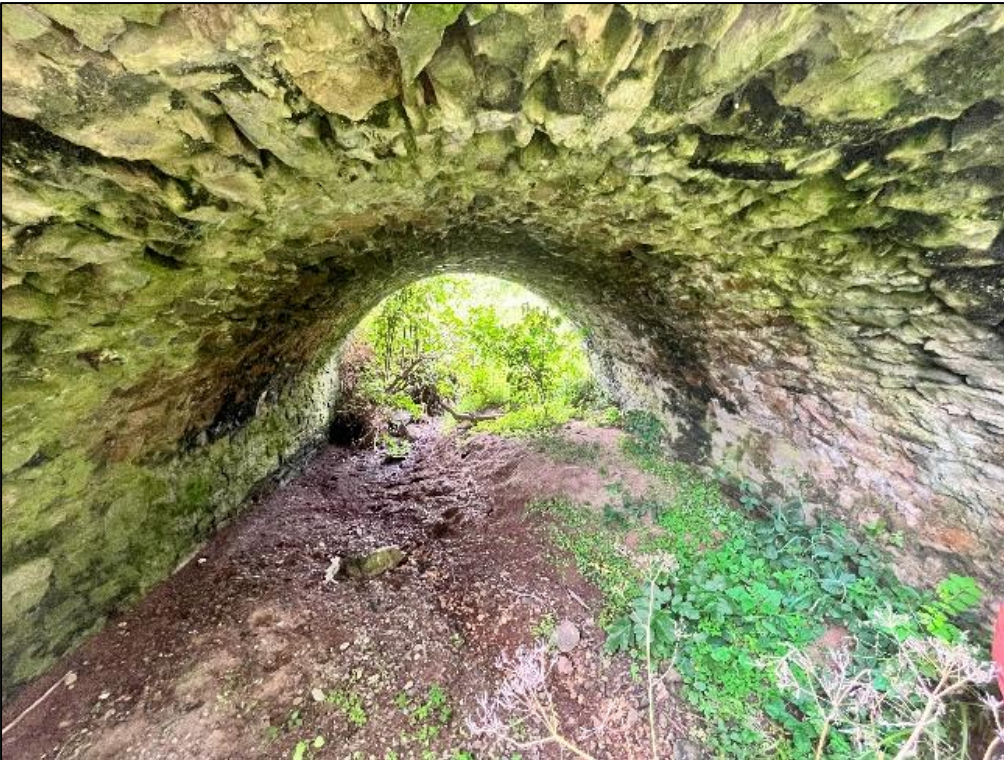
Similarly to 2024 arch 4 (south end of bridge) was a dry arch with no river flow present (*Image 2-1*) and arch 1 to 3 had a moderate to fast river flow passing beneath. Arch 4 had a mostly dry earth floor with little vegetation throughout. These conditions were favourable to complete a footprint and general activity assessment of under the bridge. The majority of the tracks identified were rodent and bird tracks. Some larger mammal footprints were present however they appeared aged and disturbed making them unidentifiable (*Image 2-2*). A trial camera was deployed at this under this arch in a position that allowed the images to capture the full width of the arch.

Image 2-1 – Arch 4, south arch of bridge

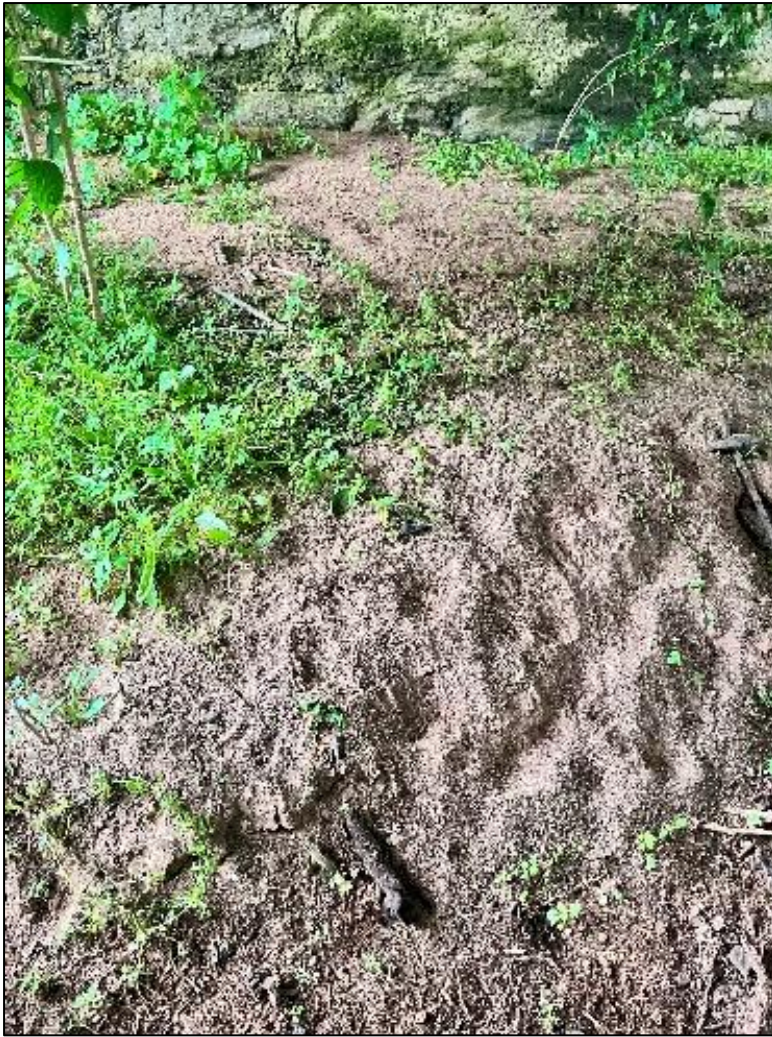
Image 2-2 – Unidentifiable prints under arch 4 of bridge

Site	Date	Findings	Sign found	Notes
Arch 4 - Dry Arch	18-Jul	Visual check on prints under arch - Rodent and unidentified (aged) mammal tracks only	None	
Bridge	18-Jul	Tracks present under dry arch however they appeared aged and deformed making them unable to confirm if they are otter prints.	None	Additional tracks identified - Bird and rodent prints only
Upstream bank	18-Jul	Territorial sprainting identified approx. 110m upstream. Light staining of rocks and vegetation. Appeared to not be used often.	Spraint	Likely to be insignificant with respect to otter presence at the bridge
Downstream bank	18-Jul	Spraint identified approx. 125m downstream, appeared aged. Second spraint identified approx. 160m downstream, appeared fresh.	Spraint	Likely to be insignificant with respect to otter presence at the bridge
Arch 4 - Dry Arch	05-Aug	Visual check on prints under arch - Dry soil surface disturbed, assumed to be dogs, rodent and bird tracks present	None	Prints confirmed on trial cam

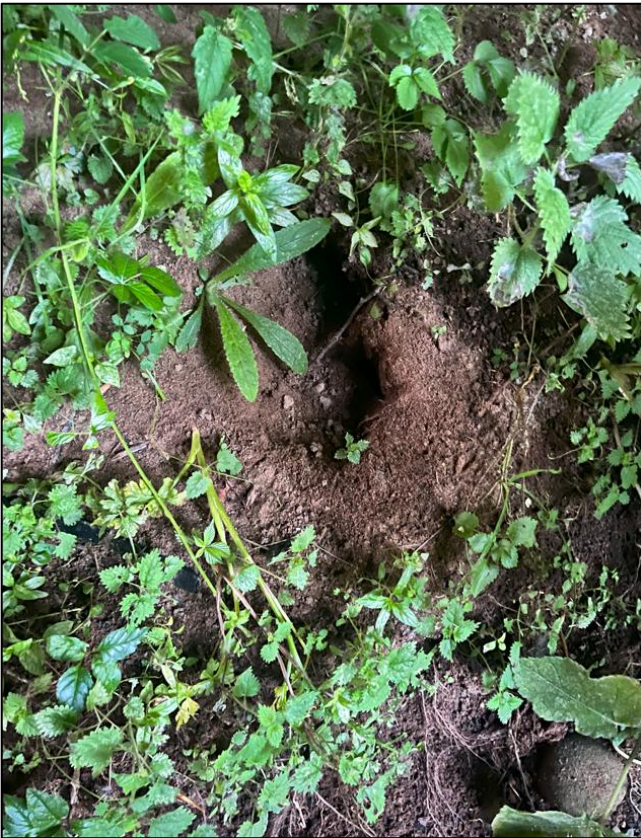
Image 2-3 – Arch 4 – Survey 2, south arch of bridge, light digging/rooting

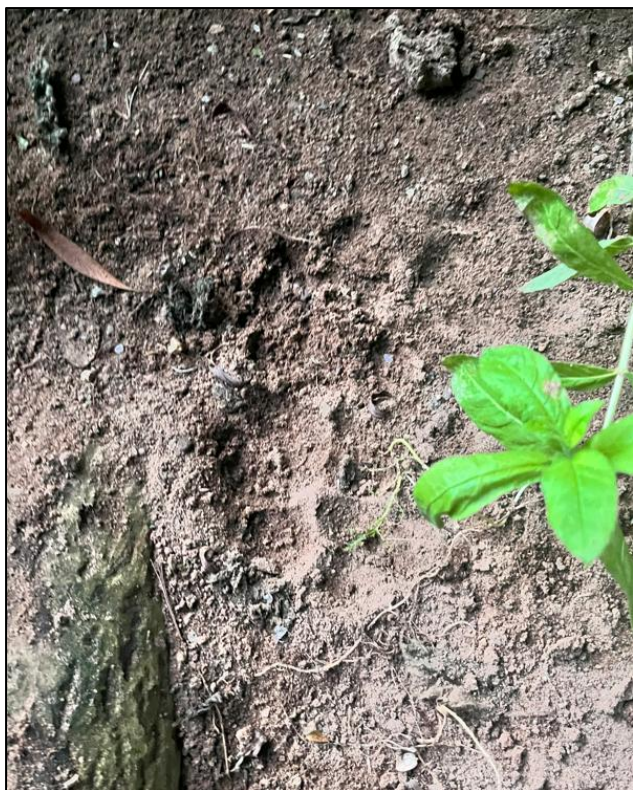
Image 2-4 – Survey 2 – Dog prints under arch 4 of bridge

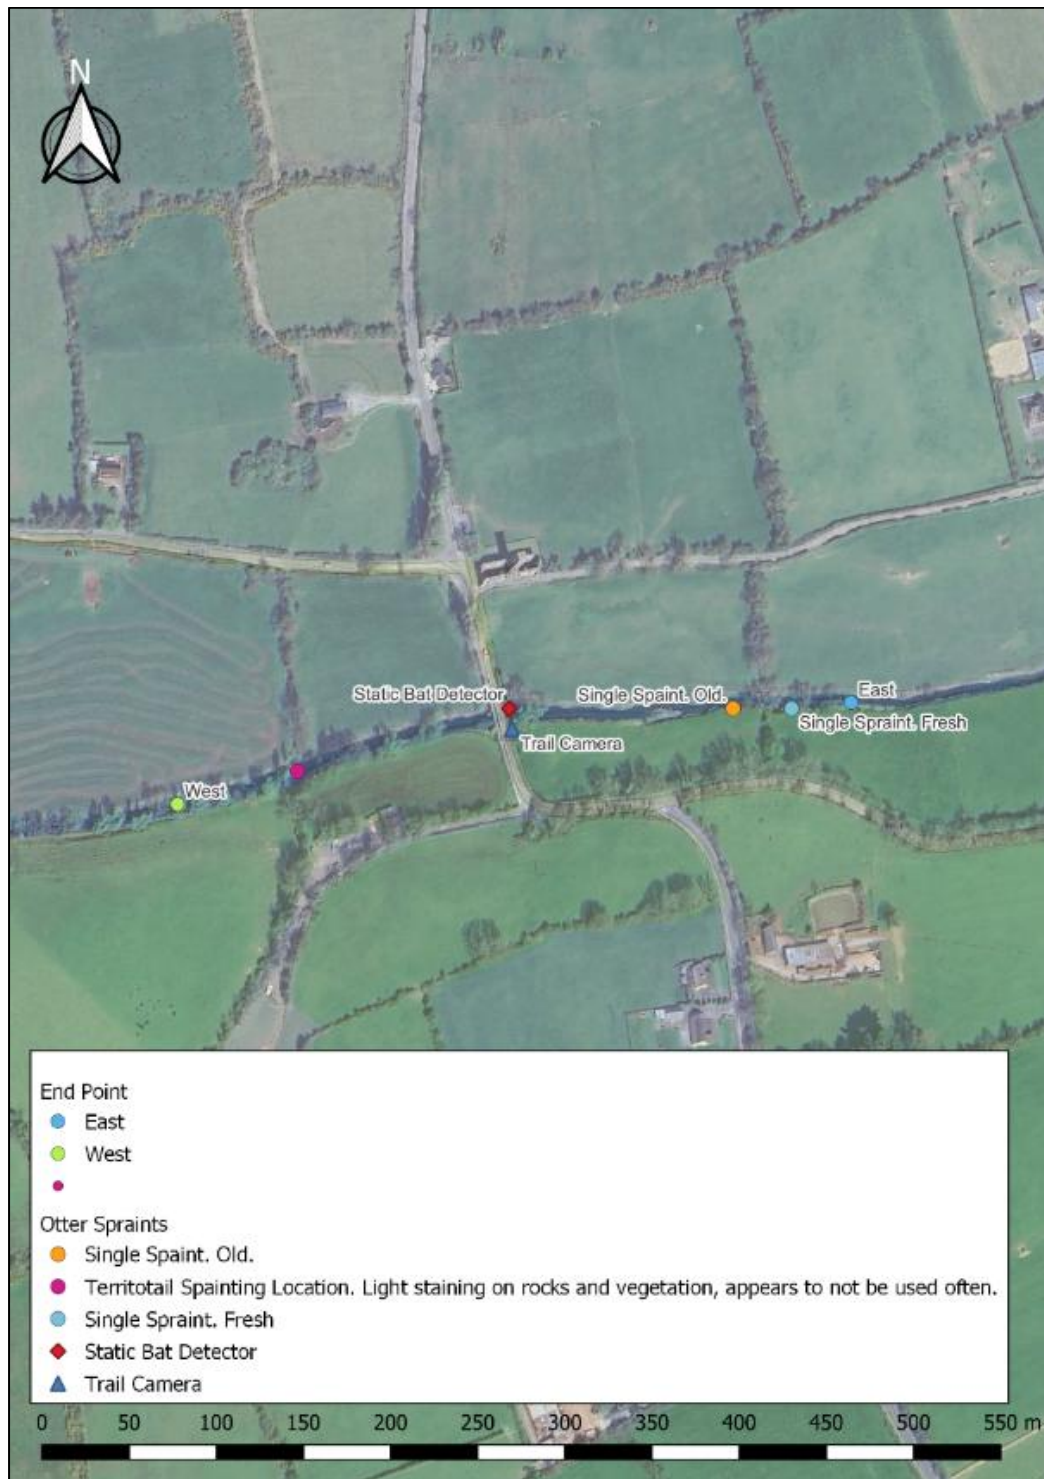
Map 2-5 - Galbally Bridge Otter survey finding's locations

A series of dedicated otter field surveys along the river corridor completed in 2024 and 2025 indicate that Galbally Bridge is not regularly used by otters. This conclusion is based on the absence of key indicators such as holts, couches, active resting sites, and spraints within the survey area. While occasional transient use is certain, the lack of physical evidence suggests the site is of low importance for otter activity at present.

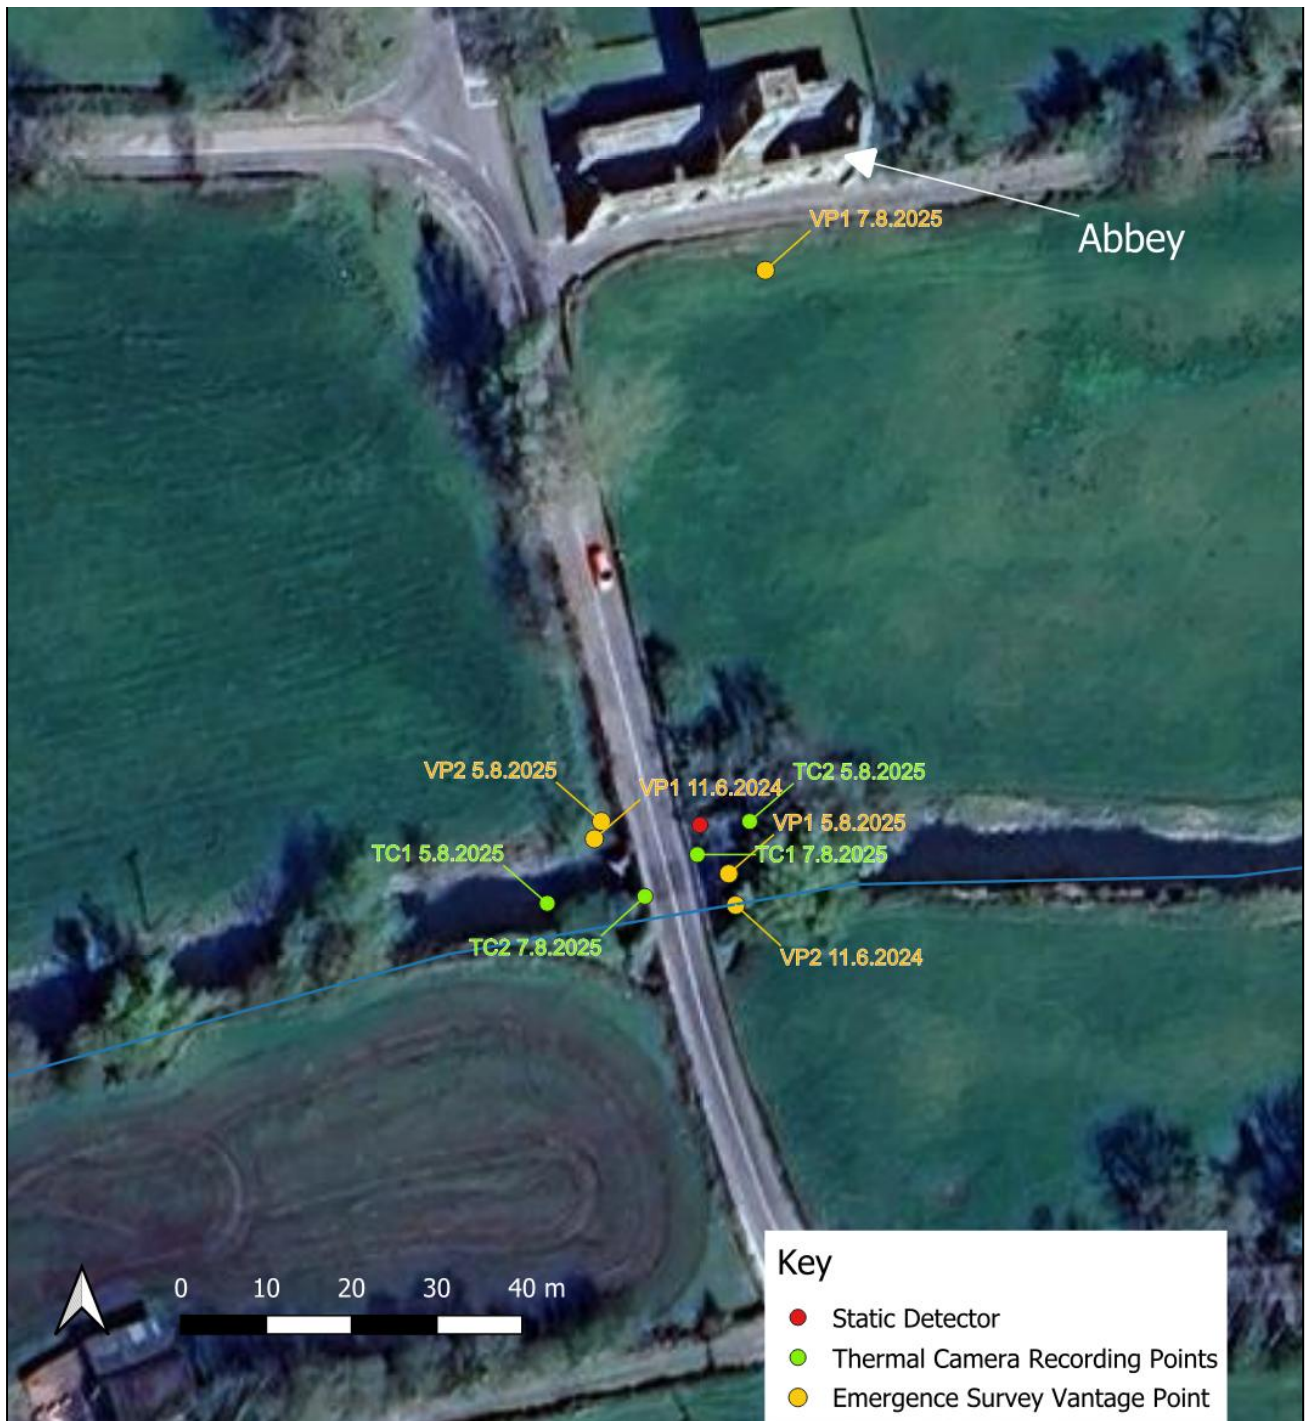
Image 2-8 - Map of the particulars of the bat survey

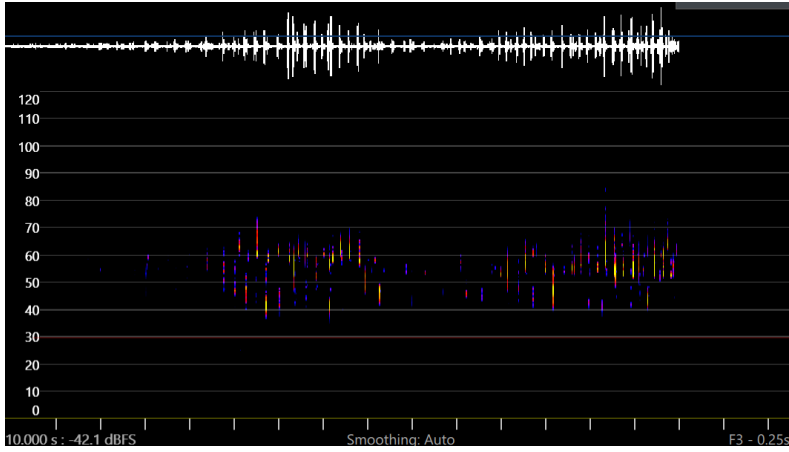
Image 2-8 - Daubenton's bat call sonograph detected on 07/08/25

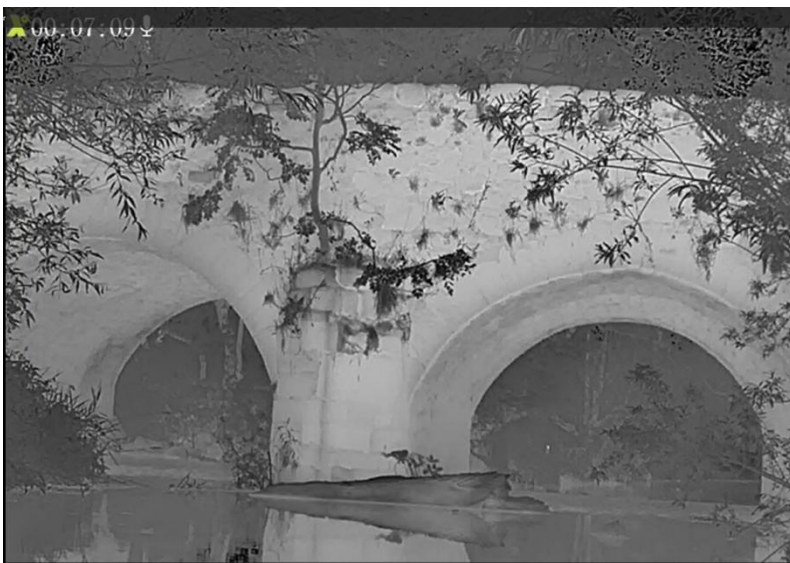
Image 2-9 - Model Pixfra A613 #1 vantage point 05/08/25

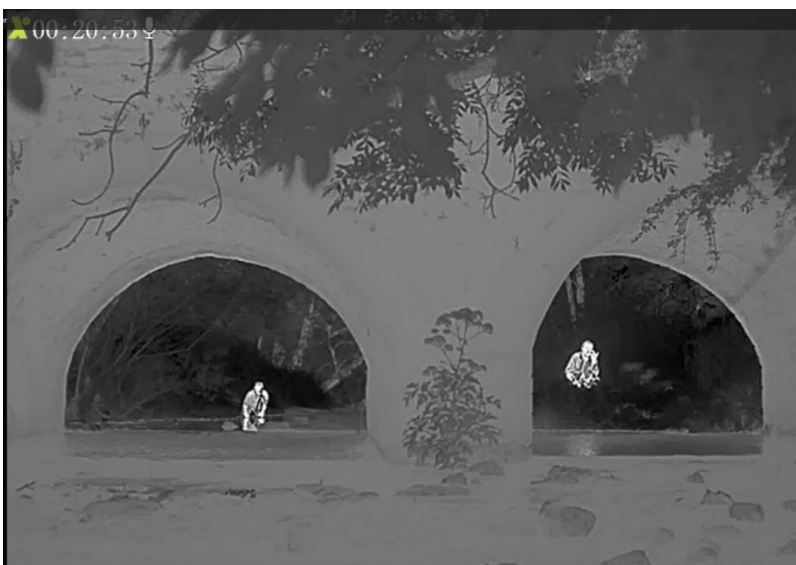
Image 2-10 - Model Pixfra A613 #2 vantage point 05/08/25

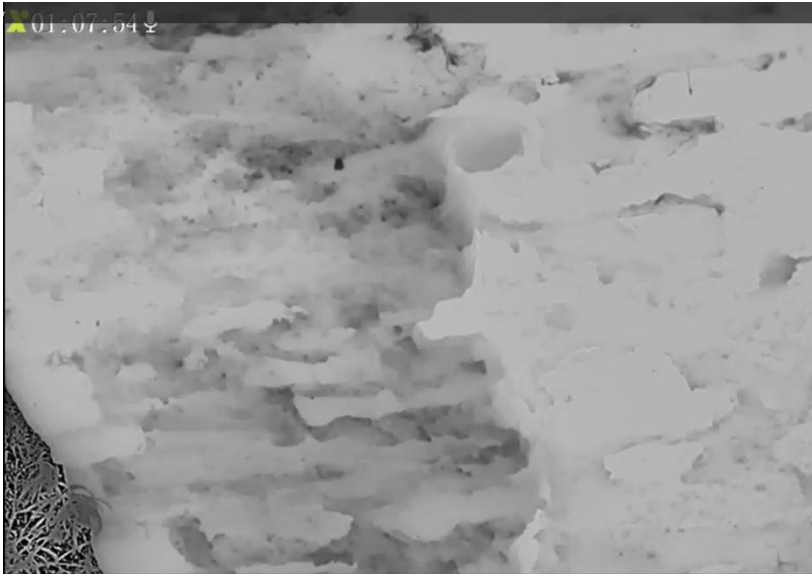
Image 2-11 - Model Pixfra A613 #1 vantage point 07/08/25

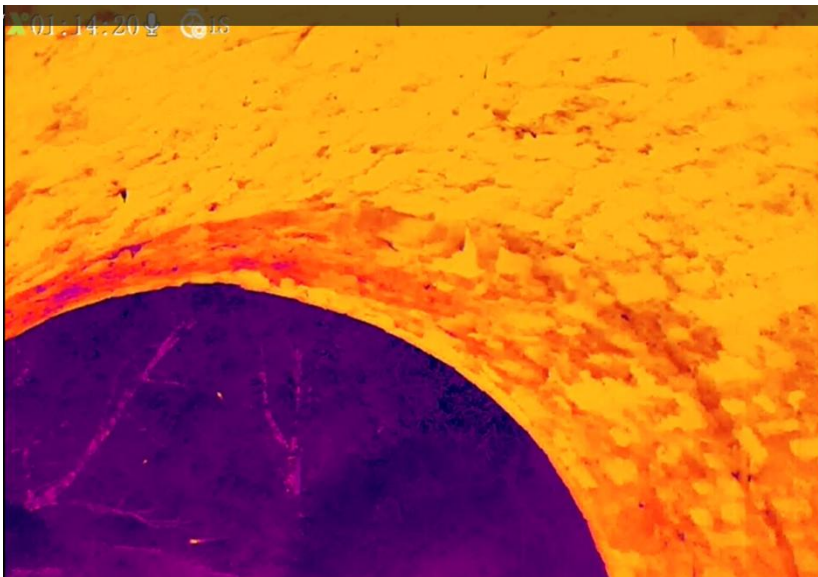
Image 2-12 - Model Pixfra A613 #2 vantage point 07/08/25

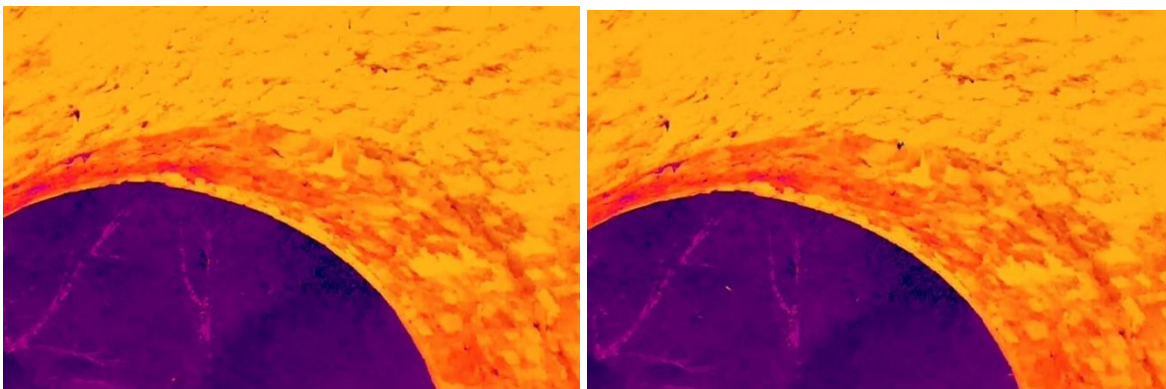
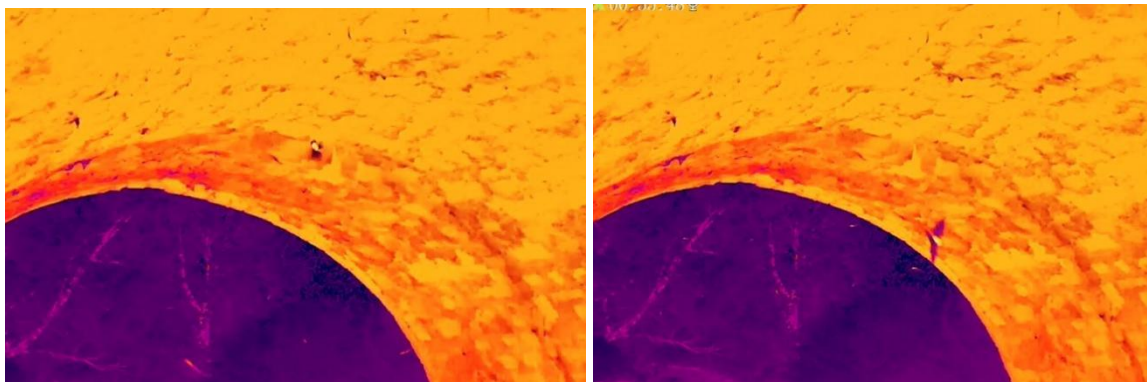
Images 2-13 - Series of images identifying the moment a bat re-emerges from a cervice on arch 2 - 07/08/25

Only one structural crevice, located on the underside of arch 2, was observed being used by a bat. A single bat was recorded entering this crevice and emerging 14 minutes later. The bat entered the crevice during a foraging session, perhaps to feed or to rest, and then left again. No other crevices or cracks assessed during the surveys were observed to be used for entry or emergence by bats.

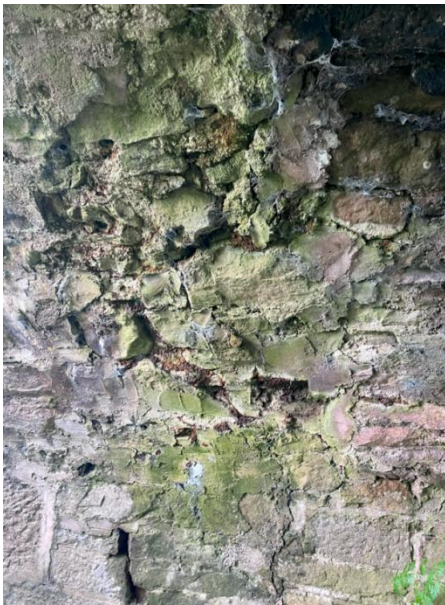
Image 3-2. Cracks, holes and deteriorating stone and mortar on the underside of one of the arches.

The bridge piers, abutments and the undersides of all four arches, have radial and vertical cracks present. Some cracks have associated stone and/or mortar loss (See *Image 3-2*, *Image 3-3* and *Image 3-4*). The parapets have various location of small holes and dislodged mortar. Both upstream and downstream abutments have vegetation growing on them including one 2.5m tree growing on top of one cutwater (*Image 3-5*). Further deterioration to the bridge structure, will eventually result in a structure failure where it will be both unusable and unsafe to the general public and users.

- In order to repair the bridge cracks, holes and dislodged mortar within the arch barrels stainless steel stitching will be inserted through the voussoirs in the arch and connected to the intrados, after a high strength cement/grout mix will be used. It will be sprayed under high pressure into the cracks. All other cracks will then be pointed.
- The piers foundations will be underpinned and grouted.
- All spandrel and parapet walls will be repointed.
- Tie bars will be inserted into each arch, there will be two in each arch.
- Vegetation removal on each elevation.
- The riverbed will be strengthened with stonework and rock armour.

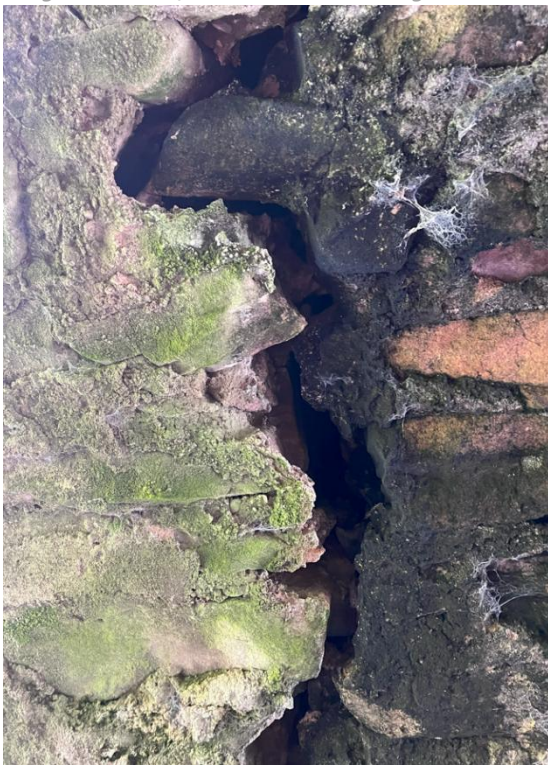
Image 3-3. A large crack present on the underside of one of the arches.

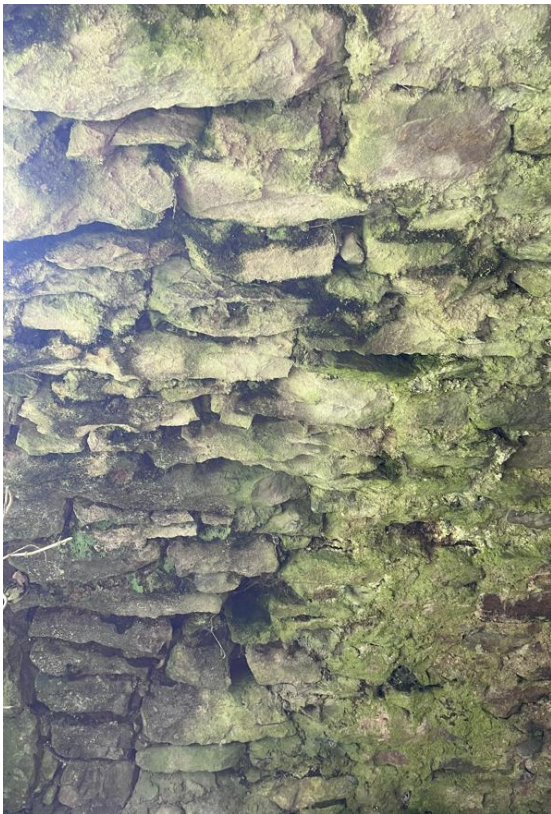
Image 3-4. Cracks, holes and dislodged mortar on the underside of one of the arches.

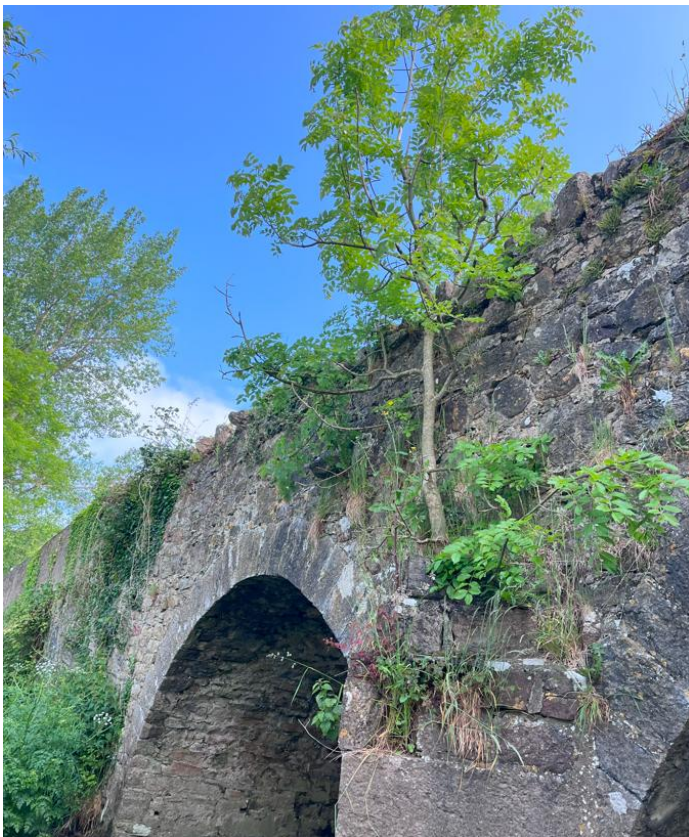
Image 3-5. Vegetation present on the upstream bridge abutment and cutwater.

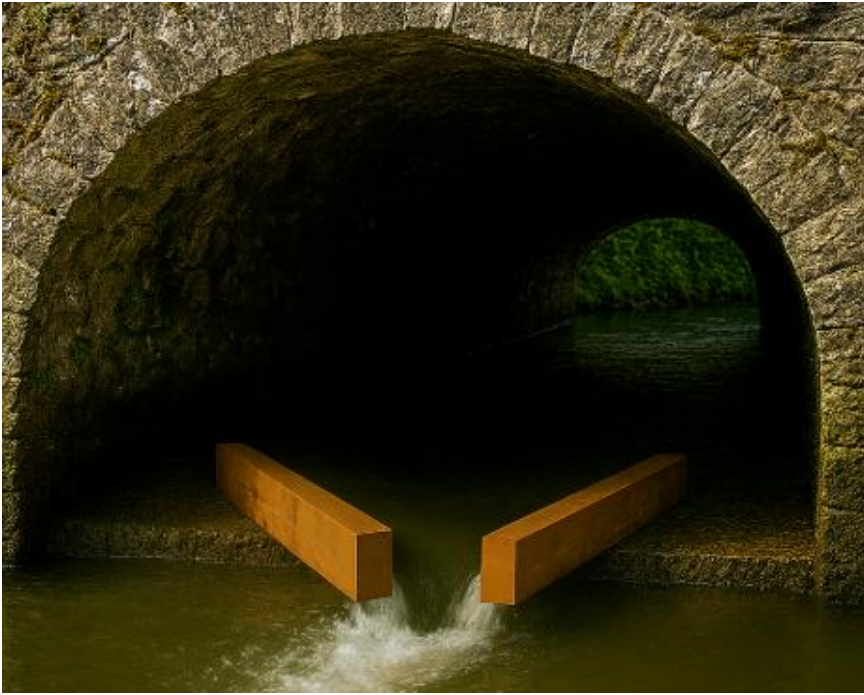
Image 7-1 – Proposed layout to baffles under arches

The proposed repair methodology, which involves creating dry cells beneath each of the three bridge arches under normal flow conditions, provides an opportunity to integrate a targeted ecological improvement. As part of these works, untreated hardwood or fully cured concrete lentils (or equivalent flow-deflecting structures) will be fixed to the flat concrete riverbed/apron. These will be strategically positioned to encourage a more concentrated flow through the centre of the arches—preferably the central arch—thereby funnelling water and creating a more naturalised flow profile downstream.

This installation will enhance water velocities and depth variability within the passage zone, resulting in improved conditions for fish migration and movement, particularly during low- to moderate-flow periods. The improvement will have an overall positive ecological impact on the river system.
