APPROPRIATE ASSESMENT

This document relates to the Appropriate Assessment process undertaken for proposed bridge repairs on Galbally Bridge, Mandeville Park, Moorabbey, Co. Tipperary

Ecology Research and Solutions Ltd.

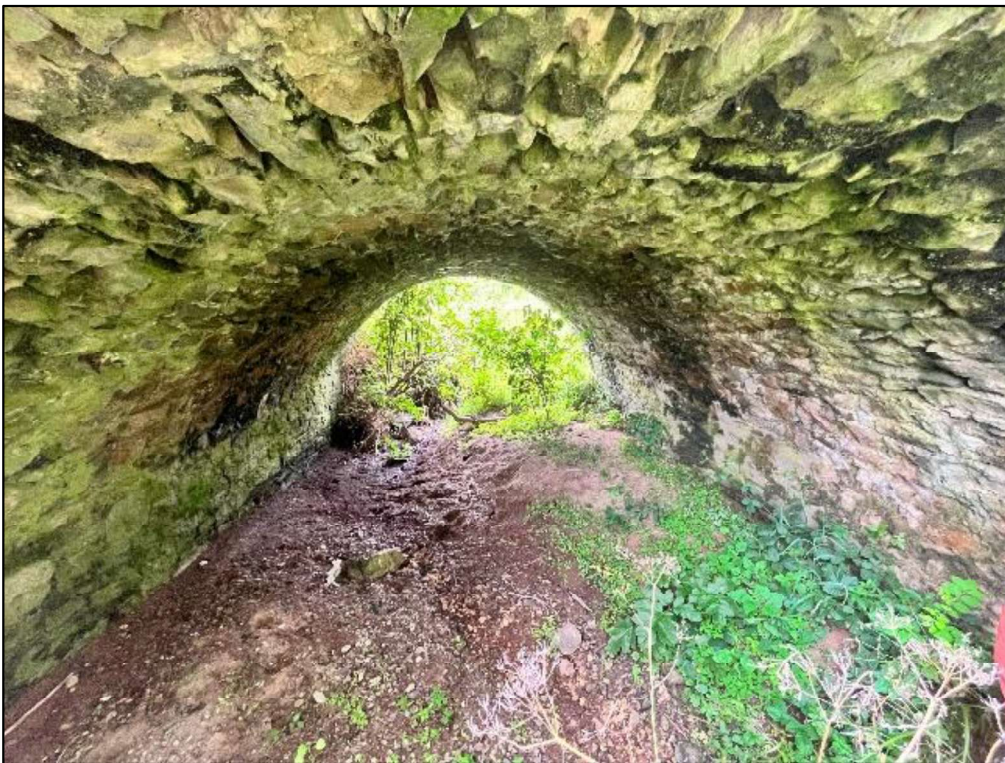
Image 2-1 – Arch 4, south arch of bridge

Similarly to 2024 arch 4 (south end of bridge) was a dry arch with no river flow present (*Image 2-1*) and arch 1 to 3 had a moderate to fast river flow passing beneath. Arch 4 had a mostly dry earth floor with little vegetation throughout. These conditions were favourable to complete a footprint and general activity assessment of under the bridge. The majority of the tracks identified were rodent and bird tracks. Some larger mammal footprints were present however they appeared aged and disturbed making them unidentifiable (*Image 2-2*). A trial camera was deployed at this under this arch in a position that allowed the images to capture the full width of the arch.

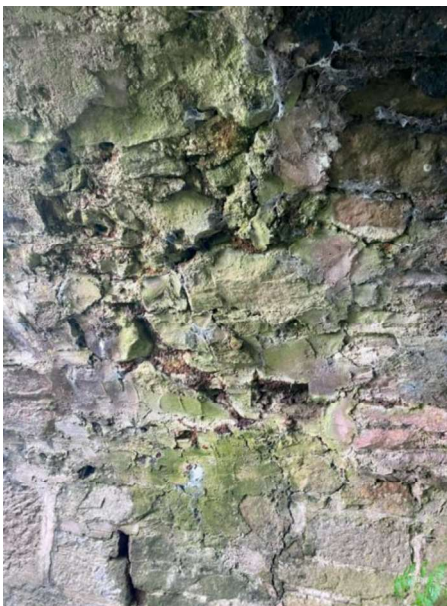
Image 3-2. Cracks, holes and deteriorating stone and mortar on the underside of one of the arches.

The bridge piers, abutments and the undersides of all four arches, have radial and vertical cracks present. Some cracks have associated stone and/or mortar loss (See *Image 3-2*, *Image 3-3* and *Image 3-4*). The parapets have various location of small holes and dislodged mortar. Both upstream and downstream abutments have vegetation growing on them including one 2.5m tree growing on top of one cutwater (*Image 3-5*). Further deterioration to the bridge structure, will eventually result in a structure failure where it will be both unusable and unsafe to the general public and users.

- In order to repair the bridge cracks, holes and dislodged mortar within the arch barrels stainless steel stitching will be inserted through the voussoirs in the arch and connected to the intrados, after a high strength cement/grout mix will be used. It will be sprayed under high pressure into the cracks. All other cracks will then be pointed.
- The piers foundations will be underpinned and grouted.
- All spandrel and parapet walls will be repointed.
- Tie bars will be inserted into each arch, there will be two in each arch.
- Vegetation removal on each elevation.
- The riverbed will be strengthened with stonework and rock armour.

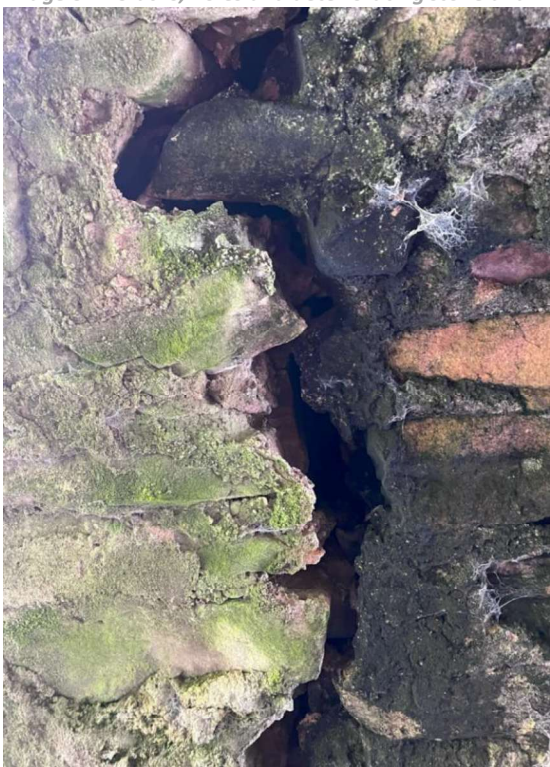
Image 3-3. A large crack present on the underside of one of the arches.

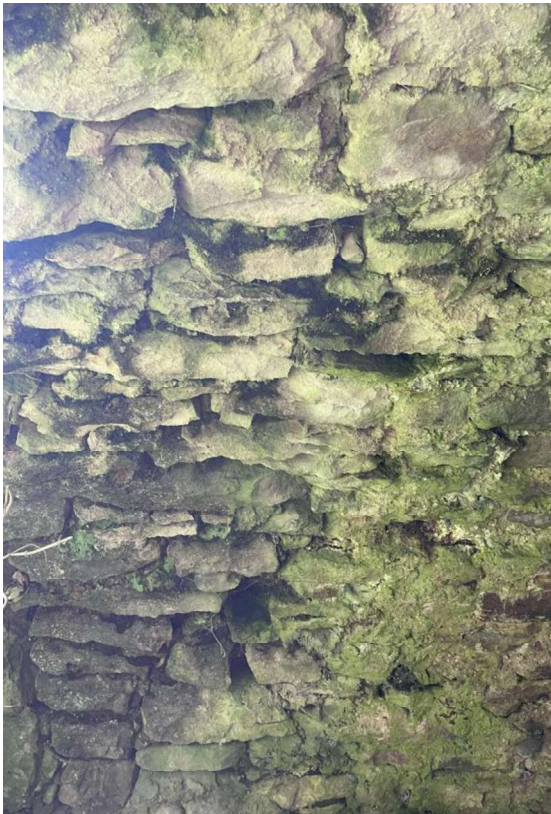
Image 3-4. Cracks, holes and dislodged mortar on the underside of one of the arches.

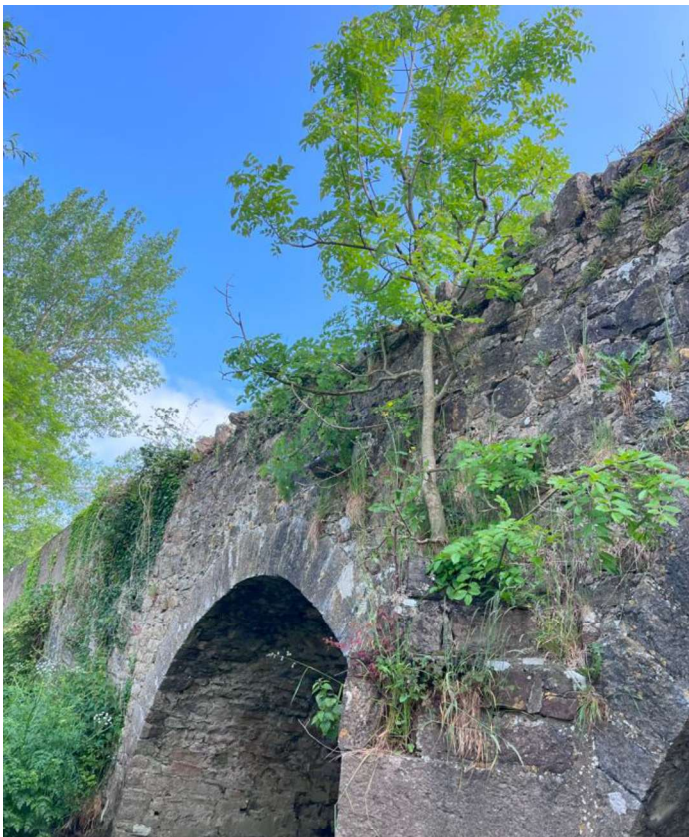
Image 3-5. Vegetation present on the upstream bridge abutment and cutwater.

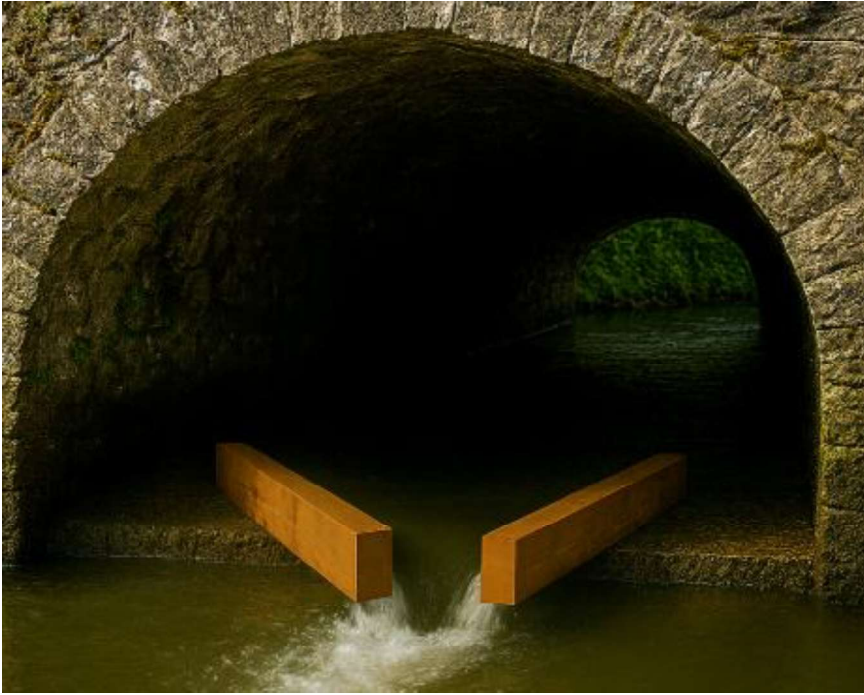
Image 7-1 – Proposed layout to baffles under arches

The proposed repair methodology, which involves creating dry cells beneath each of the three bridge arches under normal flow conditions, provides an opportunity to integrate a targeted ecological improvement. As part of these works, untreated hardwood or fully cured concrete lentils (or equivalent flow-deflecting structures) will be fixed to the flat concrete riverbed/apron. These will be strategically positioned to encourage a more concentrated flow through the centre of the arches—preferably the central arch—thereby funnelling water and creating a more naturalised flow profile downstream.

This installation will enhance water velocities and depth variability within the passage zone, resulting in improved conditions for fish migration and movement, particularly during low- to moderate-flow periods. The improvement will have an overall positive ecological impact on the river system.
