**Mungret Residential Development**  
Conservation Report

Proposed Development at Dromdarrig, Mungret, Co. Limerick

January 2021

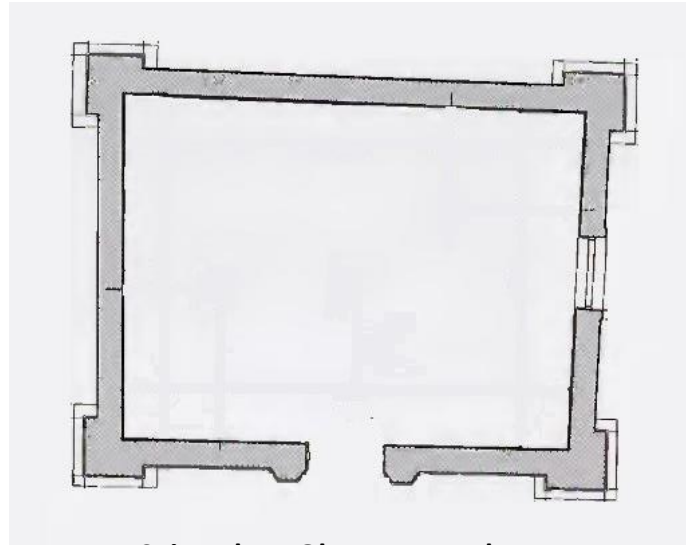
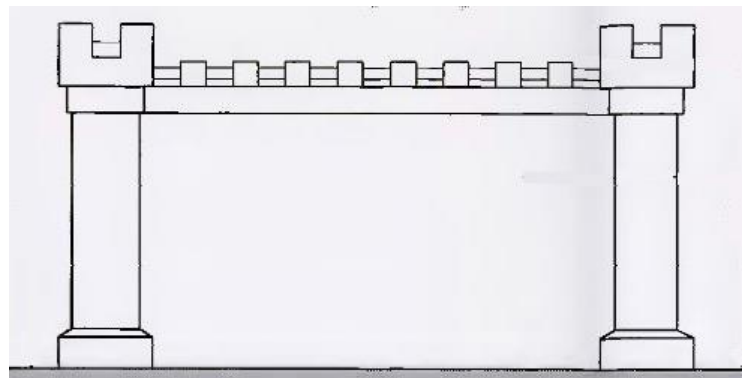
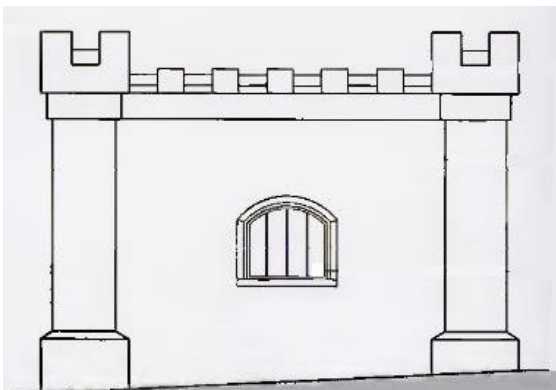
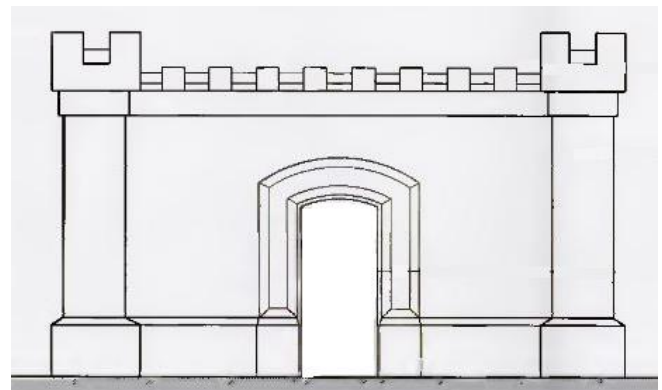
*Fig.02d : Mungret Seismology Observatory. Plan ad Elevations*

**Seismology Observatory Plan**

**North Elevation**

**East Elevation**

**South Elevation**

**West Elevation** (this elevation faces the east elevation of the main college.)

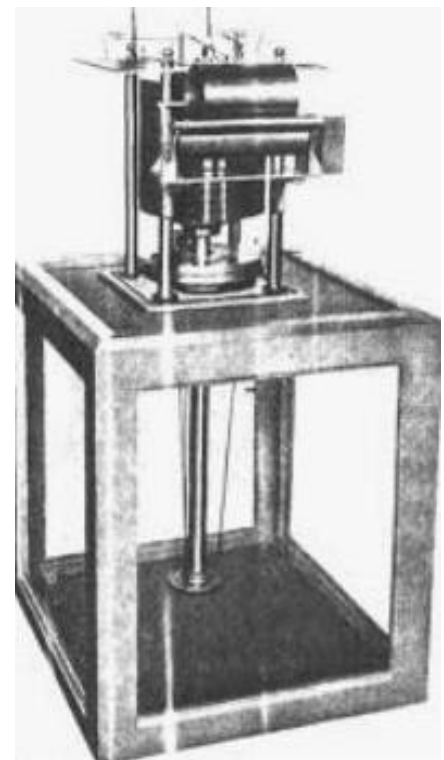
At the Coronation Exhibition in London in 1911 Fr. O'Leary exhibited his own inverted pendulum design, a new seismograph fig.05c that he used in Mungret. One of the main problems in the field of seismology is how to obtain an instrument with a fairly long period and consequent high sensitivity. Fr. O'Leary provided a solution with his two-component seismometer. Some of the leading seismologists of the time such as Professor Milne had high praise for the invention.

*Fig.05c, Reproduction of a Photograph of the seismographs installed at Mungret Sourced from Mungret Observatory building repairs- Site inspection report/method statement for building repairs.04-05-2010*

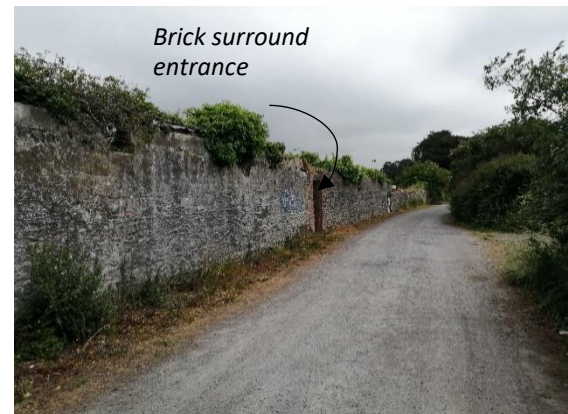
The South(A) and West(B) walls form the south-westerly corner of the site that bounds a lane fig.09. These walls are constructed with random rubble stone, built to courses with mortar joints. The wall elevation and top of wall including the bedding joints have a considerable amount vegetation growth. There is extensive lichen staining on the wall elevations fig.07 & fig.08.

Both walls have access points, with the opes formed in brick to the south and stone to the west. On the south wall level in height changes fig.08, possibly indicating previous intervention. This will require further investigation. Also, on the south wall there is evidence of a concrete capping fig.08-fig.09.

Fig.08 Survey photo of Outer wall (A) South Boundary

A cleaning and conserving strategy will be undertaken by a professional with expertise in this area. All vegetation will be removed, and care taken to the surrounding stone and mortar joints. Where mortar joints have deteriorated and decayed, a process for the repointing will be undertaken with regards to, raking out, washing, brushing, mortar mix and curing. The joints will be cleaned and loose debris removed prior to repointing. A NHL lime mortar to the appropriate specification will be used for repointing, adhering to good conservation practise of replacing like with like materials. All dependant on wall stability.

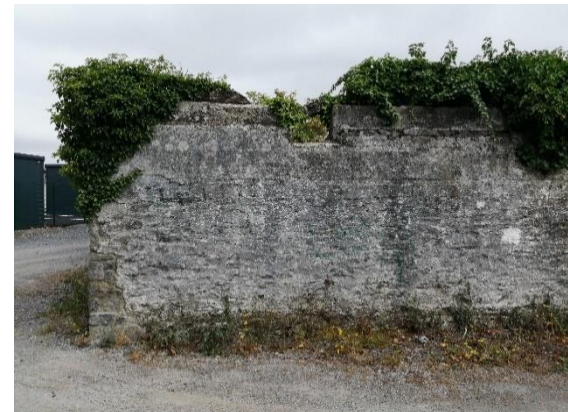
Fig.09 Survey photo: Junction where the South & West Boundary converge. Walls (A)&(B)

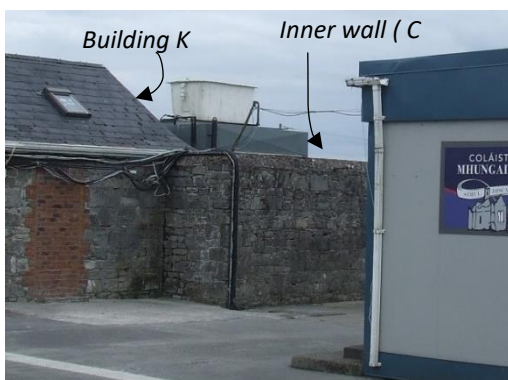
The wall (C) fig.03 is located internally and is aligned parallel to the outer western wall. It engages the south elevation of building K fig.11. This wall is constructed with random rubble stone built to courses with mortar joints. There are Two piers finished with a smooth render and stone capping fig.10. There is vegetation growth in parts.

Fig.11 Survey photo : Inner wall ( C ) / South Elevation Building K

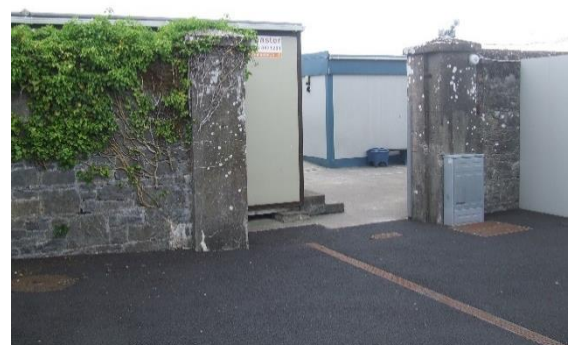
Fig.10 Survey photo Wall (C) Piers to be retained

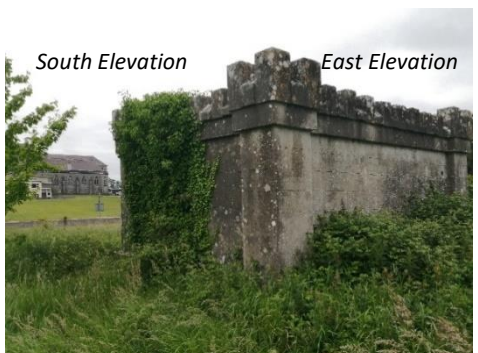
There is a castellated parapet to the top of wall with merlons and sloping crenels, above a lower section of eaves course that projects beyond the wall face. There is extensive biological and vegetation growth on all the walls.

The south elevation has a single window ope with a timber frame containing vertical iron bars. There is a raised architrave and a segmental arch with a rendered finish. There cill is of rendered concrete.

Fig.11d Survey photo: Observatory South & East Facing Elevations

All vegetation growth is to be carefully removed with care taken not to damage the surrounding wall fabric. This will include any areas of soil deposits found in wall cracks, castellated parapet (ie sloping crenels and merlons) or any part of the wall structure. An expert in this area will be engaged.

Structural Cracks in the wall of +2mm under the supervision of an expert in this area are to be raked out carefully and all loose debris to removed. An epoxy resin or equal approved mortar is to be injected. All to be agreed prior to the works commencing with a structural engineer.

Surface Cracks in the render are to be cleaned and any loose debris or contaminants are to be carefully removed. This is followed by the use of a proprietary mortar to fil the cracks. It is important prior to the commencing of the works a sample area will be prepared to match wall colour.

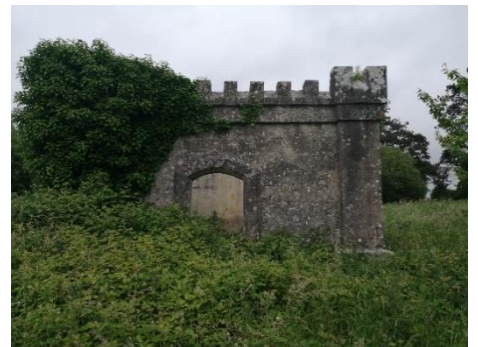
The west elevation contains a single door ope. It has a segmental arch with raised architrave and head. The material is possibly concrete with a rendered finish. This can be seen where there is a loss of render at the springing point of the arch (right side facing the door). There is no frame or door leaf.

Fig.11e Survey photo: Observatory West facing Elevation

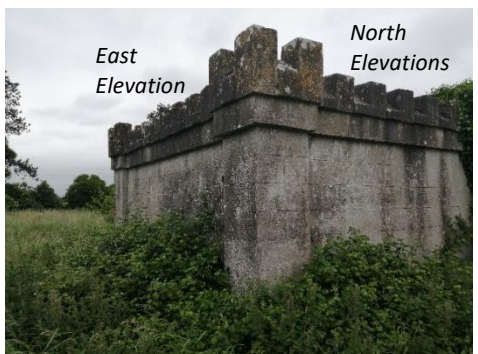
Fig.11f Survey photo: Observatory East & North facing Elevations

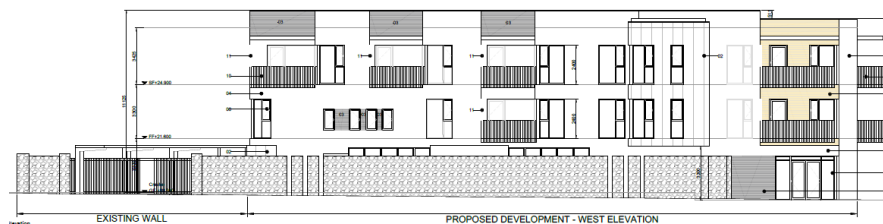
There will be six-narrow full height openings created in the inner wall (C). These are an integral part of the creche design. They allow shafts of light to pass through the wall and illuminate both the pocket garden and open dining area spaces. This light also spills into the surrounding rooms adjacent to these spaces. This light offers a softness against the strong wall and as the sun moves through the day. This allows a constant change of mood and feel about the open spaces. This can also be said of the seasons. The high summer sun and the low winter sun in the sky. Always creating light, shadow, tone, and texture. That is the importance or retaining this wall and incorporating it in the design.

Fig.14 West facing Elevation indicating the tall narrow opes and modifications to the wall.

It is the intention to retain as much of the boundary wall (C) stone fabric as possible. Where modifications and interventions are proposed, including section of wall removed. The stone will be stored on site and reused in the construction new section of wall fig.13. This will ensure the wall fabric endures.

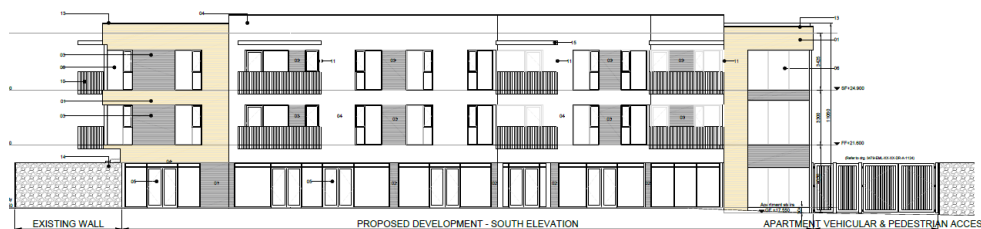
Fig.15 South facing Elevation indicating the buildings engagement with the wall.
