Quinn's Cross to Raheen Roundabout Cycle Scheme, Raheen, Co. Limerick

Tree Roost Survey Report

16th February 2022

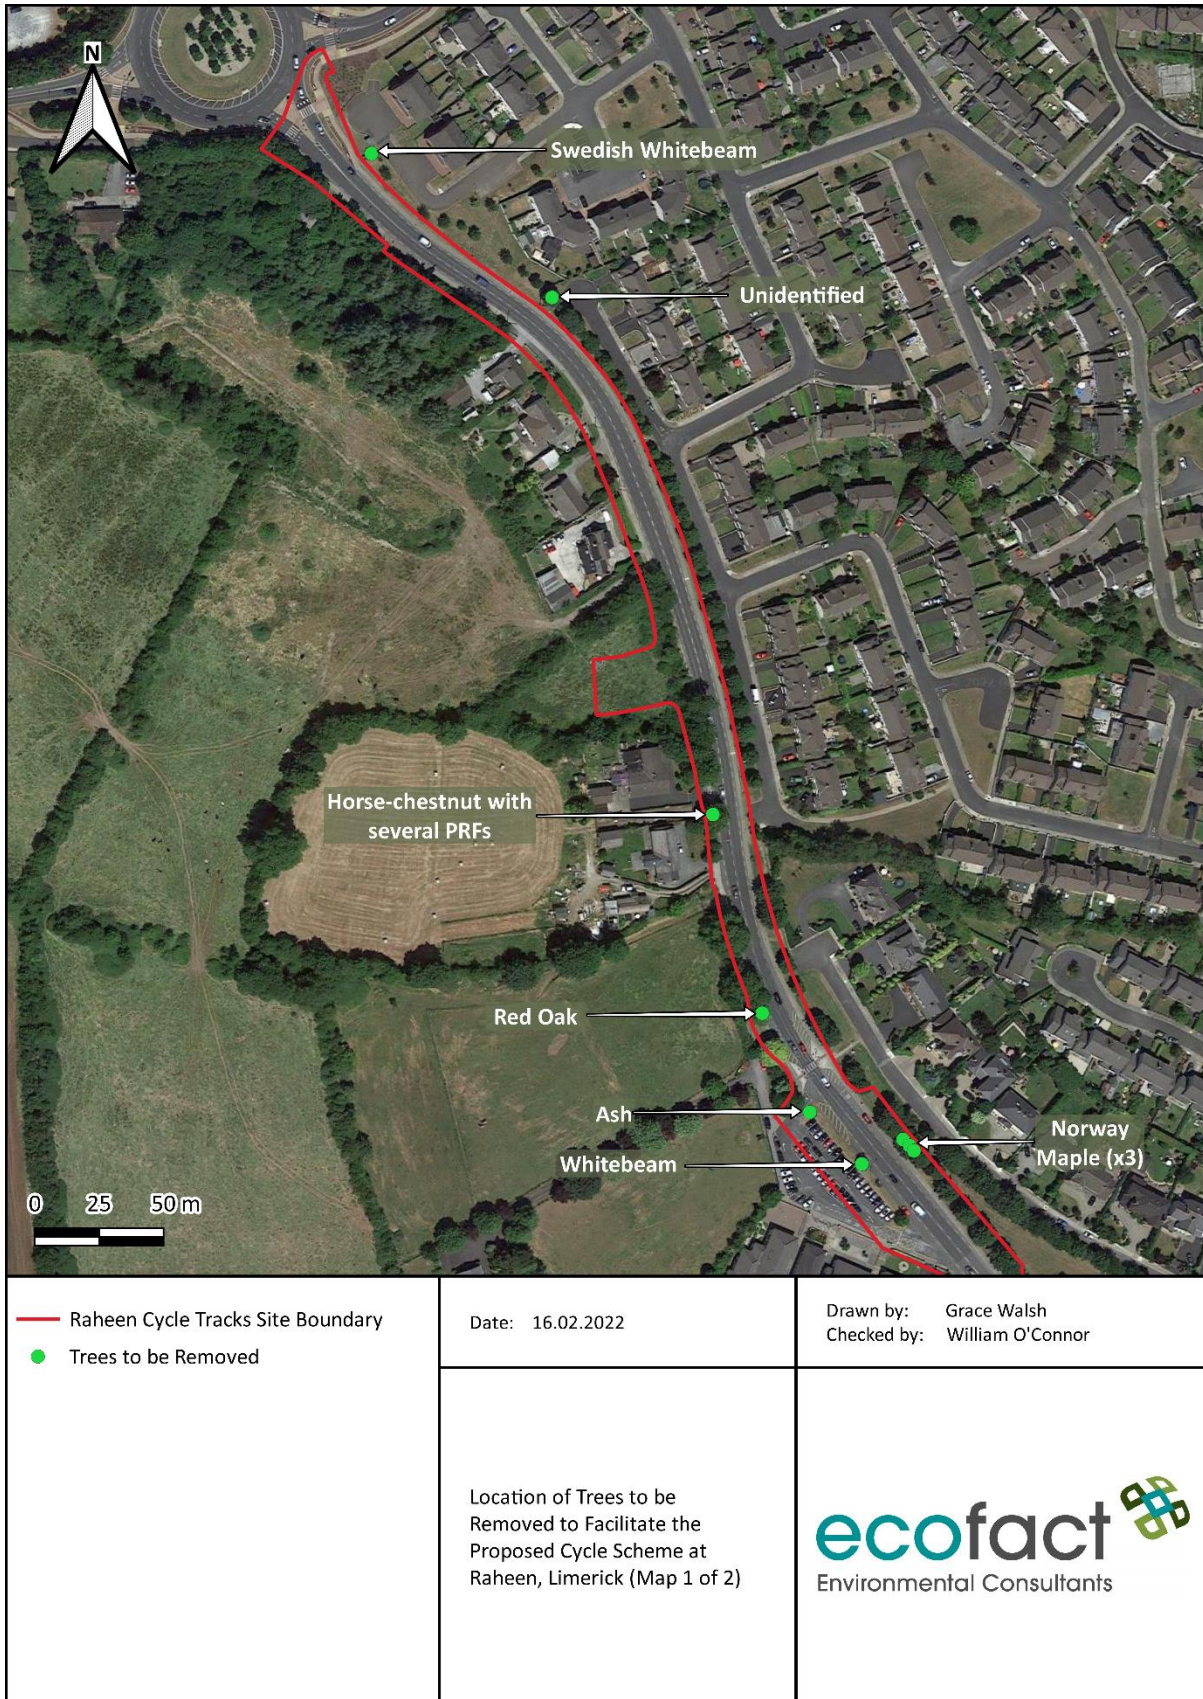
Figure 2 Location of Trees to be Removed to Facilitate the Proposed Cycle Scheme at Raheen, Limerick (Map 1 of 2).

All trees to be removed were assessed. These trees are shown in Figures 2 and 3. Starting at the southeast section of the site there are 8 Norway maple trees to be removed. These trees showed low potential for bat roosting. While there are some knotholes present, the trees are generally well seeded and the dense branches makes them unfavourable to bats. There are two streetlights either side of this treeline. Just northwest of these trees there are four hornbeams to be removed. Again, these were considered to be in good condition and were unsuitable for roosting bats. There is a sycamore adjacent to these trees that will also be removed with no bat potential. The next two trees to be removed are poplars. These again were both in good condition and unsuitable for bats. The next trees to be removed are located in the vicinity of St. Nessian's National School. There is a relatively small, but mature Whitebeam to be removed directly on-front of the school carpark. This tree has no potential for bat roosting. There are three Norway maple trees to be removed on the opposite side of the road here. These trees again were relatively small and in good condition making them unsuitable for roosting bats. The next tree is located adjacent to the St. Nessian's School. This is a small Ash tree again which is very unlikely to be used by roosting bats. Approximately 50m north of here on the same side of the road is an Oak tree to be removed. This is an early mature tree with no potential for roosting bats.

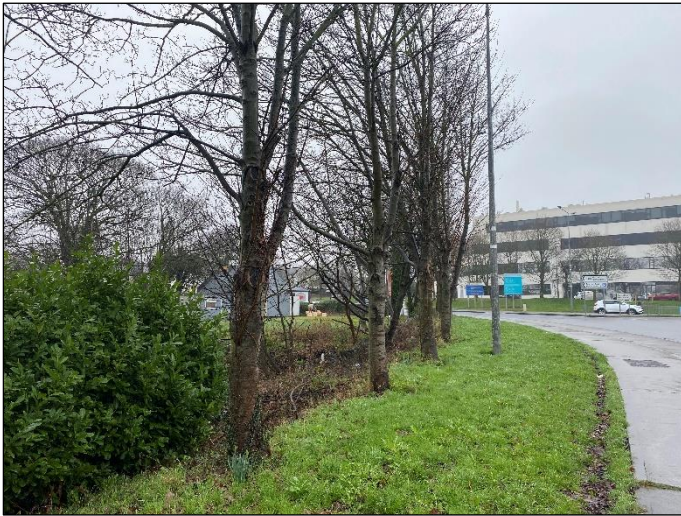
Plate 1 Some of the 8 Norway Maple trees to be removed at Raheen Roundabout. These trees showed low potential for bat roosting. While there are some knotholes present, the trees are generally well sealed and the dense branches makes them unfavourable to bats.

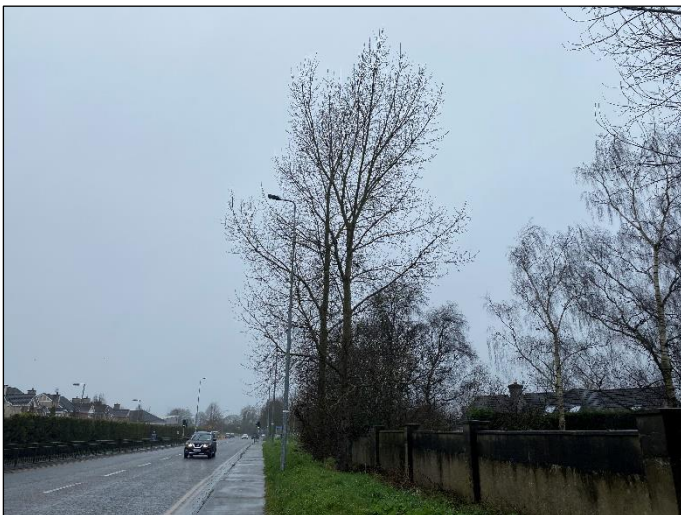
Plate 2 The two Poplar trees to be removed – the trees are positioned immediately beside a street lamp and has a thin trunk with no significant crevices – unsuitable for bats.

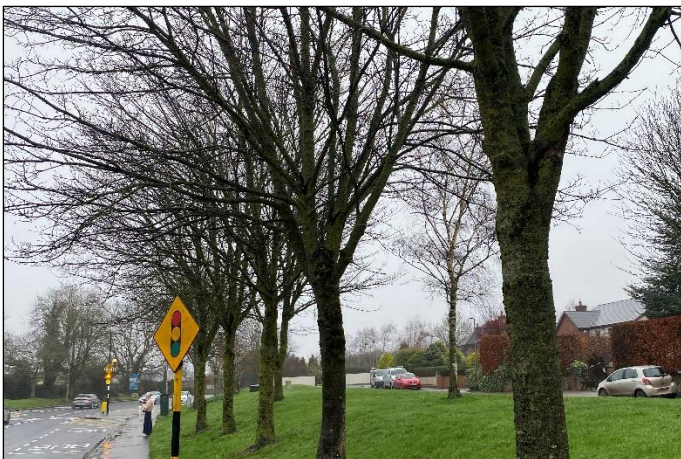
Plate 3 Three Norway Maple trees in the background to be removed. Again like most trees onsite these were in good condition and had no bat potential.

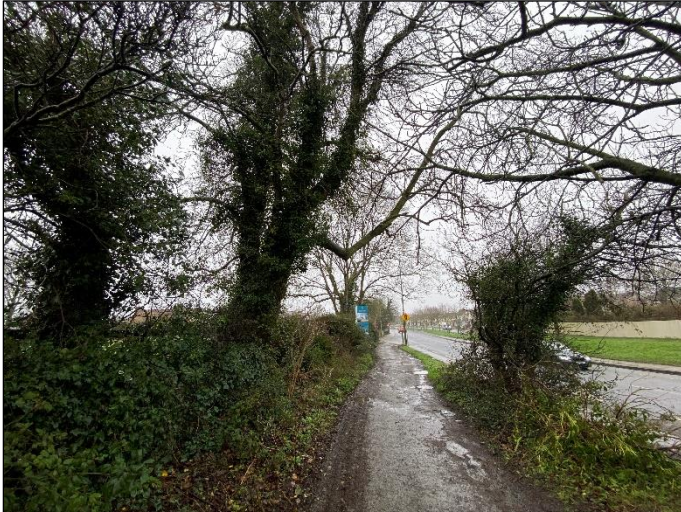
In addition, there were trees in the area that will not be felled but did have bat roost potential. There is the potential these trees to be damaged during the proposed works which could lead to disturbance to bats and further roost loss in the absence of mitigation.

Plate 4 Trees adjacent to the site that will not be removed but that do have some potential for bats.

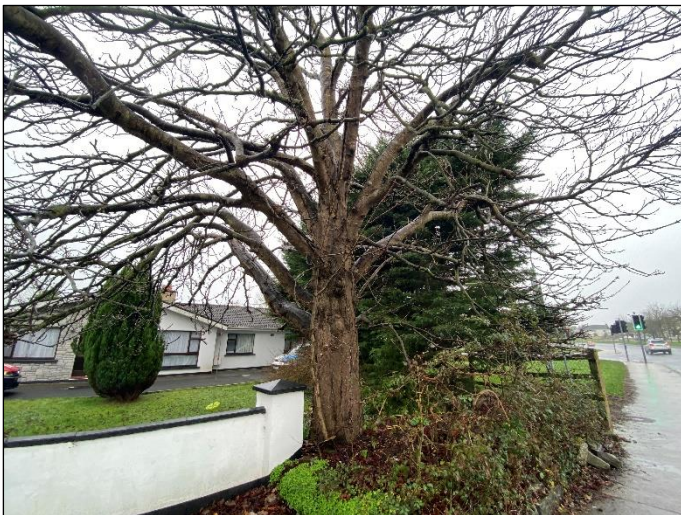
The next tree to be removed is a large Horse-chestnut tree located on private property near Mungret Gate. This tree was not in good condition with flaking bark and several cracks which provide potential resting places and roosting opportunities for bats. This tree does have potential for roosting bats. During surveys for the Screening for Environmental Impact Assessment in Spring 2021 this tree was highlighted as having the potential for roosting bats. It is noted that due to current disturbance levels in the general area, as well as in the immediate vicinity of the identified tree the potential for this tree to be used for bats is somewhat decreased.

Plate 5 Mature Horse-chestnut tree just south of Mungret Gate entrance to be removed.

The potential for bat roosting habitat has been confirmed on the site, in a tree that is to be removed. As it cannot be ruled out whether or not bats use these trees an activity survey in the appropriate season is required. This survey can also identify the level of usage of the site regarding foraging and commuting habitat. This survey should be undertaken during the active bat period from May – September for tree roosts. It is stated in the Bat Conservation Ireland guidelines that dawn surveys work best for tree roosts (Kelleher & Marnell, 2006). Full mitigation will be provided once this survey is complete.

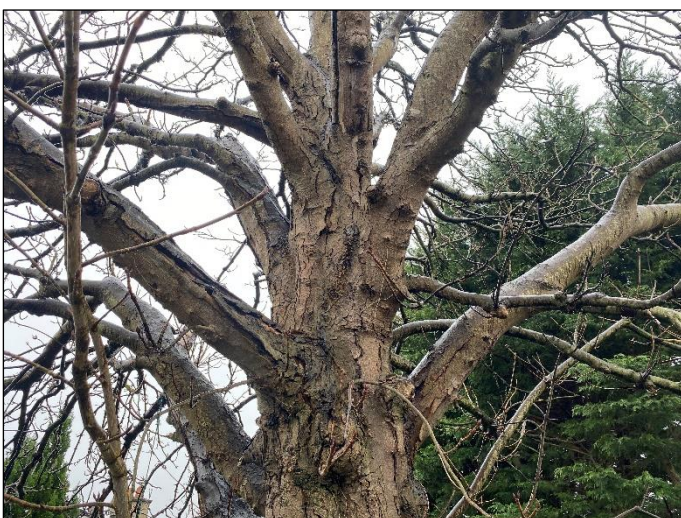
There is at least one tree on the proposed development site which has the potential for roosting bats. The tree had several Potential Roost Features (PRFs) including flaking barks and large cracks that could be favourable for bats. On the majority of trees there were no Potential Roost Features (PRFs) noted. The trees were found to be mostly in good condition. There were no signs of decay on most of the trees that would lead to potential roosting habitat for bats. However, there is one large Horse-chestnut tree that has the potential for roosting bats. The felling of this tree therefore has the potential to lead to the permanent loss of bat roosting habitat. To fully assess the impacts a further survey during the active bat season is required

Plate 6 Significant crevices were noted in the mature Horse-chestnut tree that is to be removed near the Mungret Gate entrance.

Any site clearance works will be undertaken outside of the bird nesting season (1st of March to the 31st of August) as there is the potential for bird species to use the site for nesting. Works will be undertaken during daylight hours to avoid disturbance to any bats in the local area. Tree-felling works will be undertaken in the period late August to late October / early November when bats (young and old) are capable of flight but not yet in hibernation. Additional mitigation may be provided pending further surveys.
