Preliminary Bat Roost Habitat Assessment

33 & 34 Thomas Street, Limerick

ISSUE FORM	
Project number	22191
Document number	6002
Document revision	A
Document title	Preliminary Bat Roost Habitat Assessment: 33 & 34 Thomas Street, Limerick
Document status	Final
Document prepared by	Pat Ryan [MWP 11/5/21]
Document checked by	HD (MWP 12/05/21)

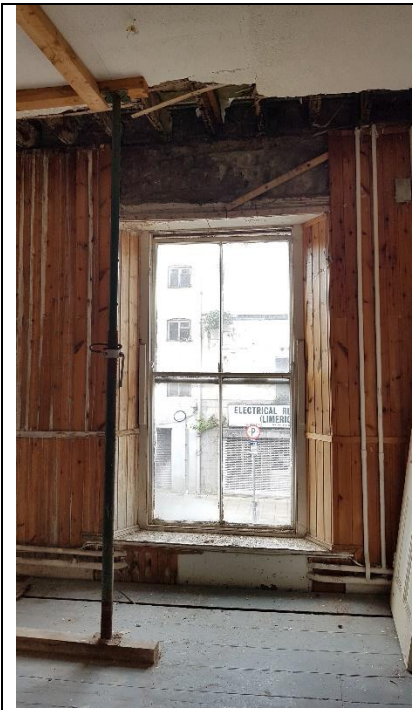
<p>Butterfly wings on floor</p>
 	<p>Wings of tortoise shell. Very old/faded. <i>Possible</i> bat feeding remains</p>
 	<p>'Kitchen'</p> <p>No evidence of bat usage</p> <p>Parts of ceiling and floor collapsed.</p>

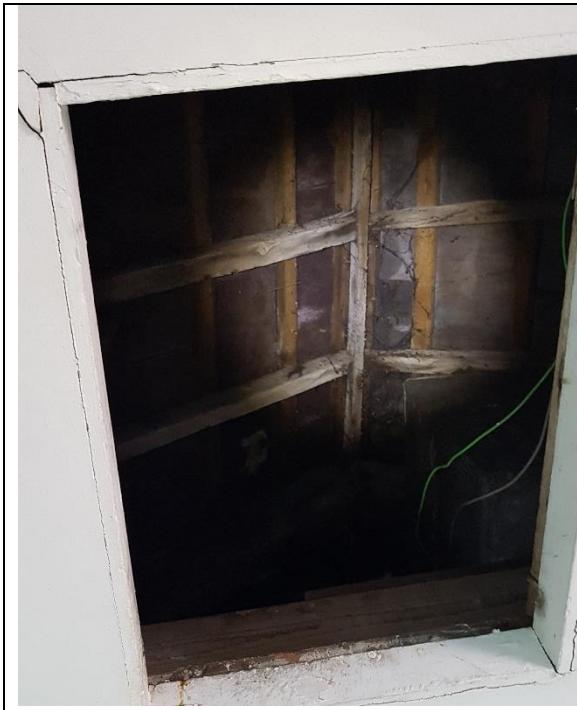
<p>As above</p>
 	<p>Room with attic space used by nesting /roosting pigeons possibly.</p> <p>Bird droppings extensive on floor underneath attic hatch, across floor of room and on windowsill (see below)</p>
