# Bloodmill Rd Extension Limerick

Proposed Bloodmill Rd Extension  
at Towlerton, Ballysimon, Limerick

## Stage 1 Road Safety Audit

July 2023

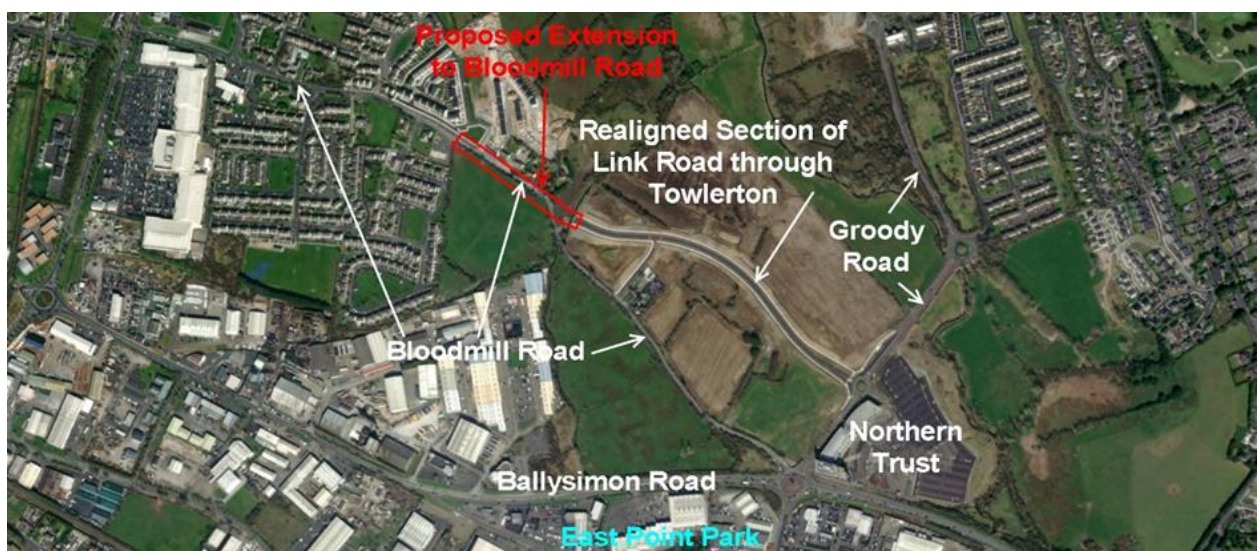
**Figure 1.2 – Site Extents**

See Figure 1.1 Site Location Map. Figure 1.2 shows the site extents on aerial photography and Figure 1.3 & 1.4 shows the site layout for the proposed works

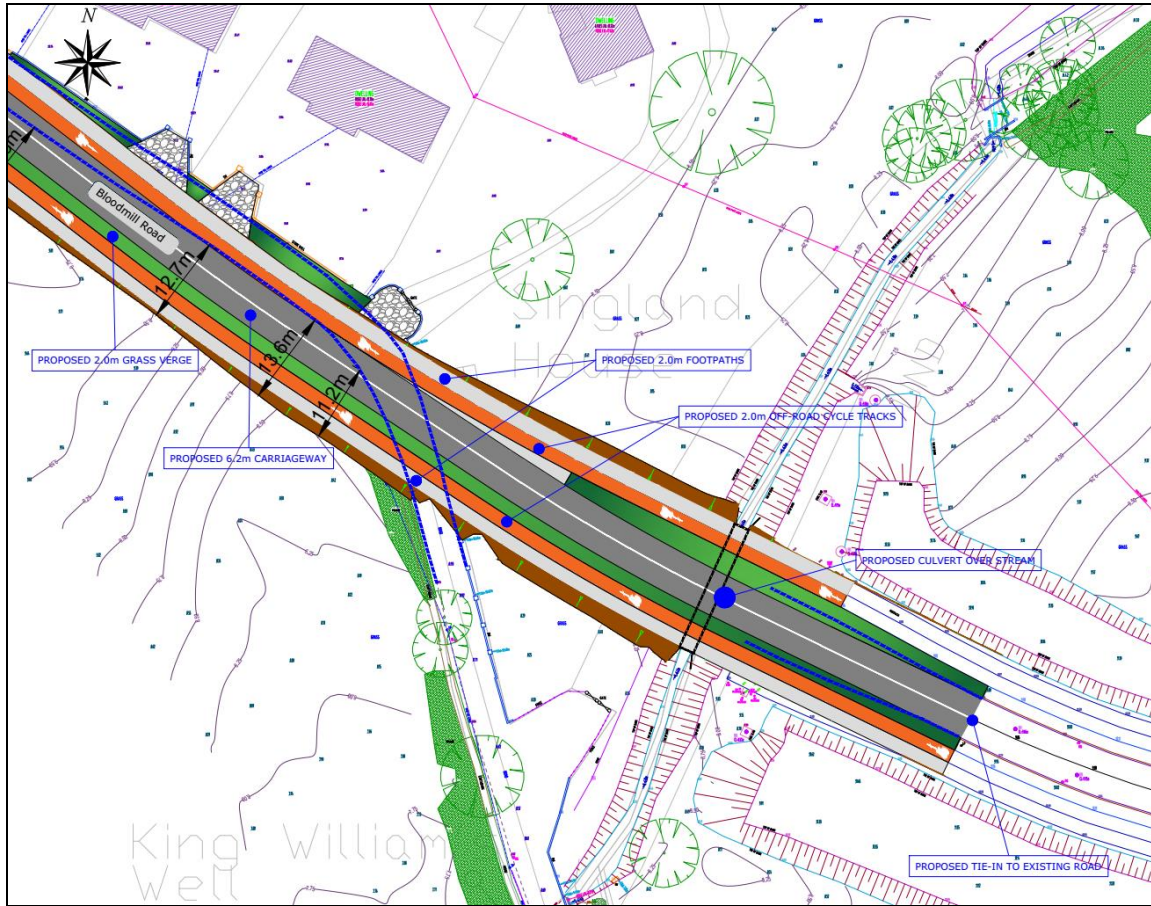
**Figure 1.3 – Proposed Road Layout**

- Construction of approx. 260m of new road corridor with a 6.2m wide carriageway, 2x2m footpaths 2x2m landscaped verges and 2x2m off-road cycle tracks.
- The construction of a new surface water drainage system.
- The installation of a new public lighting system.
- The construction of a new culvert across the Towlerton Stream where the existing newly constructed link road terminates.

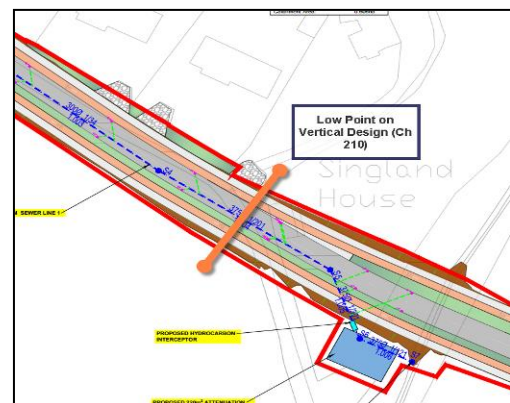
### 2.2.PROBLEM: ROAD DRAINAGE PROPOSAL

The audit team noted that the storm drainage design has been carried out but the location of road gullies should be reviewed. No road surface water Gullies appear to be shown at the lowest vertical point on the road Lack of road surface drainage could lead to surface water ponding and could lead to collisions between vehicles or vehicles and pedestrians due to aquaplaning on water ponds following periods of heavy rainfall. Ref to Fig 2.1

#### Recommendation 2

Provide adequate road surface water drainage along the length of the scheme.

| Paragraph No. in Safety Audit Report | To be completed by the Designer | | | To be Completed by Audit Team Leader |
|---|---|---|--|---|
| 2.2 | Yes | Yes | | |

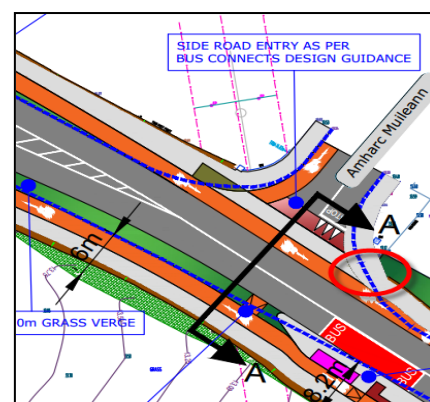
Fig 2.2

### 2.3.PROBLEM: TACTILE PAVING DETAILS AT ENTRANCE TO AMHARC MUILEANN

The drawing issued to the audit team, does not appear to show tactile paving on the eastern side of the uncontrolled pedestrian crossing at the entrance to Amharc Muileann. Failure to provide the appropriate tactile paving at pedestrian crossing may lead to confusions around priority at the crossing. This could lead to collisions between vehicle drivers and vulnerable road users.

**2.4.PROBLEM: JUNCTION ENTRY RADII TO AMHARC MUILEANN**

The drawings provided to the audit team, do not show the proposed junction radii at the junction of Bloodmill Rd and Amharc Muileann. Failure to provide adequate junction radii could lead to vehicles existing and entering the development at an excessive speed. Large junction radii also increase the distances for pedestrians to cross the junction and may lead to collision between pedestrians and vehicles entering and exiting. Refer to Fig 2.1 & 2.2

#### Recommendation 3

The design team should review the use of Tactile Paving on both sides of this junction.

**Recommendation 4**

Ensure that adequate junction radii are provided at the junction of Bloodmill Rd and Amharc Muileann.

| Paragraph No. in Safety Audit Report | To be completed by the Designer | | | To be Completed by Audit Team Leader |
|---|---|---|--|---|
| 2.3 | Yes | Yes | | |
| 2.4 | Yes | Yes | Junction radii will be reduced to 6m | |

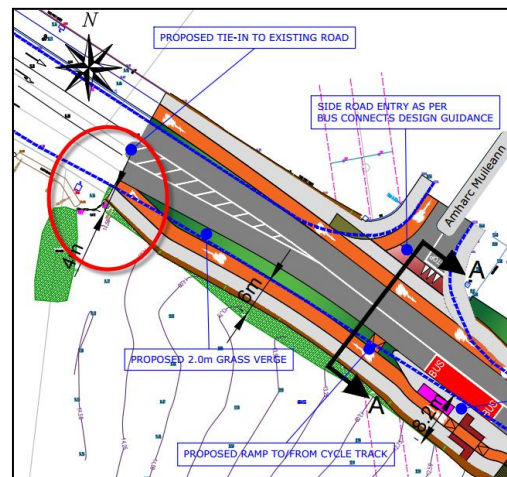
**Fig 2.3**

**2.5.PROBLEM: CYCLE TRACK TRANSITION TO BLOODMILL RD AT WESTERN END**

The drawings submitted for audit don't show how cyclist will exit the proposed cycle track to Bloodmill Rd at the western extents of the scheme. This could lead to potential collisions between cyclists and vehicles travelling on Bloodmill Rd. Refer to Figure 2.3 which shows the Western end of the Cycle Track

**Recommendation 5**

The proposed access/egress points for cyclists' should be clarified/reviewed to minimise the interaction between vulnerable road users and vehicles

| Paragraph No. in Safety Audit Report | To be completed by the Designer | | | To be Completed by Audit Team Leader |
|---|---|---|--|---|
| 2.5 | Yes | Yes | Cycle track transition to carriageway to be re-designed | |

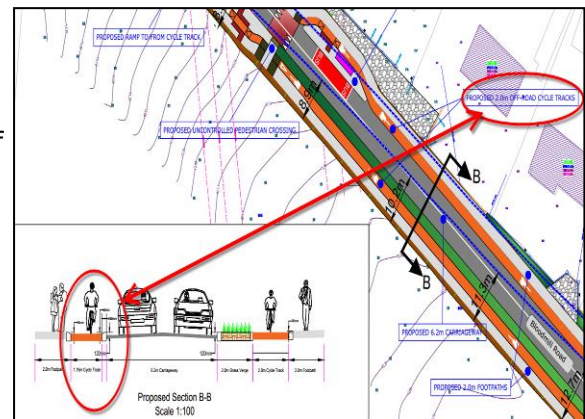
**Fig 2.4**

**2.6.PROBLEM: PROPOSED WIDTH OF CYCLETRACK**

The drawings submitted for audit appear to show a discrepancy in the width of the Cycle Track on the Northern side of Bloodmill Rd. The Plan view shows a width of 2.0m and the cross section a width of 1.75m. Refer to Figure 2.4

**Recommendation 5**

The design team should provide clarity as to the proposed cycle track width.

| Paragraph No. in Safety Audit Report | To be completed by the Designer | | | To be Completed by Audit Team Leader |
|---|---|---|--|---|
| 2.6 | Yes | Yes | Cycle track width to be clarified on all drawings | |

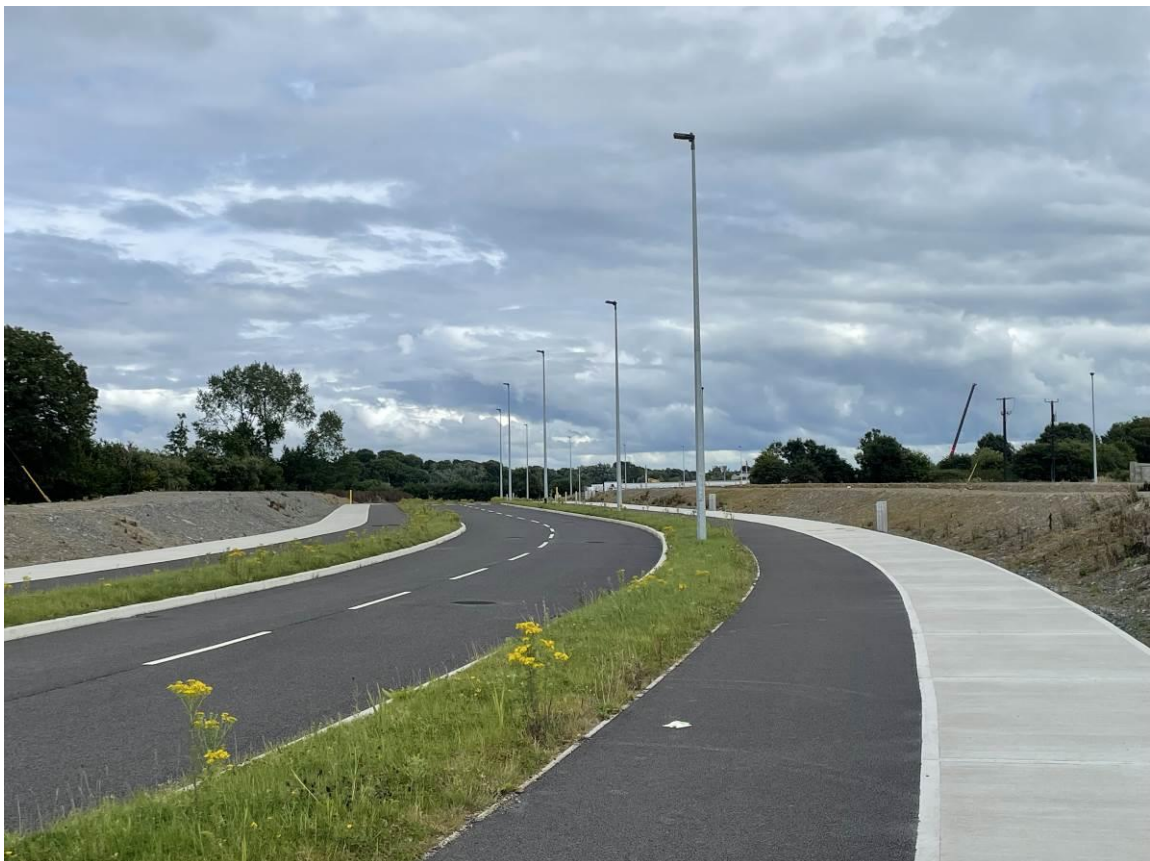
**Photo A1: Existing Link Rd at Eastern Extent of scheme**

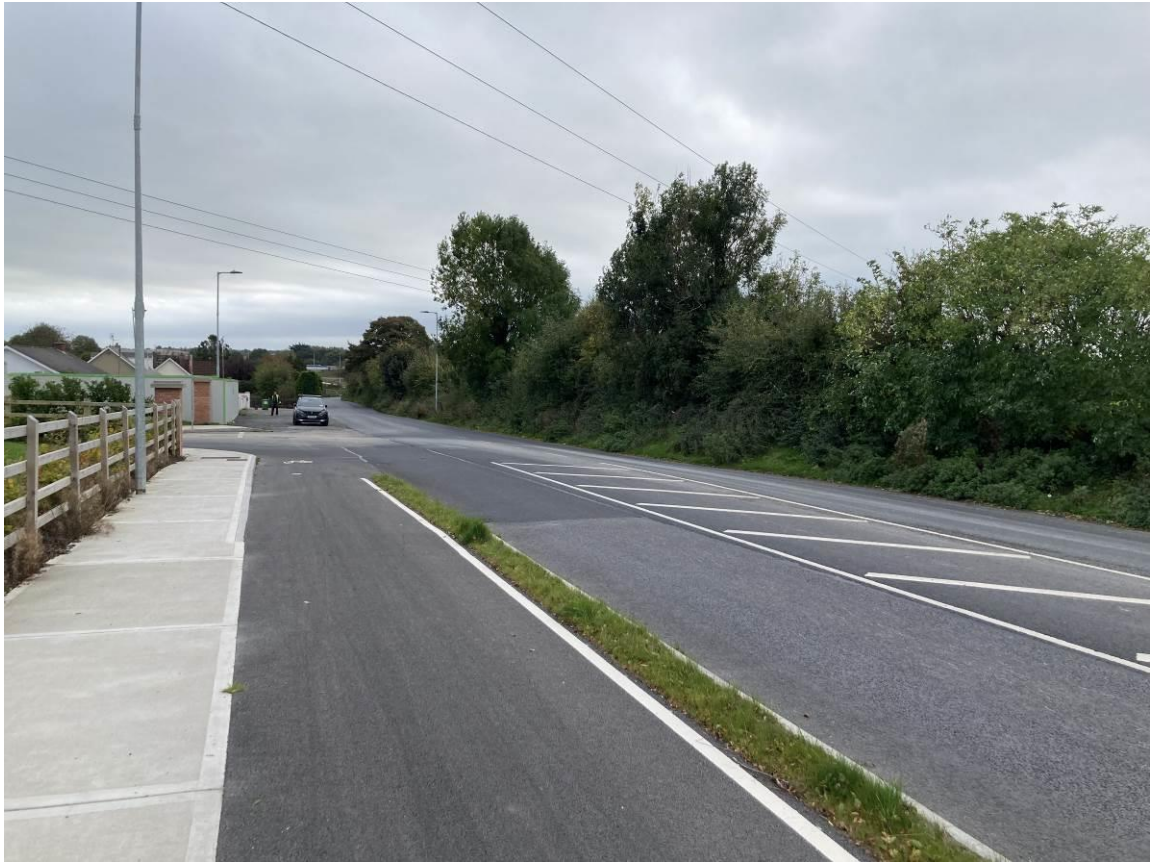
**Photo A2: Tie in location at Western extent of scheme**

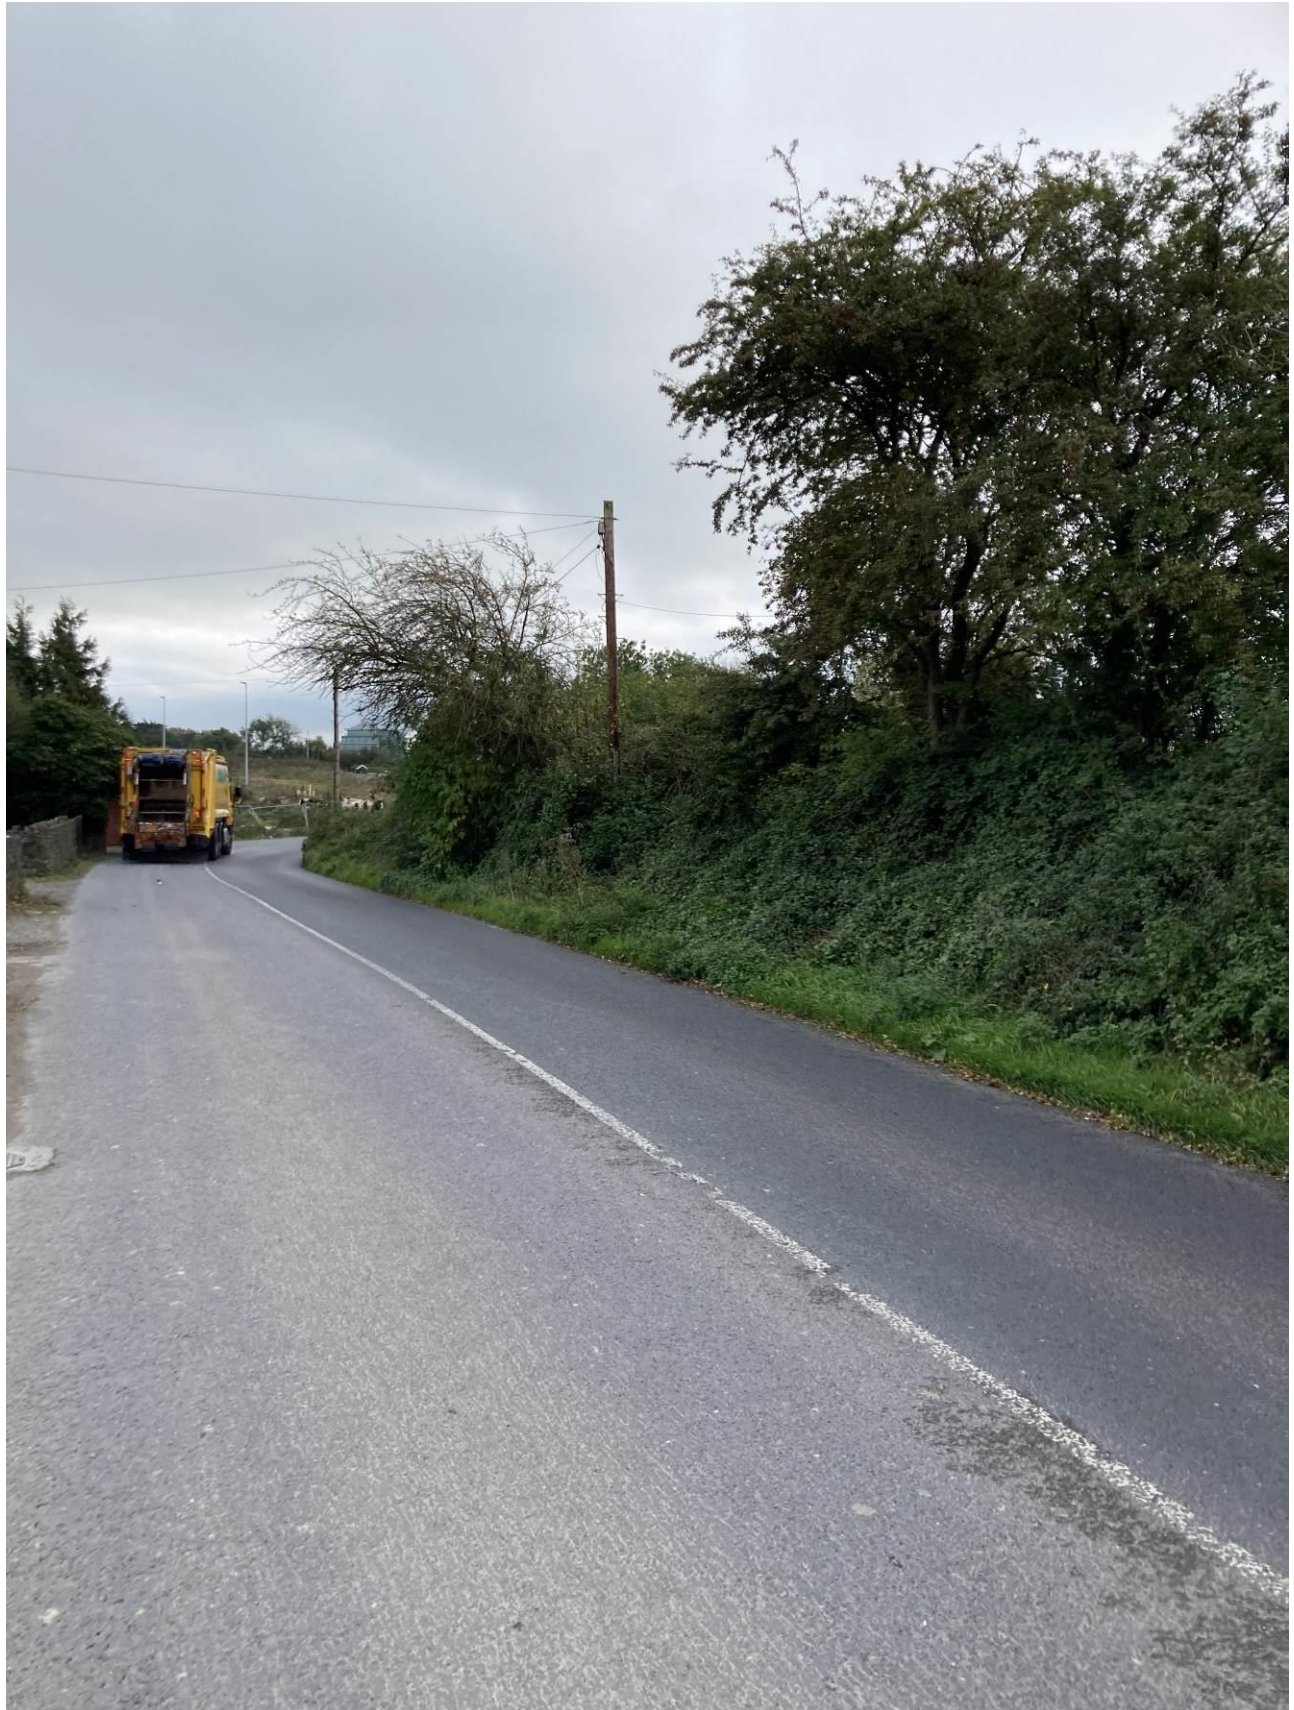
**Photo A3: Existing Bloodmill road**

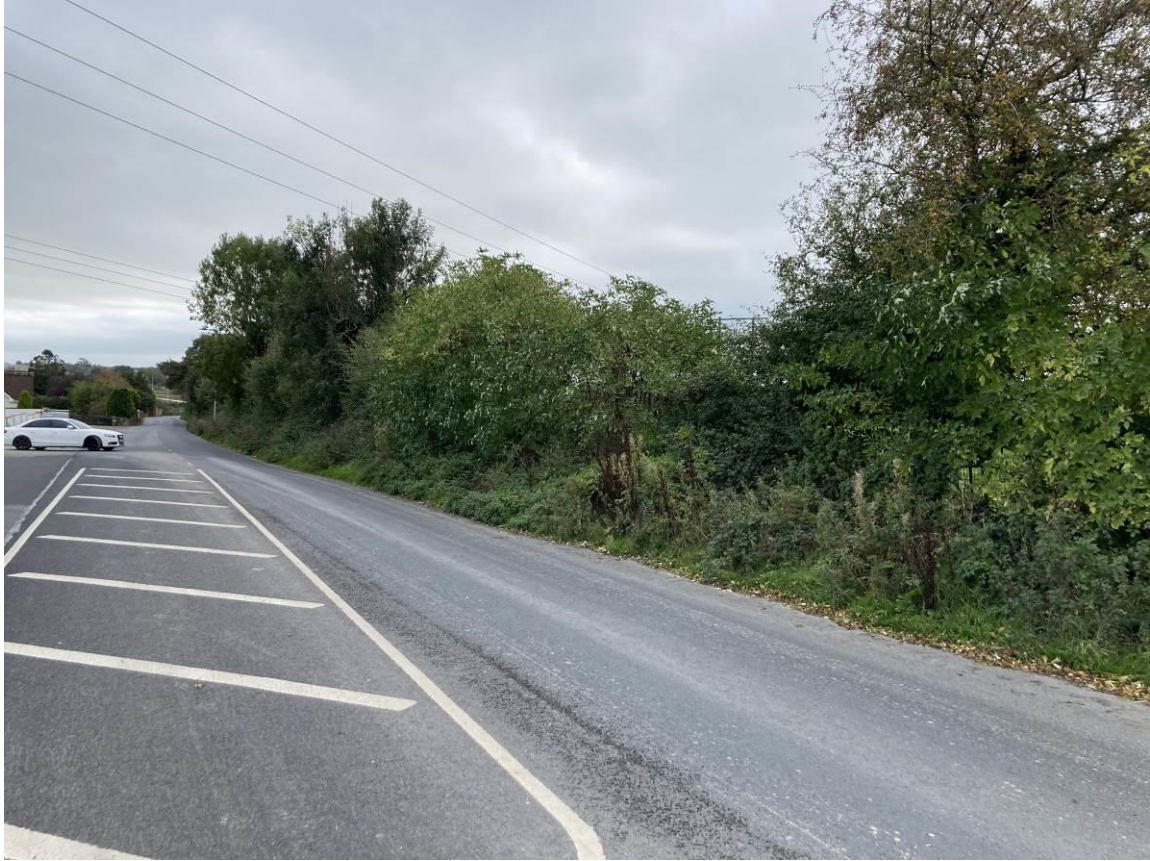
**Photo A4: Existing Bloodmill road at Western Tie in**

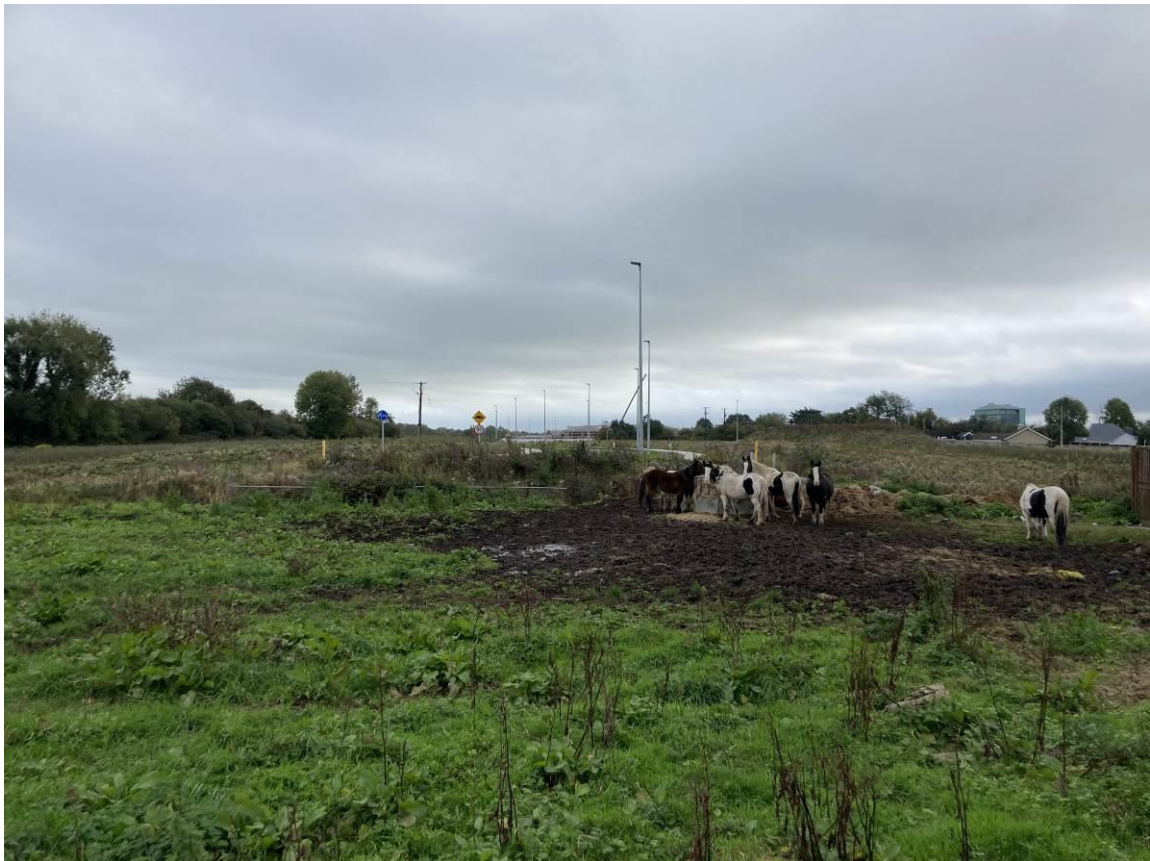
**Photo A5: Existing Greenfield lands through which the road will go**
