Ecology Research and Solutions

Re: The review of a previous NIS and the results of an updated survey of Mohernagh Bridge, Ballyhahil , County Limerick.

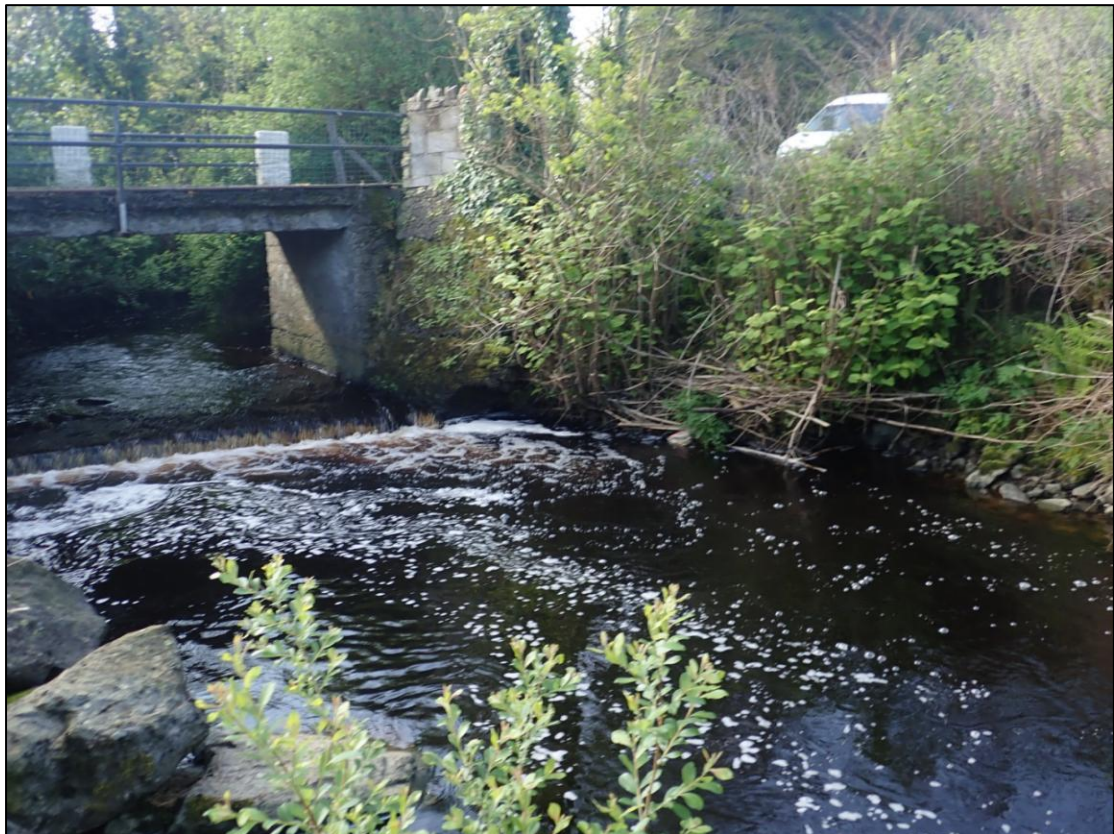
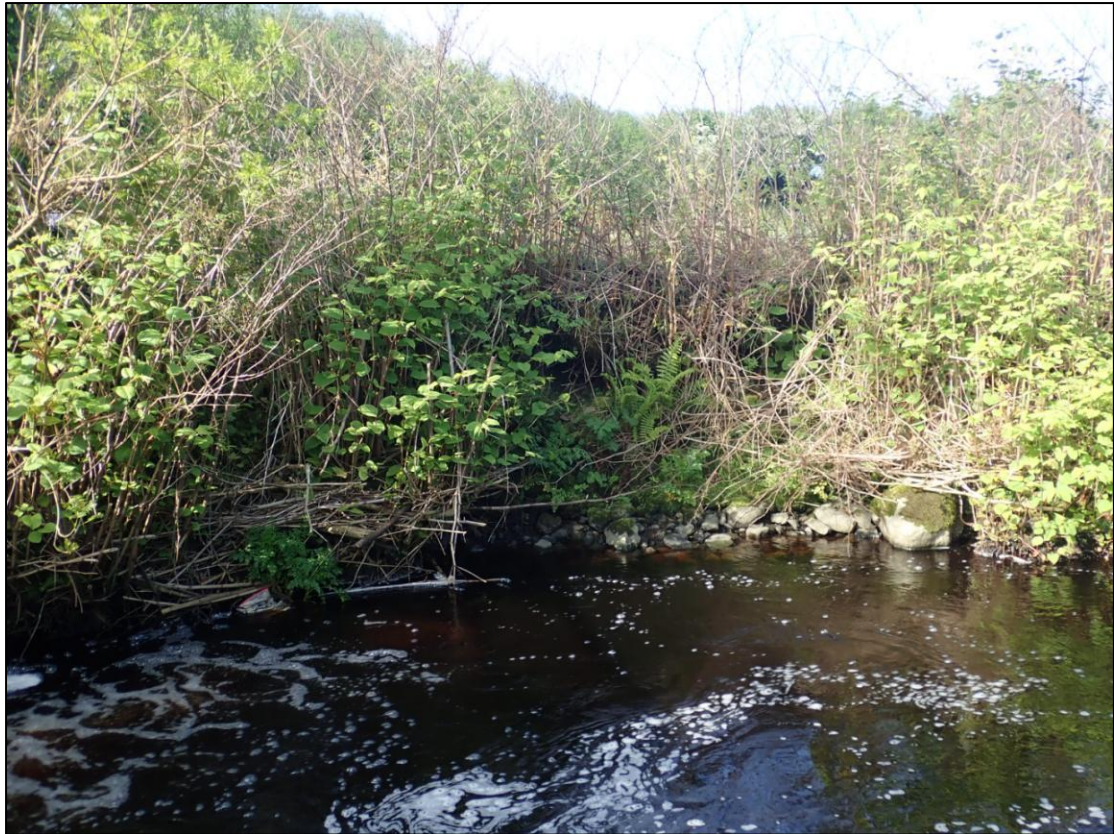
The original NIS states *“no invasive species were recorded at the site during the site survey, but precautions will be taken to ensure that no invasive species are introduced due to the proposed works,”* however, our site visit showed that there is a large stand of Japanese knotweed present at the downstream river-left wingwall (left as one looks downstream, or the western-most area of the bridge) and extending for ~20m downstream covering the river-left bank.

Since the bridge is in very poor condition, and there is no time to eradicate the plant before carrying out the bridge repairs, in order to mitigate against the spread of this plant, a number of practical measures should be followed:

1) The d/s left wingwall should be left in place until all other elements of the bridge have been removed to keep the infested from being disturbed until the bulk of the work has been done.

2) Rubble and other excavated materials should be split into two piles; uninfested material and potentially infested material. The potentially infested material should be left onsite adjacent to the stand of knotweed and treated onsite over an extended period of time with herbicide until the knotweed in the excavated material and on the river bank has been completely eradicated.

3) Removal of elements of the bridge which may contain knotweed should be done in one go so that the excavator is not contaminating the uninfested material which is to be brought offsite. As such the wing wall and whatever fill is behind it removed and placed near the existing knotweed as a separate job, perhaps done in an afternoon, and the excavator bucket and tracks should be thoroughly cleaned with a power hose of coarse-brush and water after that element of the works has been completed. This area should be cordoned off (site fencing or site tape) to ensure vehicles are not tracking over it etc.

4) The ecologist should be onsite for the removal of materials on the west bank (river left) which may contain knotweed, and the ecologist should follow the standard

approach for removal of earth contaminated with knotweed; i.e checking the bank as the bucket of the excavator has removed a scoop to see the cross-sections of the rhizomes (similar in cross-section to that of a small carrot).
