Archaeological Impact Assessment at Fuller's Folly, Newcastle West, Co. Limerick.

Report Author: F. Coyne MA MIAI

Date: 07 July 2023

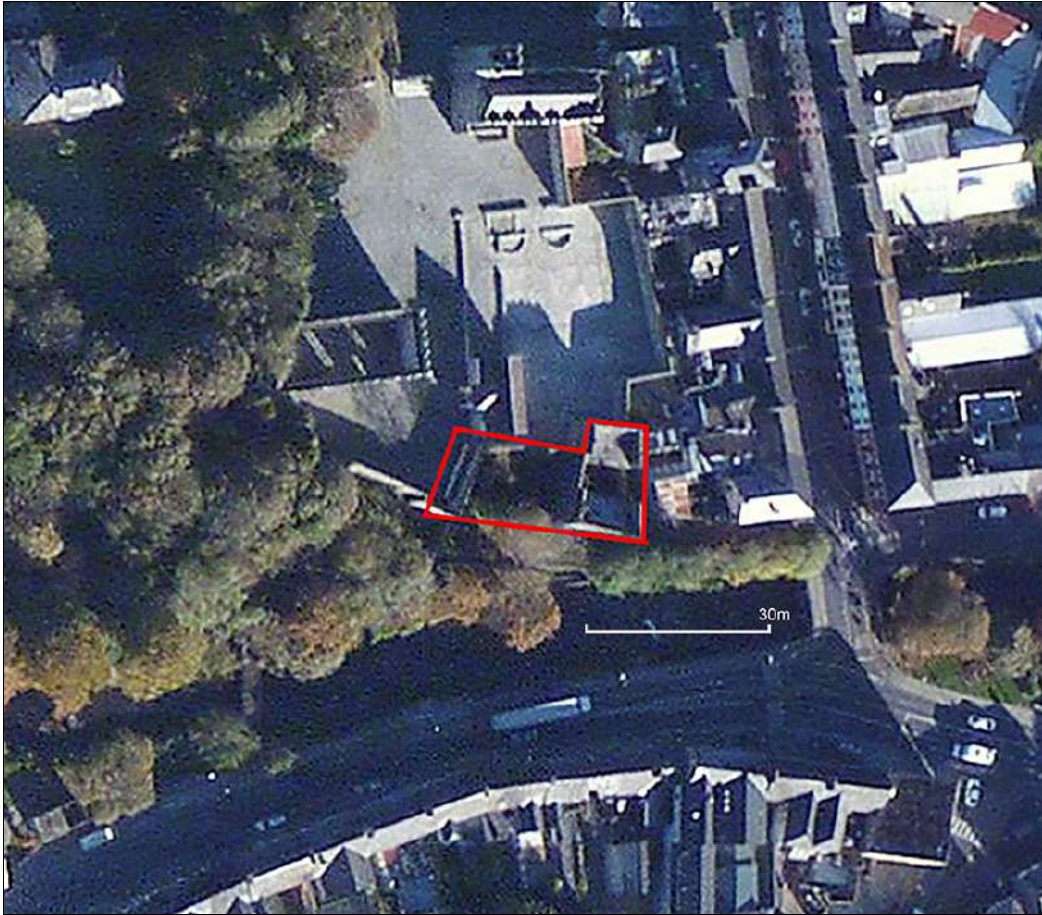
Figure 4. Aerial view of the Fuller's Folly (after Digital Globe 2011). North to top.

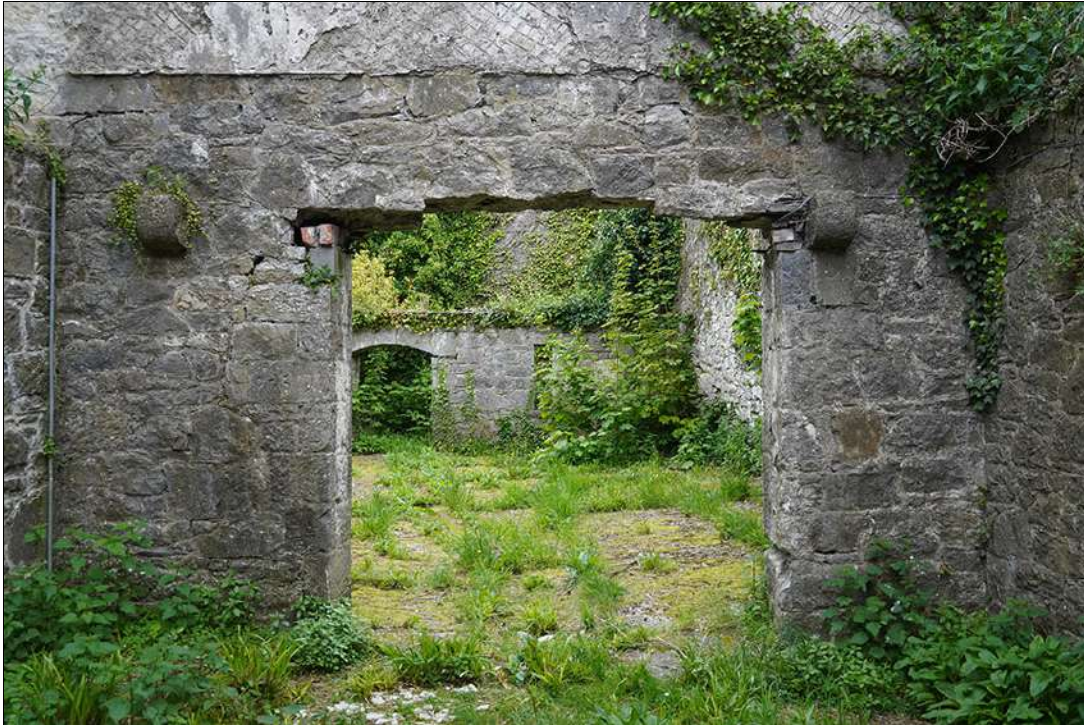
The main courtyard is entered through another arch, which is missing several of its voussoirs and keystone. A datestone has been reused in the southern side of the entrance, set on its side.

Plate 1. View through arch into courtyard area, from E.

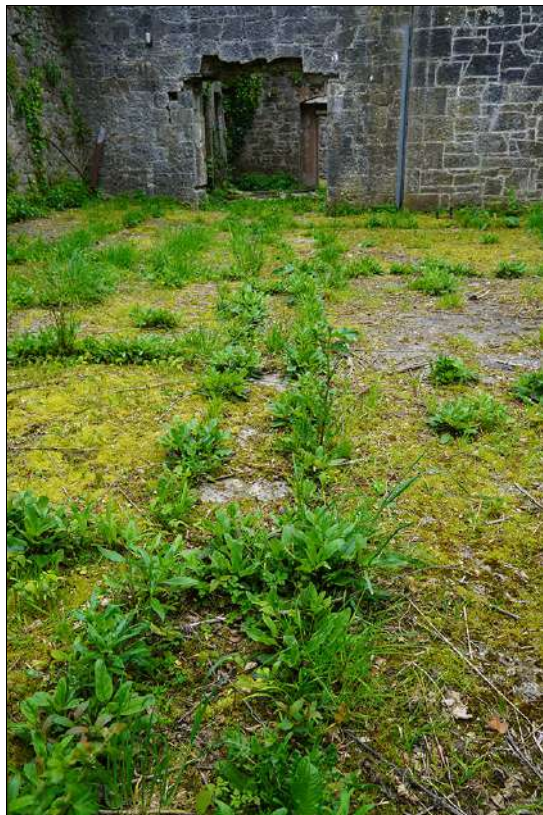
The courtyard has a concrete floor, sloping towards its centre where a wide shallow drain can be discerned. This floor and drain are the remnants of the abattoir which formerly stood on the site. An outbuilding with an *in situ* date stone as the keystone of the arch over the door is located at west. Further to the west and outside of the subject site is portion of the original bawn wall of the castle (c. 1213).

Plate 3. Detail of drains and outline of sheds relating to the use of the site as an abattoir indicated by weeds in cracks in the concrete, from E.

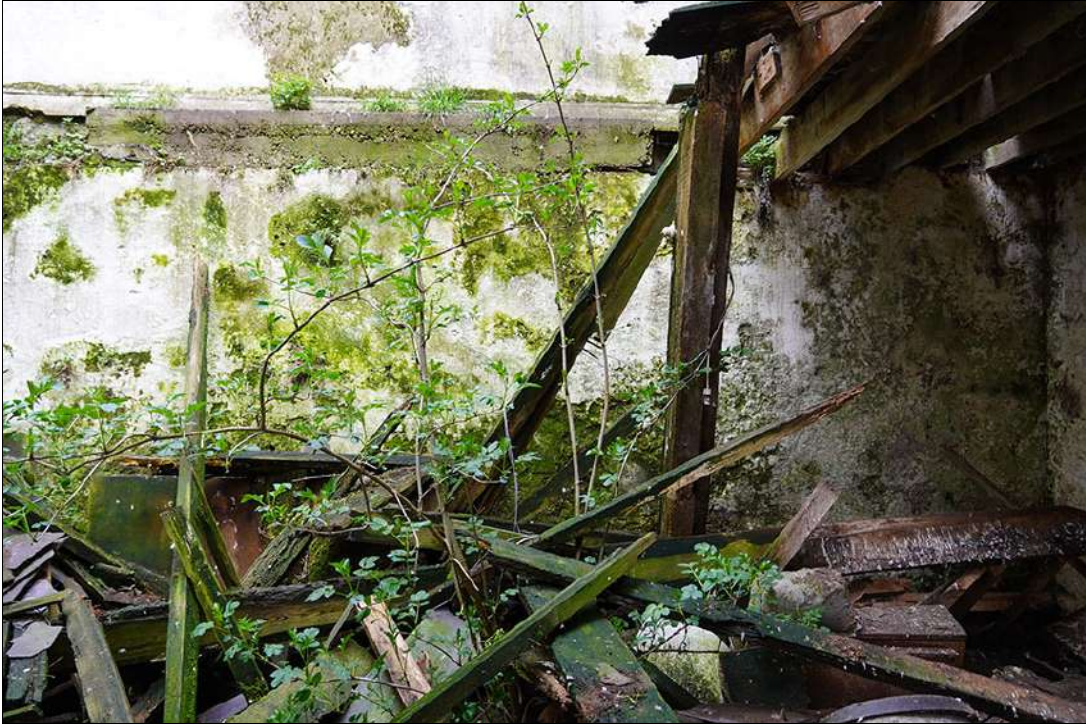
The subject site consists of the building known as Fuller's folly. It is entered through an arched entrance at east into a narrow courtyard. The building on the south side was refurbished a number of years ago. The roof of building on the north side has partially collapsed, and the interior of the building contains debris from the collapse, as well as other items which appear to have been stored here.

Plate 3. Debris from collapse and assorted items of possible cultural heritage interest in the northern building, from S.

- Any proposed works to Fuller's Folly should be carried out under Ministerial Consent (as per determination from National Monuments Service 12 July 2023). As the site is a Protected Structure a Section 57 Notification will also be required for any proposed works. The LCC&C Conservation Officer should be consulted in this regard.
- The northern structure in Fuller's Folly contains material which may be of cultural heritage interest. The original abattoir door lies on the ground nearby. These items should be examined by a heritage professional, recorded in the appropriate manner and a decision made as to what items are to be retained and possibly reused in any future development. The items in the northern building should only be examined when the building is made safe.

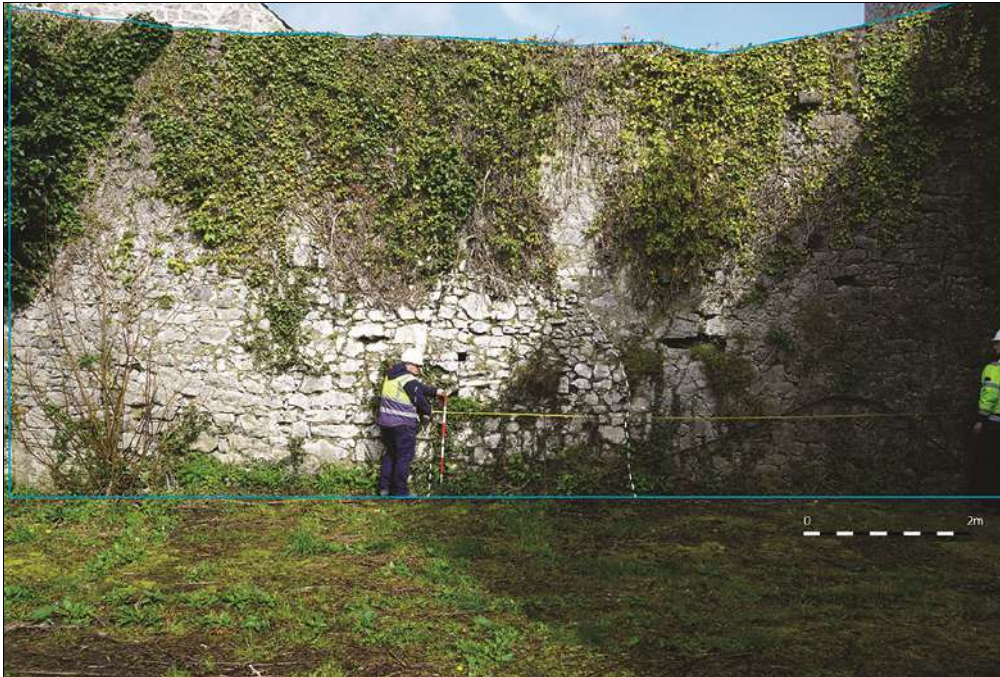
The northern boundary wall is markedly different in construction. It appears on earlier maps (Ordnance Survey 1st edition map), and corresponds to the suggested line of the thirteenth century (c. 1298) wall of the castle. Local information suggests that there was a breach in this wall until approximately 30-40 years ago, when it was closed up.

Plate 4. The south face of the boundary wall as seen from Fuller's Folly. The dashed line indicates the presence of the former hole in the wall which allowed access to the yards at north (photo by writer).

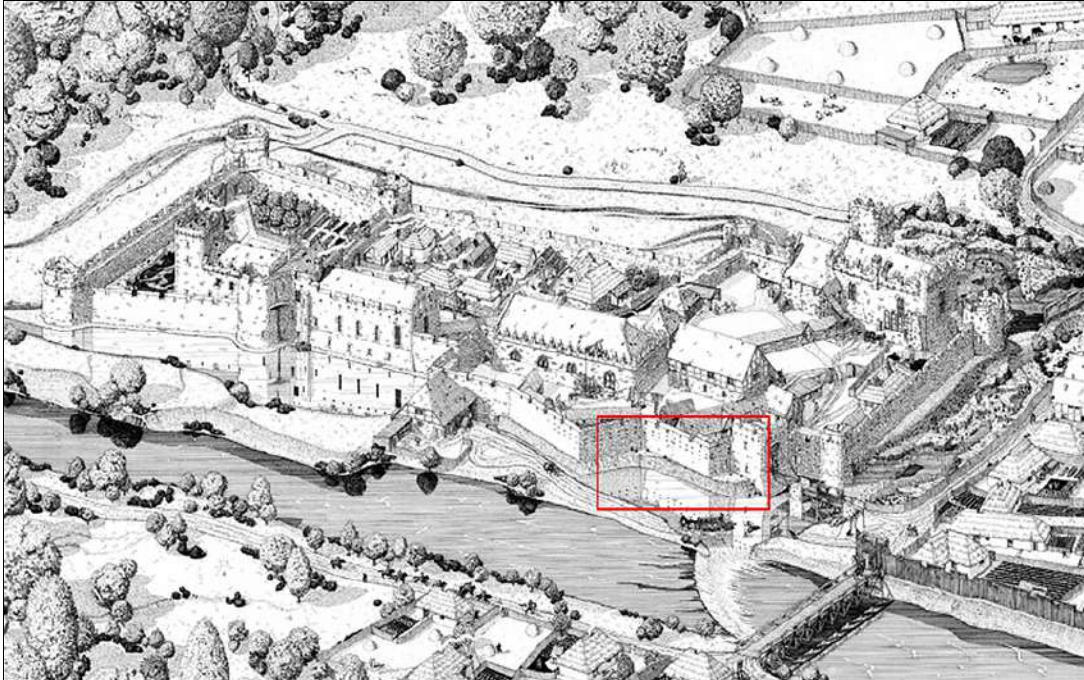
Figure 6. Reconstruction drawing of the castle complex (Tietszh-Tyler 2011, 4). Note location of Fuller's Folly in the moat area (annotated by writer).

Based on the current reconstruction drawing and proposed development of the Desmond Castle, the subject site contains the bawn wall of the Desmond Castle. If the reconstructions and proposed development are accurate, Fuller's Folly is constructed in/on the defensive moat of the castle. Therefore, Fuller's Folly must be considered to be built on part of the castle.

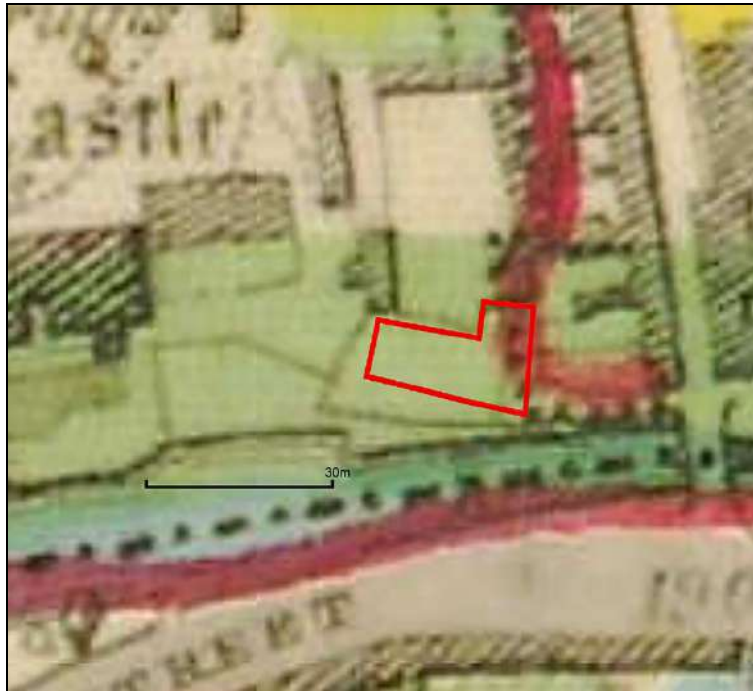
Figure 8. Fuller's Folly in red on OS first edition (c. 1840) 6-inch map (after www.archaeology.ie). North to top. This suggests that the wall between Fuller's folly and the castle ground pre-dates the construction of Fuller's Folly (annotated by writer).

Fuller's Folly dates from 1863, according to a date stone in the southern wall of the courtyard of the structure. The wall between the site known as Fuller's Folly and the grounds of the Desmond Castle is approximately 5.5m high, constructed of roughly coursed random rubble. It has been repointed with lime mortar on its northern face. On its southern face in the yard of Fuller's Folly, cementitious mortar is used on its eastern length, with lime mortar used elsewhere. A visual examination of the visible fabric suggests that the northern building of Fuller's Folly has utilised portion of an earlier wall in its construction. The wall which runs from the northern building in a westerly direction, and forms the boundary between the yard of Fuller's Folly and the castle grounds to follow the line of an earlier wall depicted on the Ordnance Survey 1st edition map (c. 1840). Local information records that the yard of Fuller's Folly was used as an abattoir in the late 20th century. The concrete floor in the courtyard relates to the use of the site as an abattoir. It is unclear what this concrete is laid on-it is possible that there is a cobbled surface beneath this. At this time also, a hole in the wall was opened to give access to the yard in the castle grounds to the north. Local information suggests that it was repaired within living memory. The repair is clearly visible on the southern face of the wall, and less so on the northern face. This wall is constructed along the suggested line of the bawn wall of 1298, as suggested by Tietszh-Tyler (figures 8 and 9). Therefore, there is a likelihood is a possibility that wall contains medieval fabric. It is difficult to say how much of this wall is medieval-it may be entirely medieval in date.

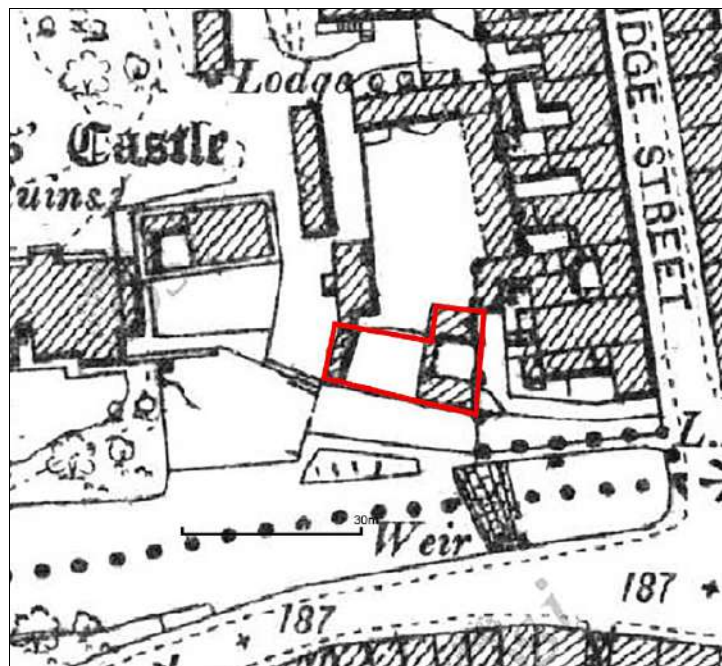
Figure 9. Fuller's Folly in red on 25-inch OS map (after www.archaeology.ie). North to top. Surveyed 1897, published 1900. Annotated by writer. Note the curved wall
