**Mungret Residential Development**  
Conservation Report

Proposed Development at Dromdarrig, Mungret, Co. Limerick

November 2023

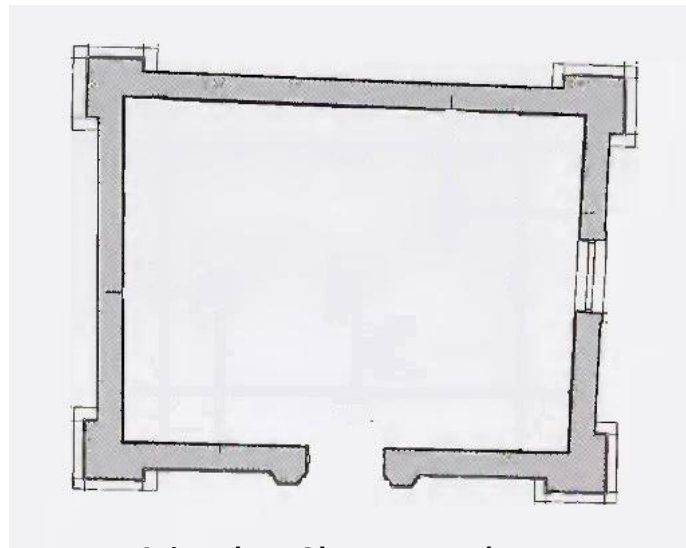
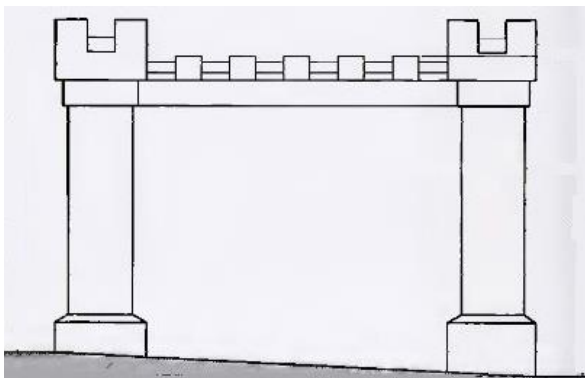
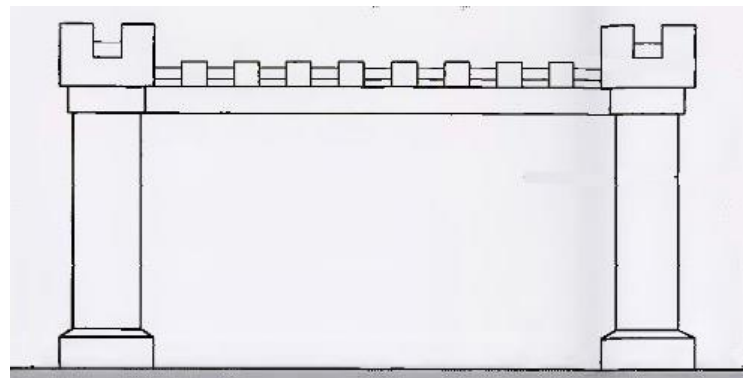
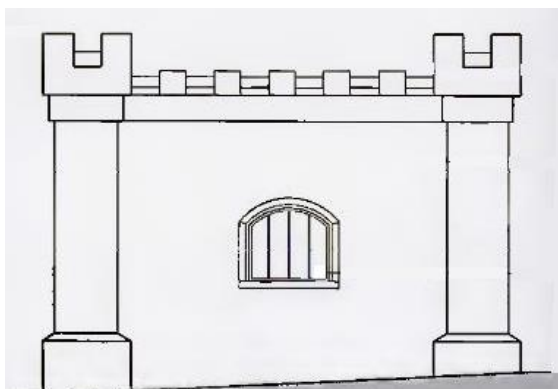
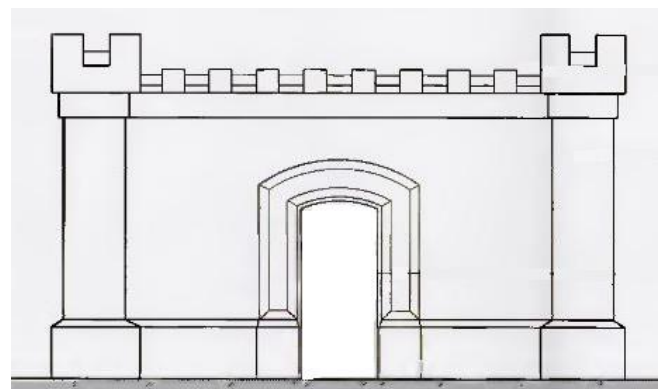
*Fig.02d : Mungret Seismology Observatory. Plan ad Elevations*

**Seismology Observatory Plan**

**North Elevation**

**East Elevation**

**South Elevation**

**West Elevation** (this elevation faces the east elevation of the main college.)

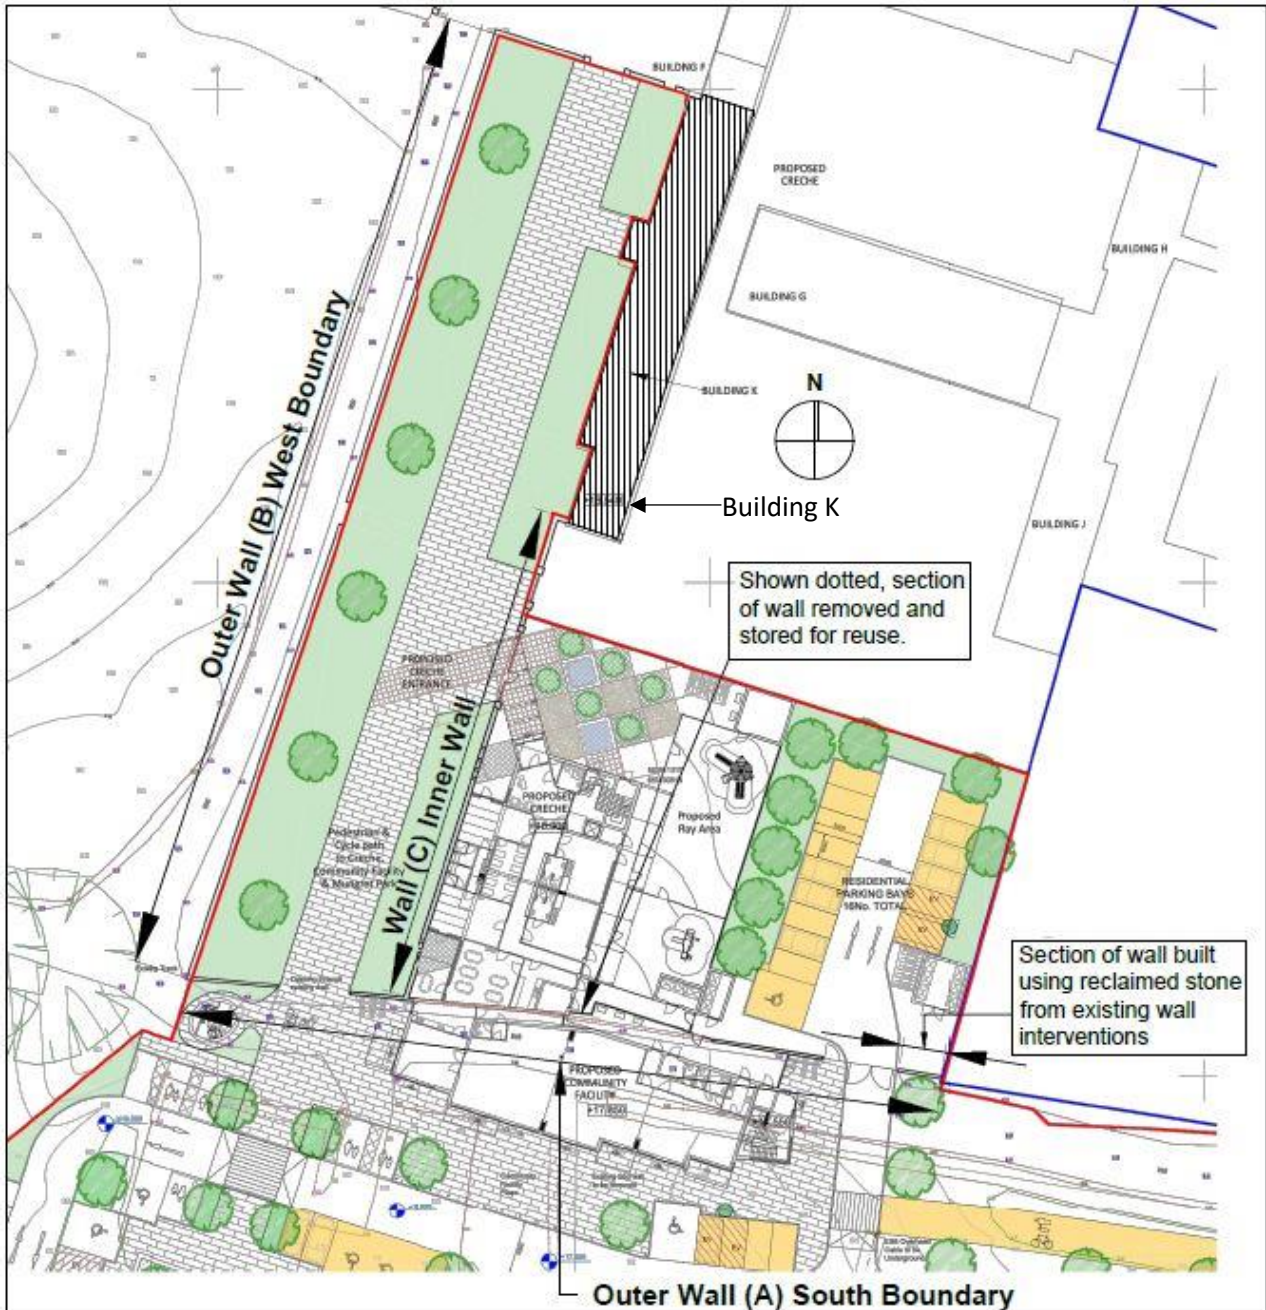
fig:-03 Plan of Existing Walls and Proposed Creche & Community Facility

The walls as found on site can be divided into two main elements. The outer boundary walls facing South (A) and West (B) and the inner enclosing wall (C) fig.03

The wall (C) fig.03 is located internally and is aligned parallel to the outer western wall. It engages the south elevation of building K fig.11. This wall is constructed with random rubble stone built to courses with mortar joints. There are Two piers finished with a smooth render and stone capping fig.10. There is vegetation growth in parts.

There will be six-narrow full height openings created in the inner wall (C)fig.03. These are an integral part of the creche design. They allow shafts of light to pass through the wall and illuminate both the pocket garden and open dining area spaces. This light also spills into the surrounding rooms adjacent to these spaces. This light offers a softness against the strong wall and as the sun moves through the day. This allows a constant change of mood and feel about the open spaces. This can also be said of the seasons. The high summer sun and the low winter sun in the sky. Always creating light, shadow, tone, and texture. That is the importance or retaining this wall and incorporating it in the design.

A central axis way has been created between wall (A) and the Creche and Community Facility. It is the intention to retain as much of the boundary wall (C) stone fabric as possible. Where modifications and interventions are proposed, including section of wall removed. The stone will be stored on site and reused in the construction new section of wall fig.13. This will ensure the wall fabric endures.

In concluding, the walls indexed (A),(B) and (C)fig.03 will form part of the proposed crèche and community facility fabric. The life of these historic walls will therefore be prolonged by undertaking a strategy to clean, restore, and repair them. Thus, these interventions will allow the retention of their own individual character. All new openings formed in these walls will have been carefully considered during the design process. A key factor is not to remove the wall's original purpose, which was to surround, protect and create boundaries of safety.

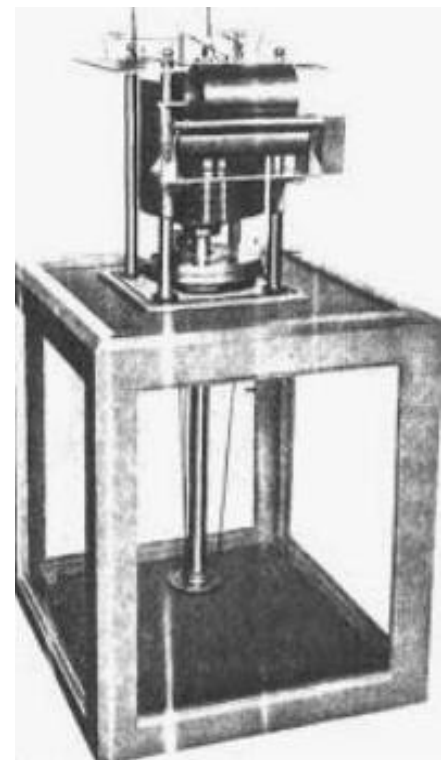
At the Coronation Exhibition in London in 1911 Fr. O'Leary exhibited his own inverted pendulum design, a new seismograph fig.05c that he used in Mungret. One of the main problems in the field of seismology is how to obtain an instrument with a fairly long period and consequent high sensitivity. Fr. O'Leary provided a solution with his two-component seismometer. Some of the leading seismologists of the time such as Professor Milne had high praise for the invention.

*Fig.05c, Reproduction of a Photograph of the seismographs installed at Mungret Sourced from Mungret Observatory building repairs- Site inspection report/method statement for building repairs.04-05-2010*

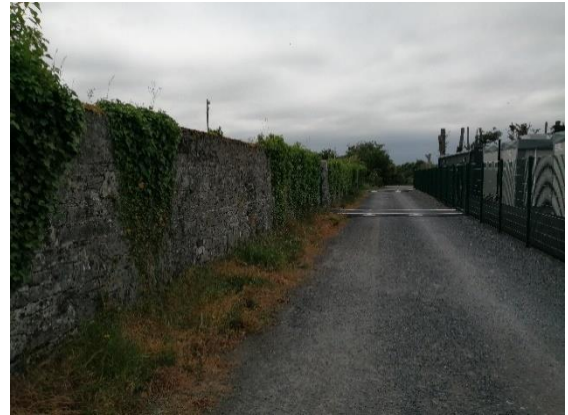
Fig.07 Survey photo of Outer wall (B) West Boundary

The South(A) and West(B) walls form the south-westerly corner of the site that bounds a lane fig.09. These walls are constructed with random rubble stone, built to courses with mortar joints. The facade and top of wall including the bedding joints have a considerable amount vegetation growth. There is extensive lichen staining on the wall elevations fig.07 & fig.08.

The bedding joints as found are in various stages of deterioration and decay. In sections there is a loss of material.

There is a light render finish on sections of the wall, which have deteriorated. The stone outline can be seen underneath said render.

A cleaning and conserving strategy will be undertaken by a professional with expertise in this area. All vegetation will be removed, and care taken to the surrounding stone and mortar joints. Where mortar joints have deteriorated and decayed, a process for the repointing will be undertaken with regards to, raking out, washing, brushing, mortar mix and curing. The joints will be cleaned and loose debris removed prior to repointing. A NHL lime mortar to the appropriate specification will be used for repointing, adhering to good conservation practise of replacing like with like materials. All dependant on wall stability.

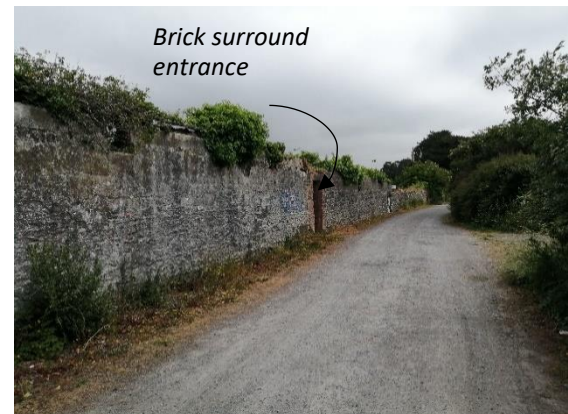
Fig.08 Survey photo of Outer wall (A) South Boundary

Both walls have access points. The opes are formed in brick to the south and stone to the west. On the south wall there are changes in height fig.08, possibly indicating previous intervention. This would require further investigation. Also, on the south wall there is evidence of a concrete capping fig.08-fig.09.

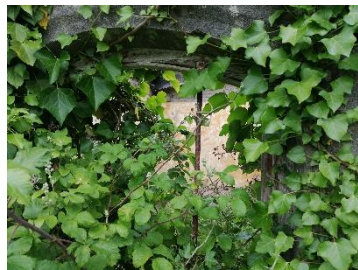
Fig.11a Survey photo: Window

The south elevation has a single window ope with a timber frame containing vertical iron bars. There is a raised architrave and a segmental arch with a rendered finish. There cill is of rendered concrete.

Prior to the beginning of works on the window. A survey of the timber frame (head jambs cill) and vertical iron bars including their fixings will be carried out to assess their current condition. The timber frame is to be cleaned and any localised decay will be spliced with new timber (using a compatible wood with similar characteristics to the original). This procedure will also apply to rotten wood. The wood will be primed and painted with a finishing gloss coat. The vertical bars are to be cleaned with rust removed. Note, where corrosion has taken hold, new Iron bars are to be used.

Brushes are to be used when applying the primer and the final gloss paint. The bar fixings to the frame are to be assessed for stability. Any deteriorated fixings will be replaced with similar fixings. A professional in the conserving of historical windows will be engaged for their professional expertise and guidance in this area.

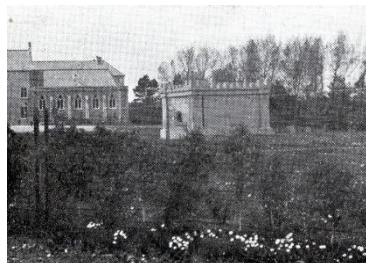
Fig.11b, Mungret Observatory 1909. Reproduction of a Photograph taken by Fr. William O

There is no roof on this building. The type and build-up of roof is unknown but may have been a flat roof to a fall. See fig.11b from 1909, a flat roof may have been contained within the confines of the wall parapet. Holes on the inside face of the external west and east elevation walls may have supported a roofing structure. (this will require further investigation)

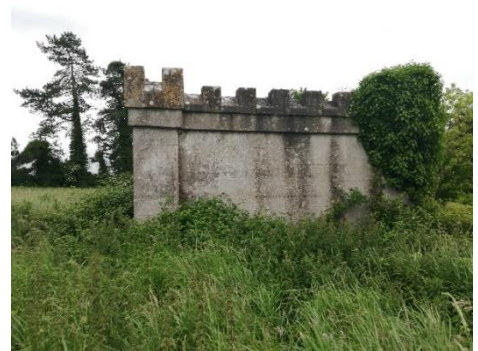
Fig.11c Survey photo: Observatory North Facing Elevation

As found on site, the walls are constructed from shuttered concrete. There is evidence of formwork on the internal walls, where the plaster has dislodged and exposed the shutter texture. The internal walls have a plaster finish. There is a render finish on the external wall with equal ruled and lined coursing. (suggesting ashlar stone). The four corners of the building have pilasters with rendered deep raised plinths.

There is a castellated parapet to the top of wall with merlons and sloping crenels, above a lower section of eaves course that projects beyond the wall face. There is extensive biological and vegetation growth on all the walls.

The North and East elevations contain no opes, except for a single circular drainage ope below the eaves band on the west elevation.

All vegetation growth is to be carefully removed with care taken not to damage the surrounding wall fabric. This will include any areas of soil deposits found in wall cracks, castellated parapet (ie sloping crenels and merlons) or any part of the wall structure. An expert in this area will be engaged.

Structural Cracks in the wall of +2mm under the supervision of an expert in this area are to be raked out carefully and all loose debris to removed. An epoxy resin or equal approved mortar is to be injected. All to be agreed prior to the works commencing with a structural engineer.

Surface Cracks in the render are to be cleaned and any loose debris or contaminants are to be carefully removed. This is followed by the use of a proprietary mortar to fil the cracks. It is important prior to the commencing of the works a sample area will be prepared to match wall colour.

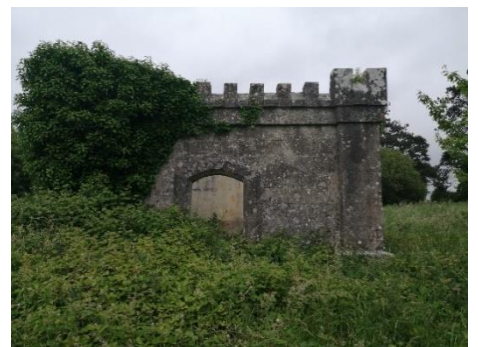
Fig.11e Survey photo: Observatory West facing Elevation

The west elevation contains a single door ope. It has a segmental arch with raised architrave and head. The material is possibly concrete with a rendered finish. This can be seen where there is a loss of render at the springing point of the arch (right side facing the door). There is no frame or door leaf remaining.

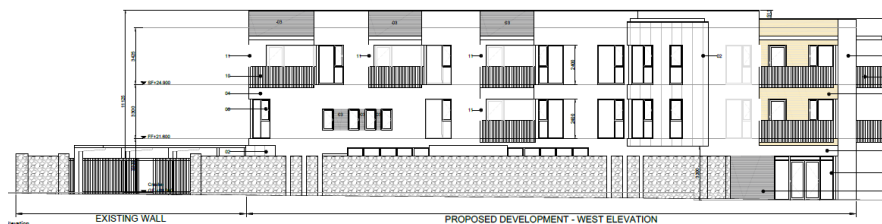
Fig.14 West facing Elevation indicating the tall narrow opes and modifications to the wall.

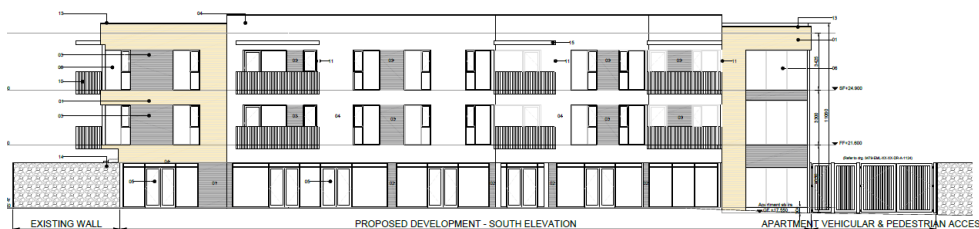
Fig.15 South facing Elevation indicating the buildings engagement with the wall.

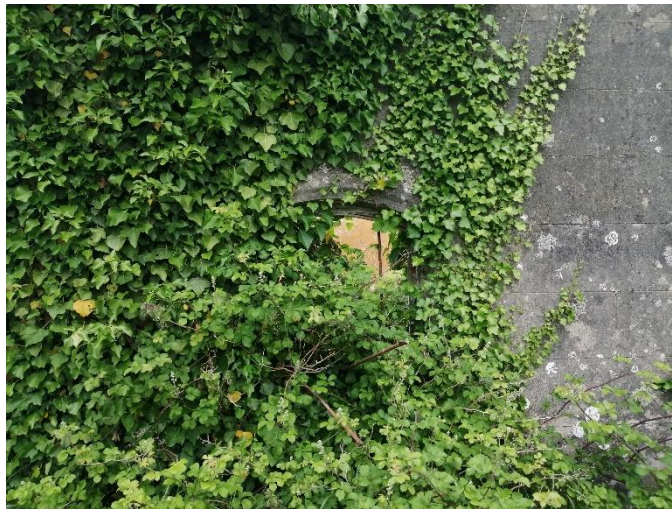
*C5: Observatory South Facing Elevation, Indicating Window completely overgrown with vegetation*

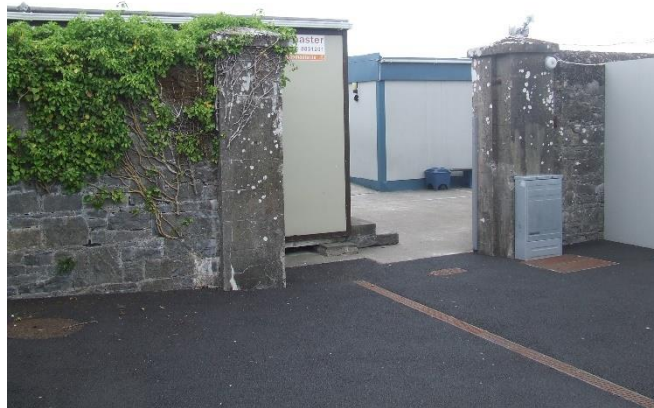
*D7: Wall (C)fig.03 External elevation Piers to be retained.*

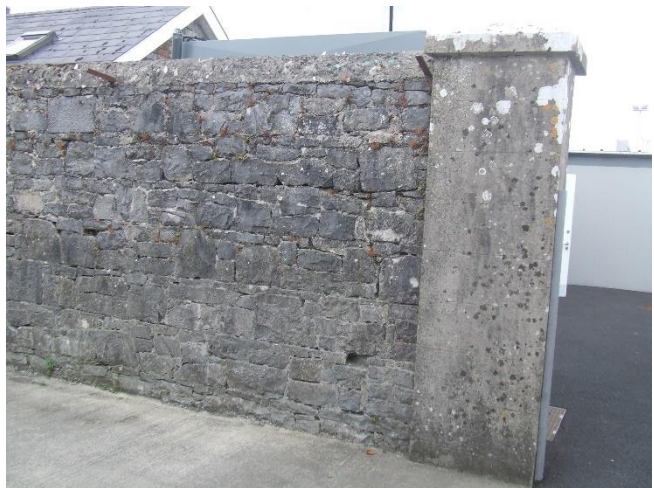
*D8: Wall (C)fig.03- Internal elevation Piers to be retained.*
