Stage 1 Road Safety Audit

South Circular Rd to Bishops Quay Cycle Lane, Limerick City

On behalf of Limerick City & County Council

September 2022

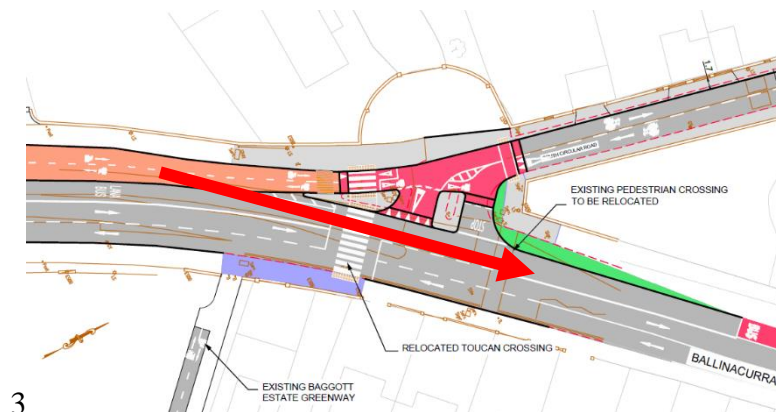
3

4.3.1 Ballinacurragh Road cyclists

Problem: Cyclists travelling south to north on Ballinacurragh road are not given opportunity to egress the cycle facility to continue their journey on the main carriageway.

Hazard: Cyclists are likely to jump down the full face kerb and enter the bus lane immediately prior to the South Circular Road junction. Cycle loss of control / impact with a passing bus may result.
