Kilfinane Market House Conservation Report

20th November 2023

**Document Title: Structural condition report
231245-PUNCH-XX-XX-RP-S-001**

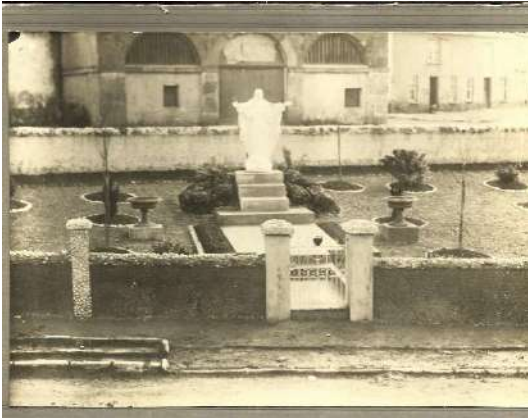
1927. Ground floor arches enclosed. Former school house on Captains Lane visible on right.

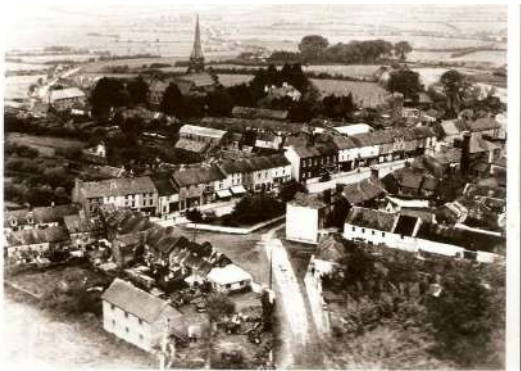
c. 1950 Market House roof appears intact. Former National school on Captains Lane (now demolished) in foreground.

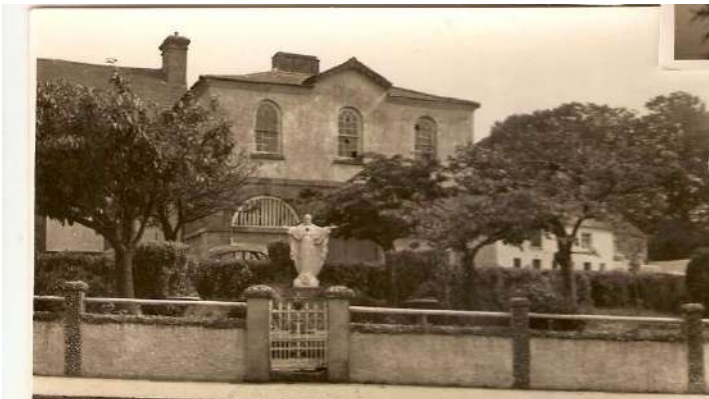
1952. The Sacred Heart Grotto with Market House in the Background. Roof is intact but broken glass to first floor indicates the building a possibly not in use.

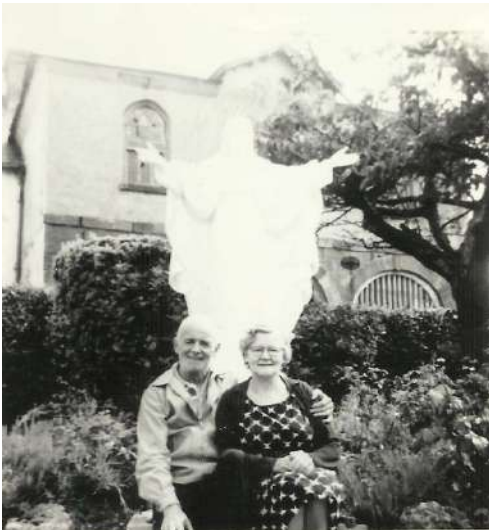
1972 . John Landers with his sister Nora Kenneally at the Sacred Heart Grotto with the Market House in the background. The building appears largely unaltered since 1950 with roof intact. Some deterioration of the rendered eaves detail is evident .

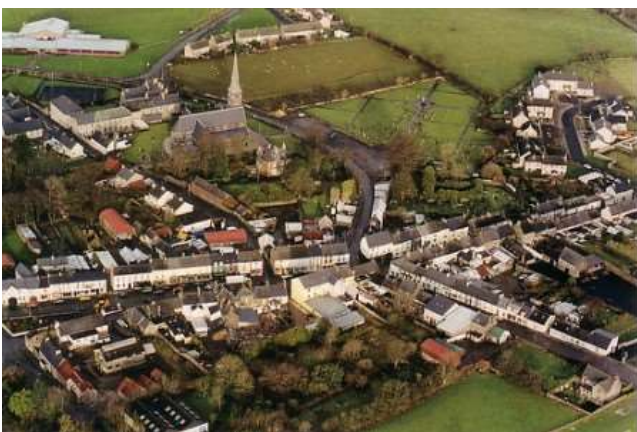
1990s Kilinane Aerial View. Market House visible in bottom left corner. Roof possibly missing but image unclear.
