For: Limerick City & County Council

Adare Public Realm Upgrade Project 2026,
Adare, Co. Limerick.

STAGE 1 ROAD SAFETY AUDIT

December 2025

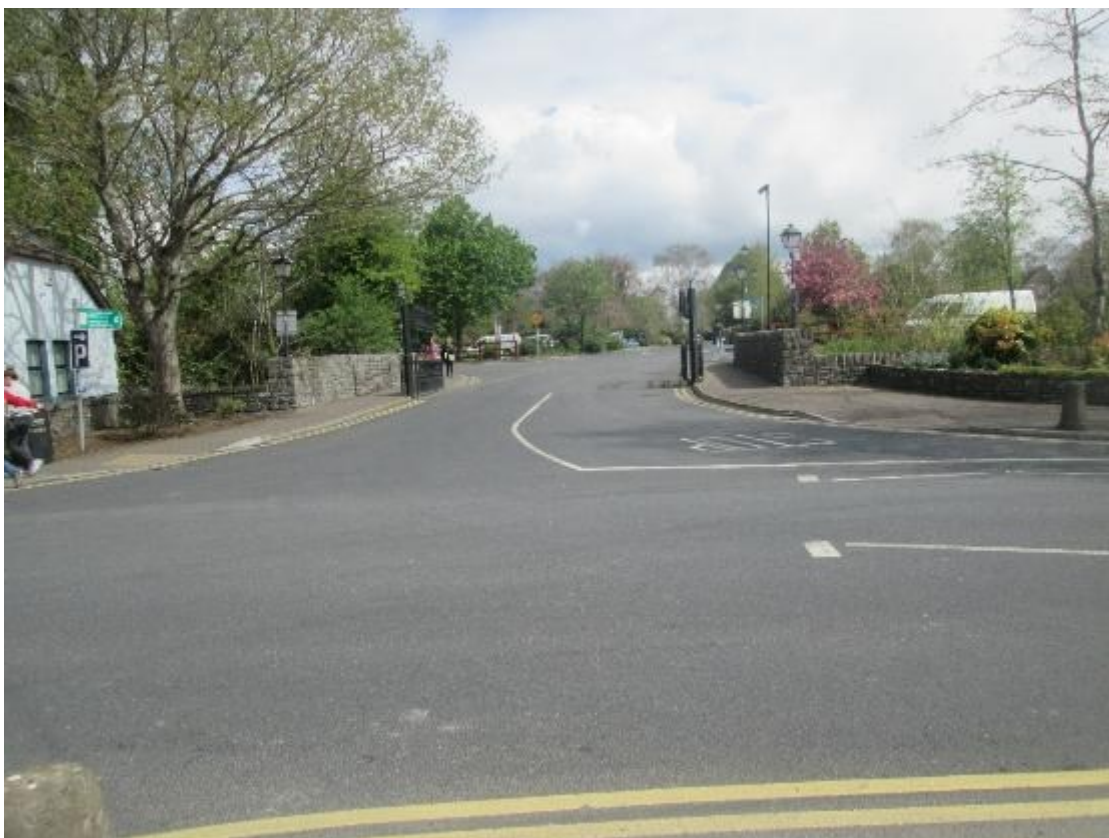
Figure 5.4 Photo 4 Heritage Centre Car Park Entrance

Junction visibility splays have not been shown on the drawings provided to the Audit Team. Both the Proposed and existing Landscape features appear to be potential obstructions to forward visibility splay emerging from Heritage Centre Car Park onto Station Rd. Failure to provide adequate forward visibility at junctions can result in conflict between emerging traffic from junctions and lead to collisions.

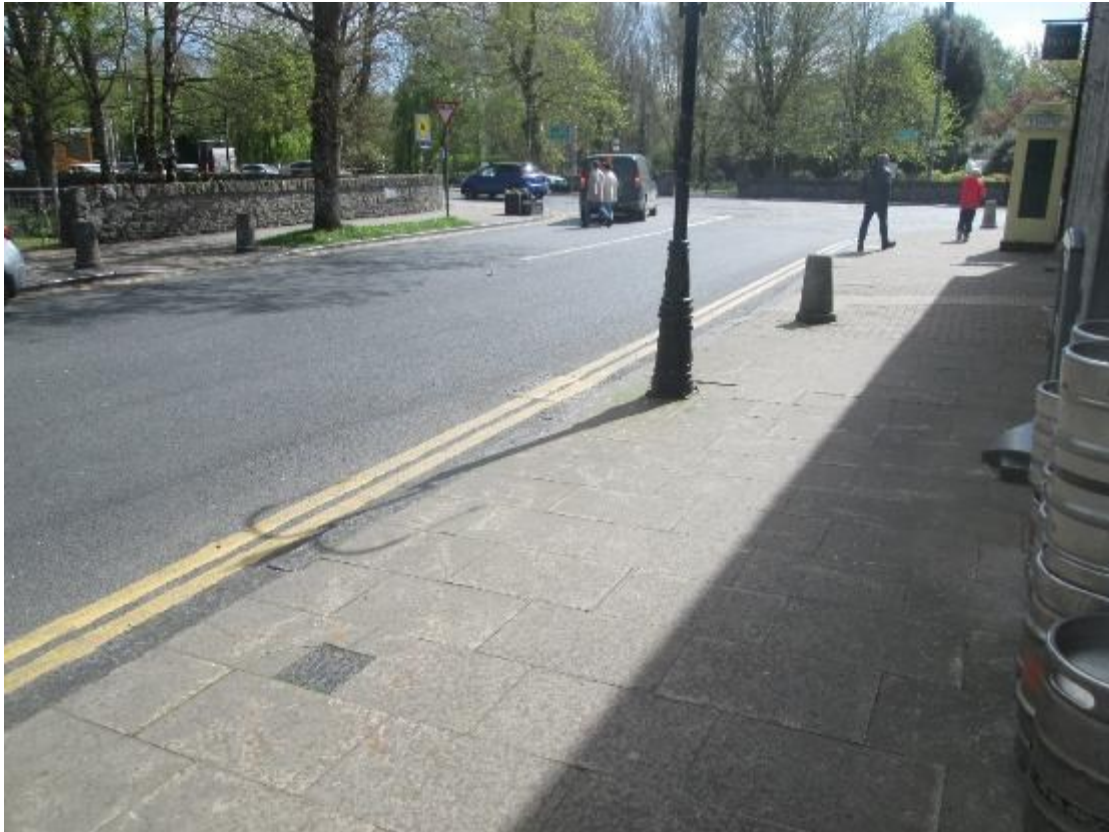
Figure 5.5 Photo 5 Station Road / Main Street Existing Junction

Ensure sufficient forward visibility is provided to vehicles at all emerging roads and junctions. Forward visibility at the proposed junction of Station Rd. / Main Street appears to be obstructed by existing Landscape. Failure to provide adequate sighting distances to vehicles can result in drivers not allowing adequate time or distance to oncoming traffic which may result in collisions with vehicles.
