Site Inspection Report

H1137 - Tourism and Limerick Greenway Projects

Structural Condition Survey - Fullers Folly

15.02.2023

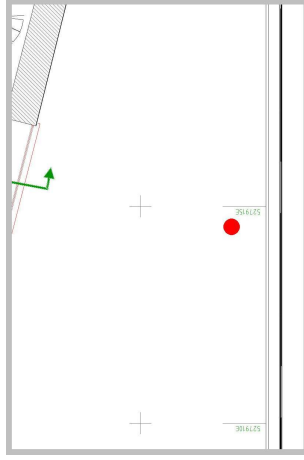
001 / 003

West Elevation of Fullers Folly showing south section of the building.

Southern section of building - Vacant office accommodation over 3 no. floors.

This section of the building is generally in good structural condition.

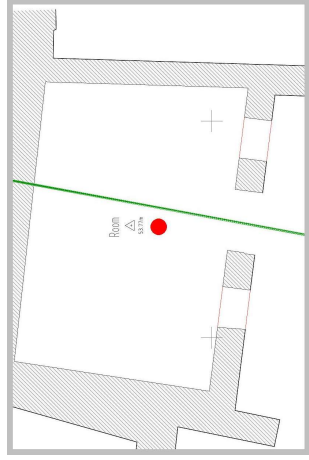
001 / 008

A part of the first floor remains intact but is in poor condition. The floor joists are open to the elements and degraded.

We recommend that the remaining first floor structure is demolished and removed off-site.

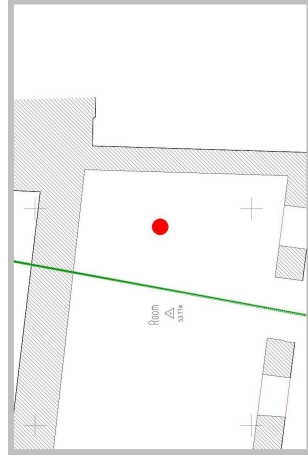
001 / 009

A part of the first floor remains intact but is in poor condition. The floor joists are open to the elements and degraded.

We recommend that the remaining first floor structure is demolished and removed off-site.

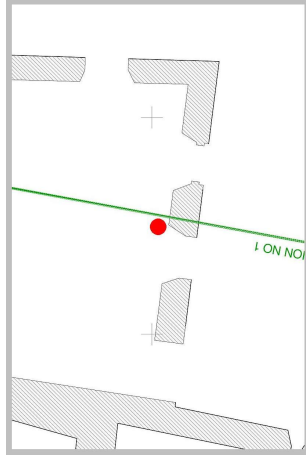
001 / 011

The existing timber lintels are exposed and have degraded. There is a brick arch visible above the timber lintels. The window opening is stable. The timber lintels will need to be removed and replaced during the proposed refurbishment of the building.

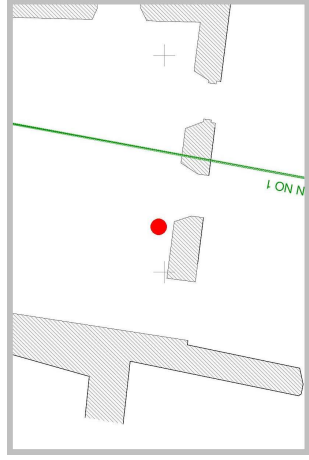
001 / 012

There are brick arches visible over the door and window openings at ground floor level. The arches generally appear to be in good condition.

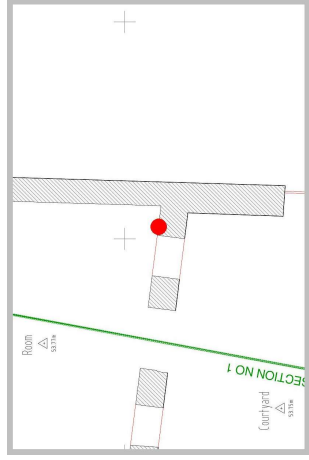
001 / 018

The roof has partially collapsed over this wall.
The north stone rubble wall is stable and generally in good condition.

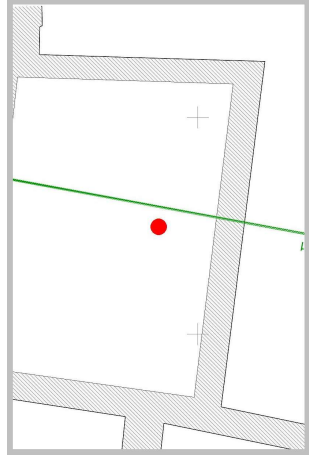
001 / 020

The castellated parapet walls above the roof appears to be structurally stable in the relatively good condition.

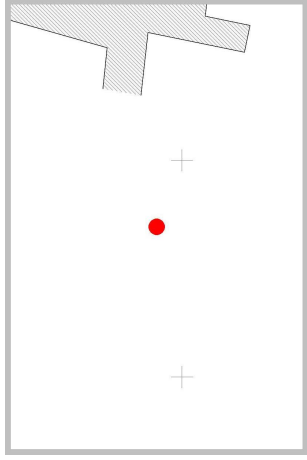
001 / 028

The wall appears in be stable and in good condition.

We would recommend that the ivy is cut back at the base and removed when it has died back to prevent the ivy damaging the wall.

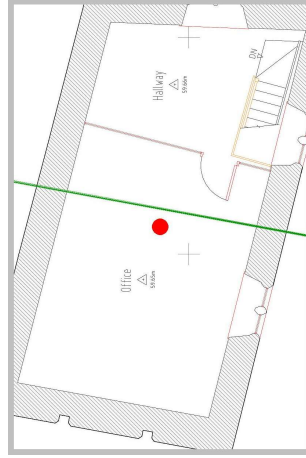
001 / 031

Walls are drylined. The structure generally appears to be good condition.
