Arboricultural Impact Assessment

Limerick City & County Council

Quins Cross to Raheen Rounabout Cycle Scheme

Arbor-Care (Ltd) Professional Consulting Tree Service, Unit 1A, Crossagalla Enterprise Centre, Ballysimon Rd., Limerick.

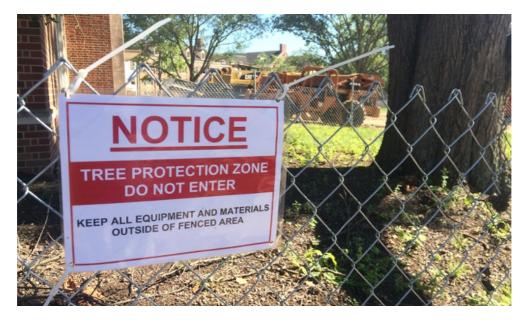
Fig. 4 Signage to be placed on all protective fencing

The signage must state the following;

8.7 The erection of protective fencing is to be erected to the fence line shown in tree protection plan. The fencing must adhere with BS 5837: 2012 (Figure 4 and Figure 5 above). Signage must be placed on the fence to highlight its importance. Once the fencing is erected works can commence on-site.
