NATURA IMPACT STATEMENT ADDENDUM

Response to Request for Further Information

Bruree Bridge, Bruree, Co. Limerick

Our ref: ABP-322242-25
ABF Ref: 177AE Bruree Bridge

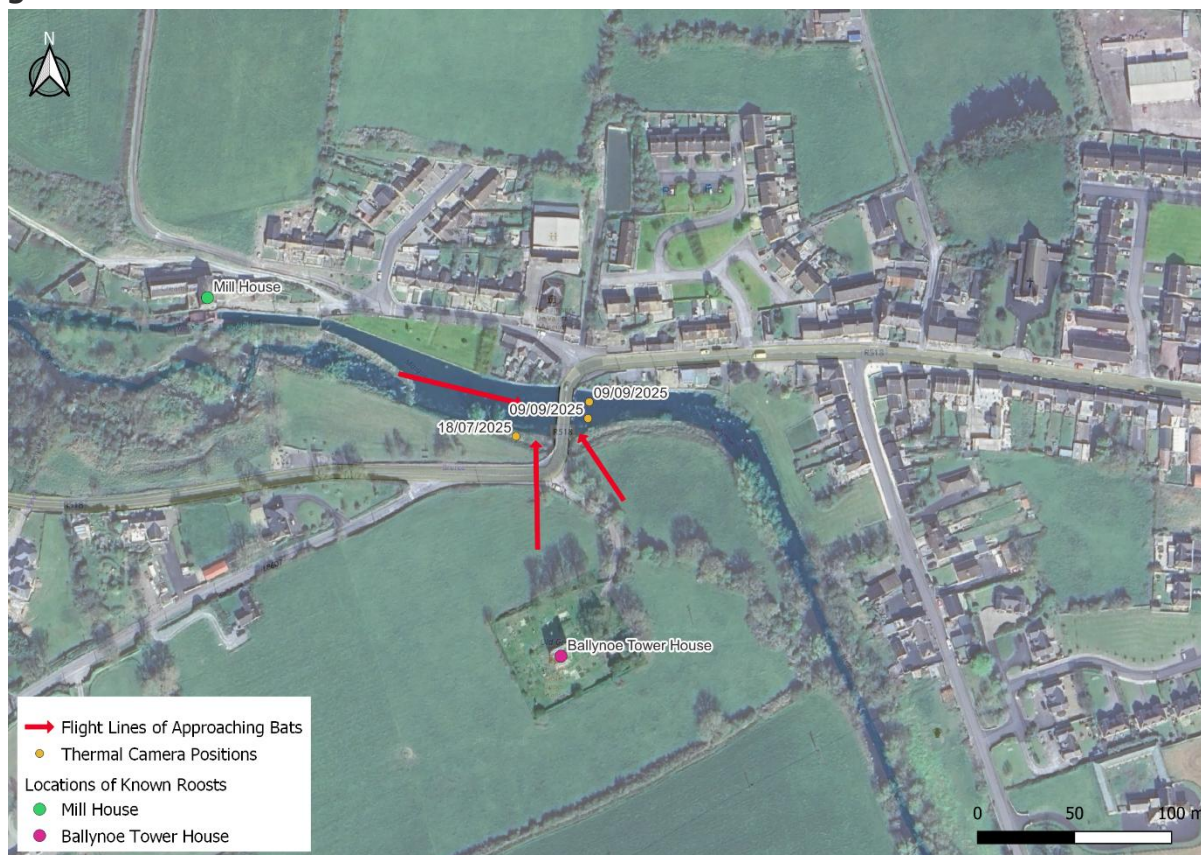
Figure 1. Map of survey positions and flight lines

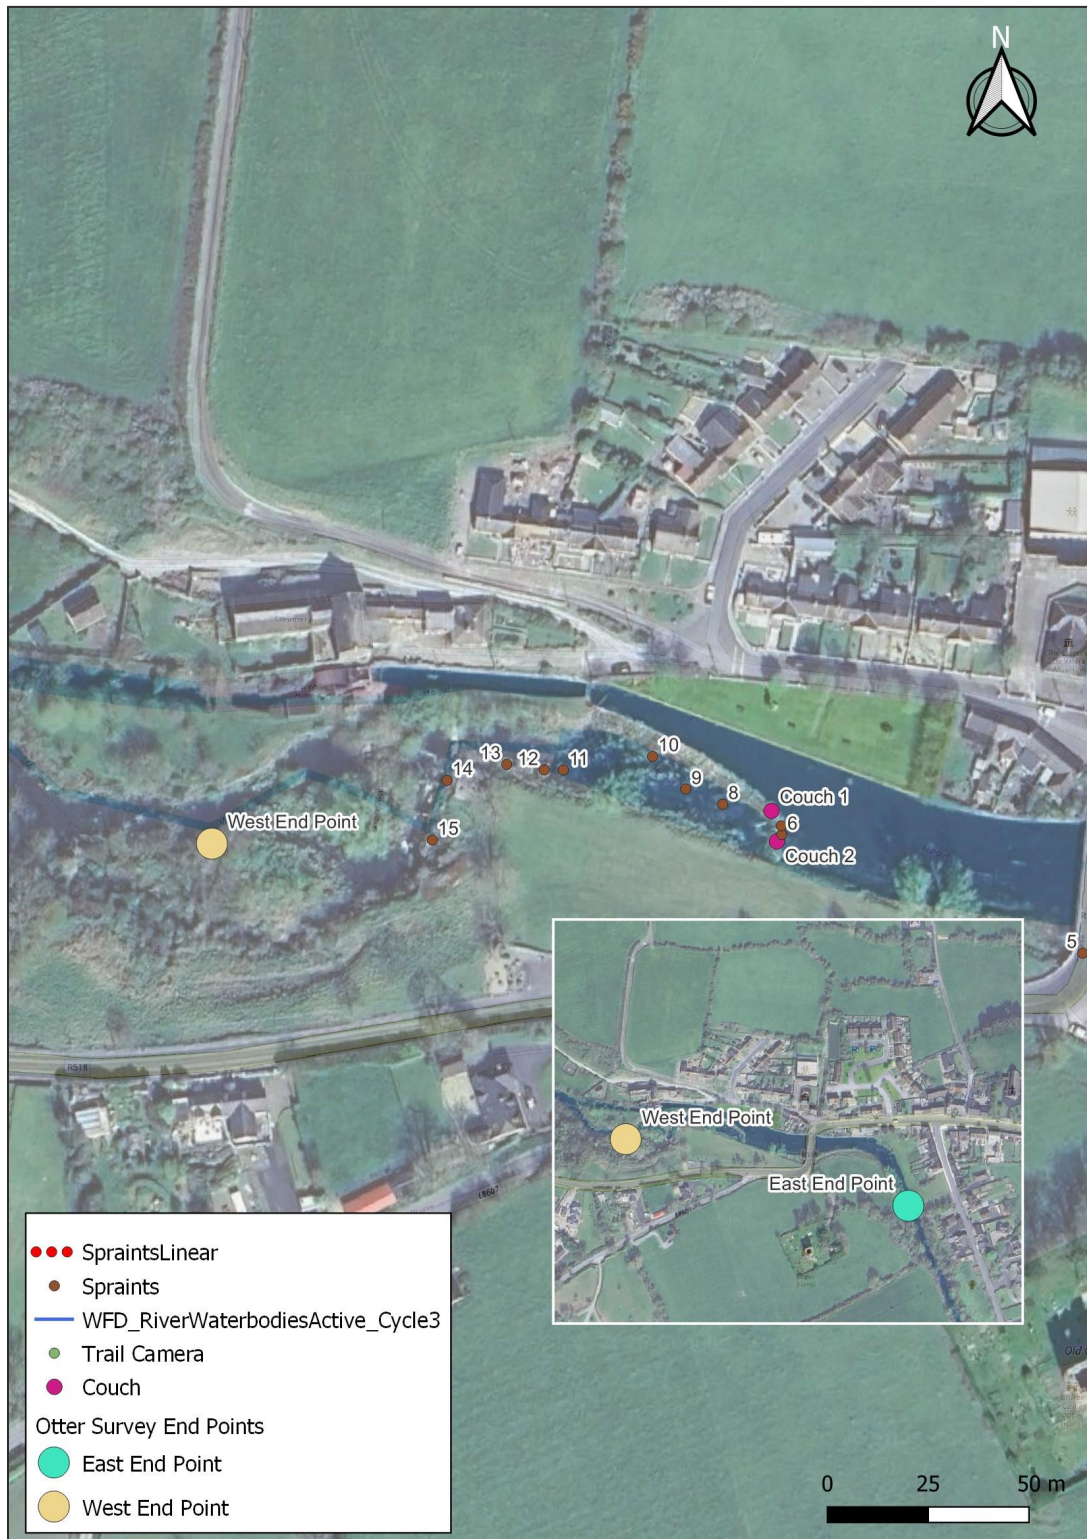
Figure 2. Otter survey area to the west of the bridge.

Downstream there were a total of 9 separate sprainting sites. Activity close to the bridge itself was minimal until the weir is reached. As the weir is old it is damaged in places. Near the southern bank at the western end of the weir, there is a chute in order to facilitate fish passage. Either side of this there was evidence of otters couching. This is an ideal location to hunt. As fish try to make their way up or down the chute they become easily predated by otters. There were spraints close by to the couching locations. Evidence of otter activity continued downstream with any prominent rocks having spraints present. Evidence of otters was found to continue for 175 metres downstream of the bridge. This area consists of a series of stepped pools and cascades which would hold up upward migrating fish and disorientate downward migrating fish; in both cases making them easier to catch for otter. As such, this is excellent otter hunting habitat, and would no doubt be a coveted reach of river territory. No holts or slides were found on the western side of the bridge.

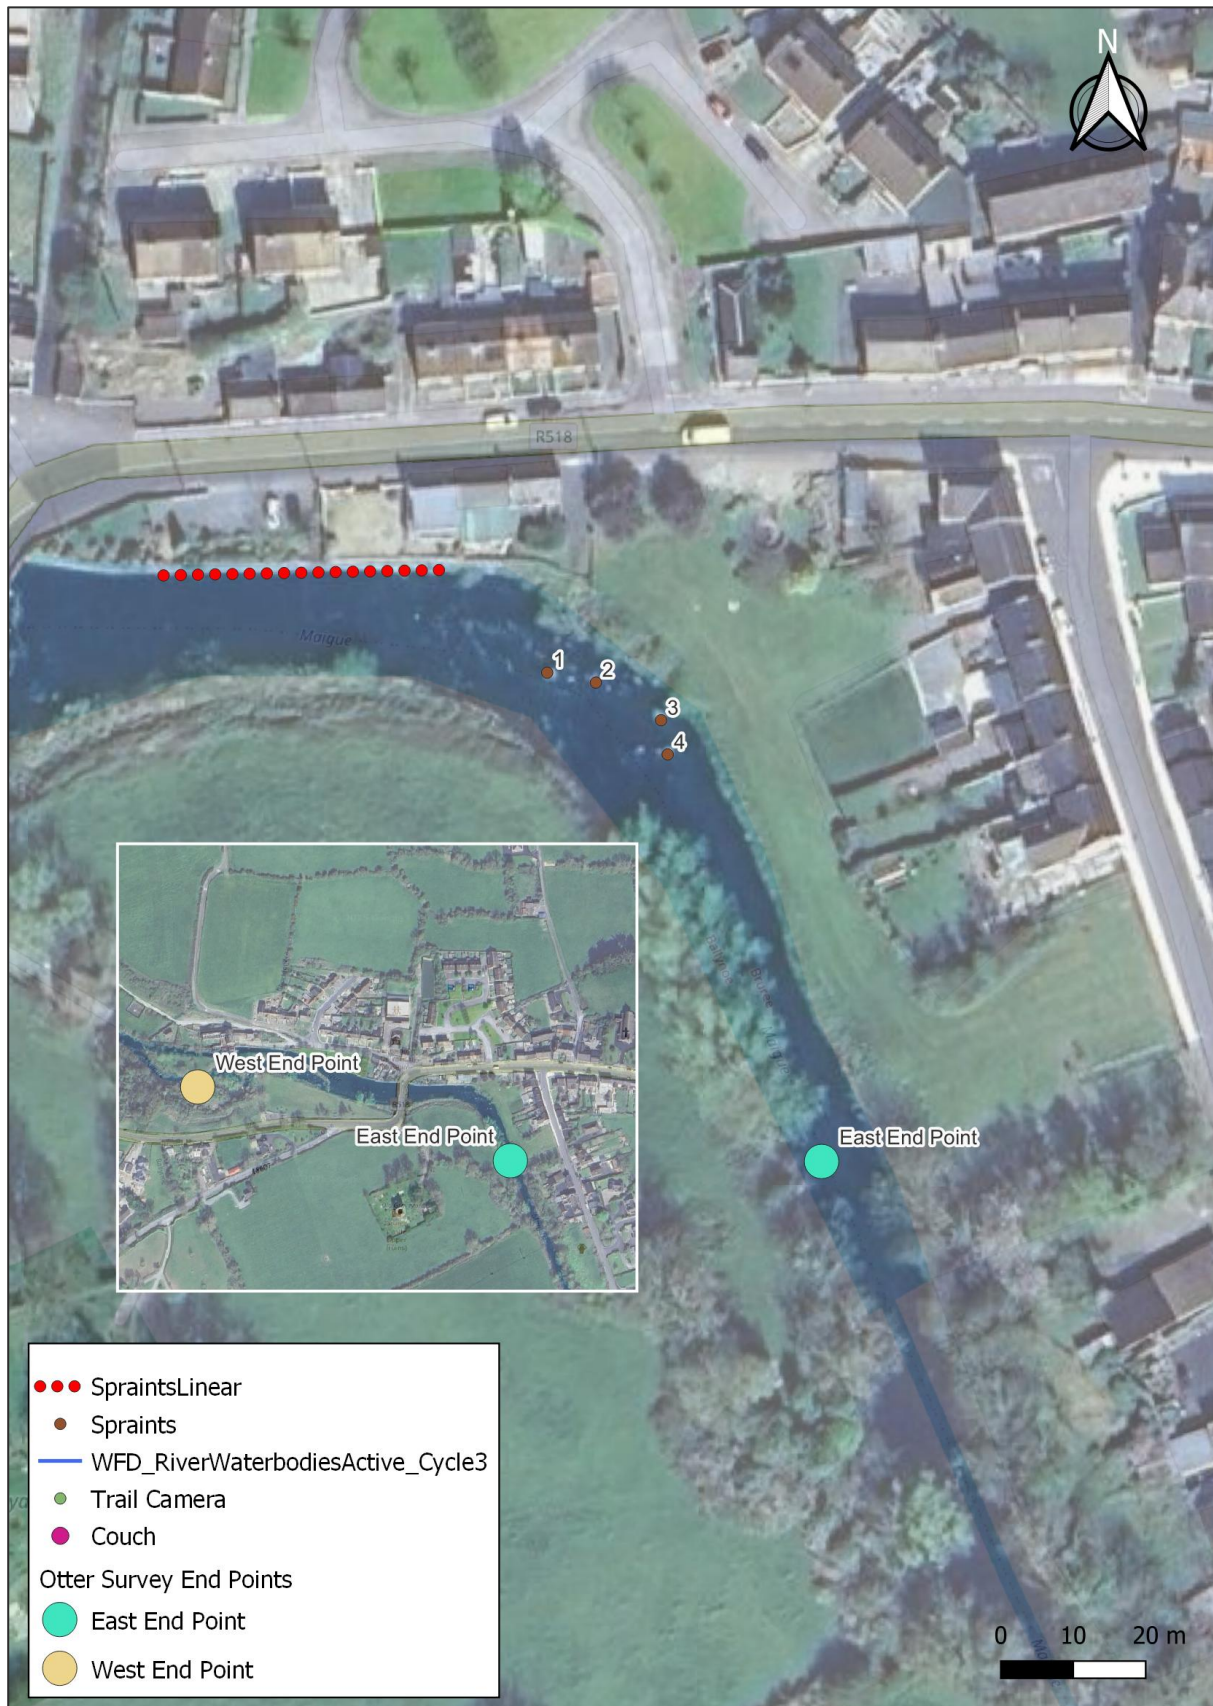
Figure 3. Otter survey area to the east of the bridge.

To the east of the bridge there a number of areas where otter spraints were found. In the river channel itself, emergent rocky debris (looks as though from a previous walled bank) was clearly frequented by otters as there were four separate sprainting sites. All sites had fresh and old spraints present. The north bank is a heavily modified man-made structure. There is a slight lip which stays out of the water, except during very large floods. This lip has a lot of otter activity, with a number of fresh and old spraints present. The frequency of spraints was observed to decline as we moved closer to the bridge. No holts, couches, or slides were found on the south bank of the eastern side of the bridge. Signs of otter activity continued for 90 metres upstream of the bridge.

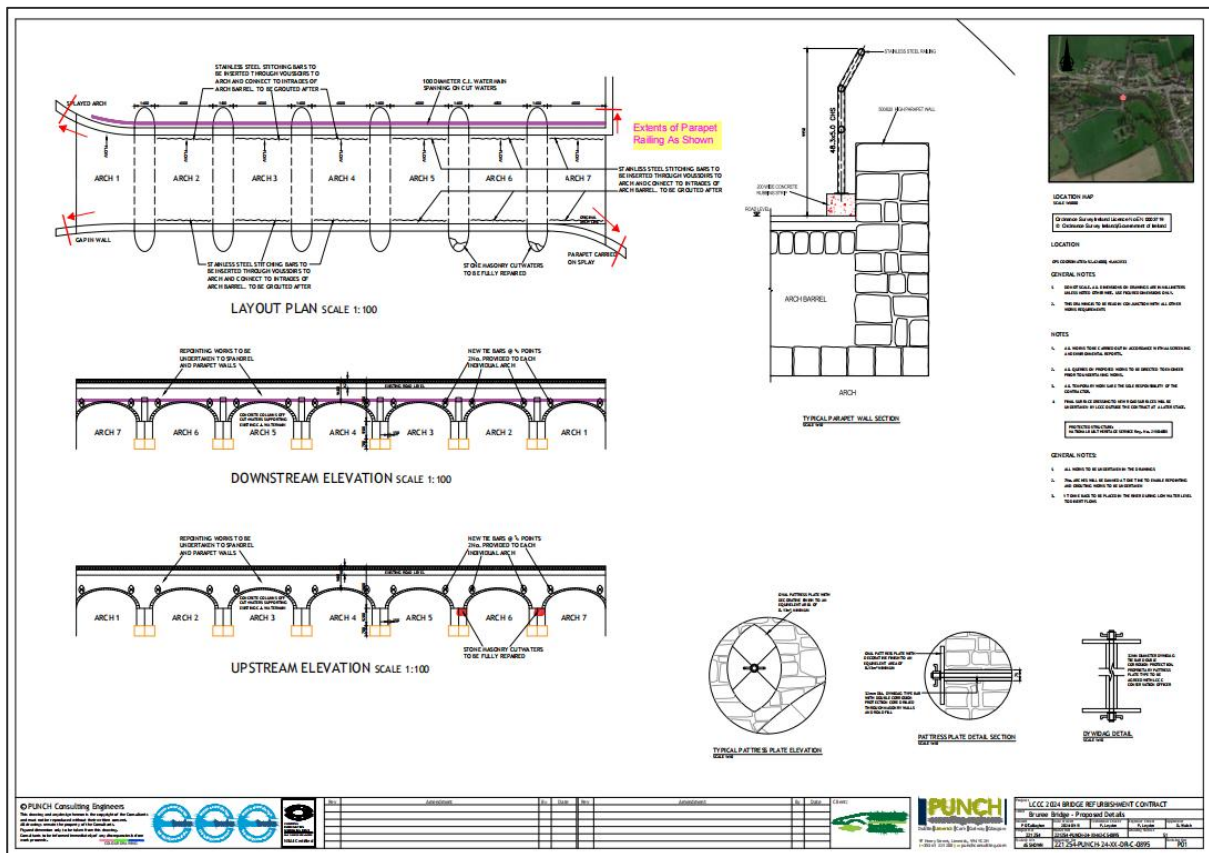
Figure 4. Plan of works.

- Localised pointing and stitching of cracks in arch barrels using stainless steel bars.
- Lime mortar repointing of arch soffits undertaken from mobile scaffolds.
- Grouting of voids using pump units located at road level, with containment to prevent runoff.
- Works undertaken in low-flow conditions and completed before 15 September.

- Repointing of spandrel and parapet walls with lime mortar.
- Installation of new stainless-steel tie bars and pattress plates from road level.
- Backfilling of tie bar trenches with lean-mix concrete.
