Kilfinane Market House Conservation Report

20th November 2023

**Document Title: Structural condition report
231245-PUNCH-XX-XX-RP-S-001**

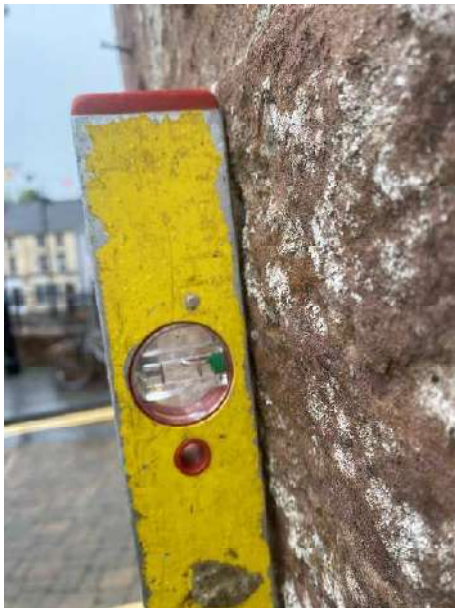
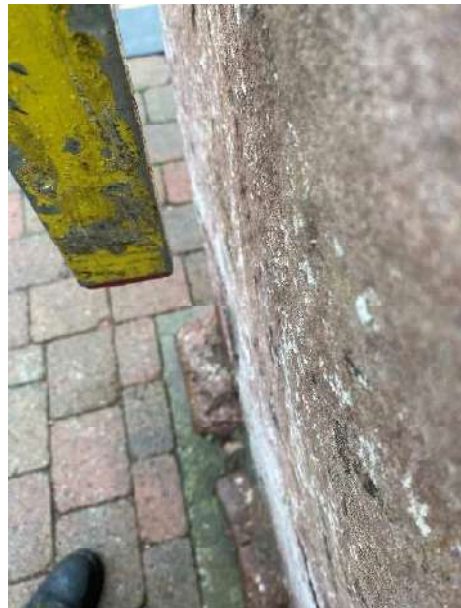
- We would recommend mortar analysis of remaining mortar before any repointing commences.
- Tie bars with Pattress plates have been placed on the front North-West & Gable South-West walls due to outward leaning of the upper part of the wall.

Photograph 024. Gable wall South-West façade the top is leaning outward.

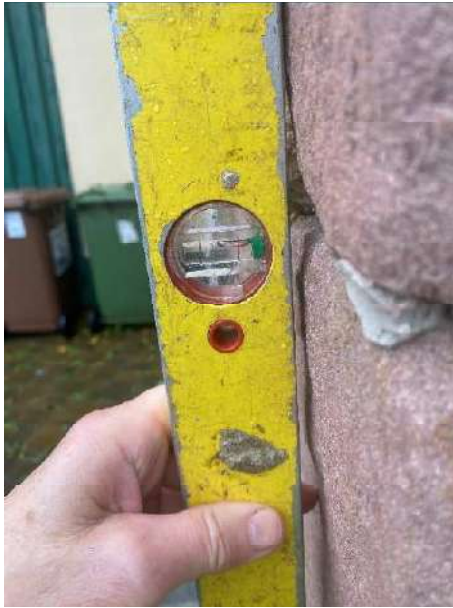
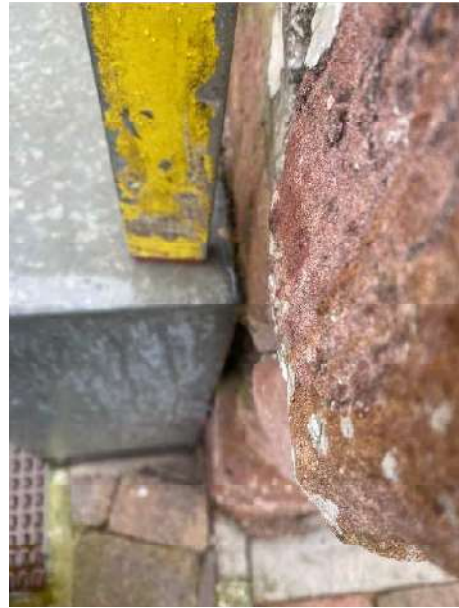
Photograph 025. Gable wall North-East façade the top is leaning outward.
